Mercer Inspection Services

Property Inspection Report

This report published on Tuesday, June 19, 2012 11:39:27 AM PDT

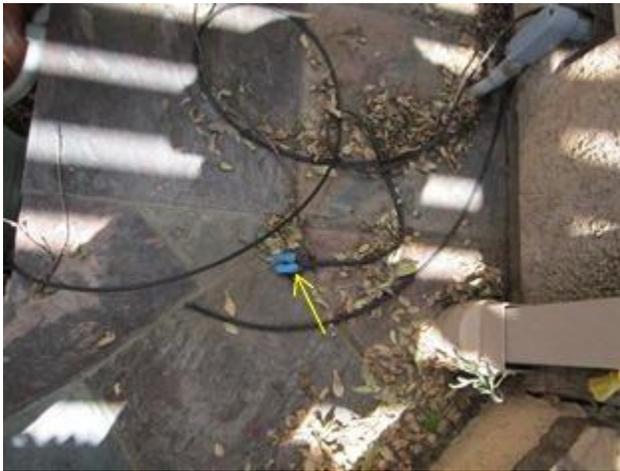
Extension cords are being used as permanent wiring in the outdoor kitchen, the base of the stairs going to the pool, and in one location at the base of the NW corner wall (back side of the house). This wire comes out of the crawl space vent and enters the dirt. The insulation on this wiring is partially melted and should be removed as soon as possible.

Photo 13
Adjacent spa, spliced wiring.

All other extension cords should be removed as necessary, or a qualified electrician should evaluate and make repairs as necessary. For example, install additional circuits and/or electric receptacles.

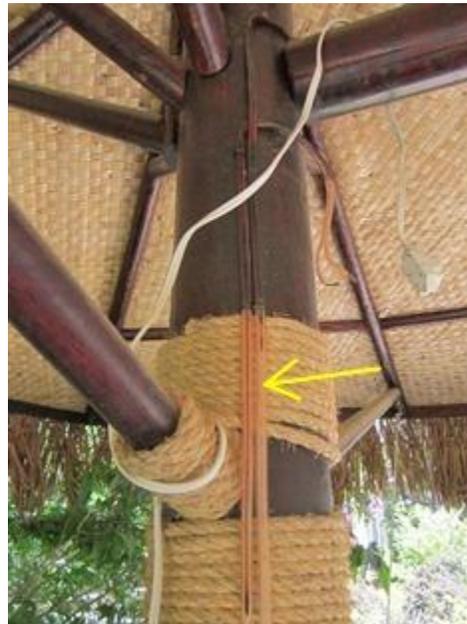
Photo 16
Outside entertainment area, improper electrical line.

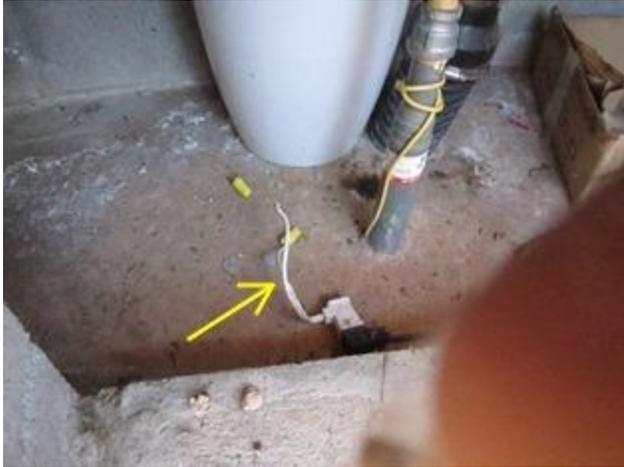
Photo 17
Outside entertainment area, under grill,
improper electrical line.

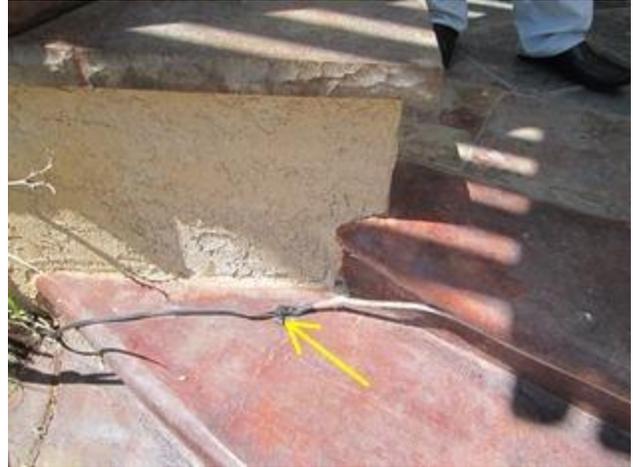
Photo 18
Rear step to pool, improper electrical

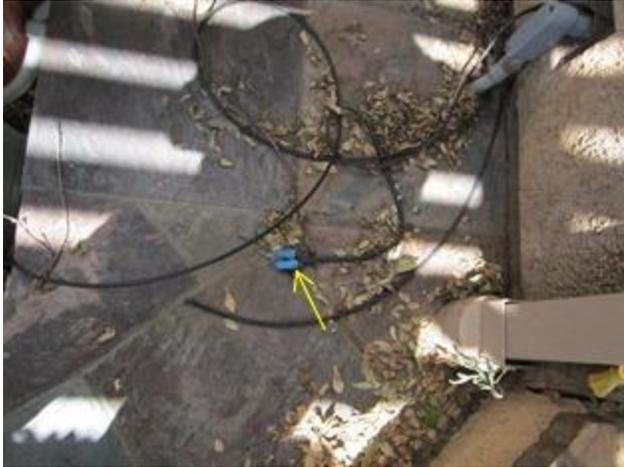
Flexible lamp or appliance cord are being used as permanent wiring in the outdoor kitchen, the base of the stairs going to the pool, and in one location at the base of the NW corner wall (back side of the house). This wire comes out of the crawl space vent and enters the dirt. The insulation on this wiring is partially melted and should be removed as soon as possible.

Photo 13
Adjacent spa, spliced wiring.

All other lamp/appliance cords should be removed as necessary, or a qualified electrician should evaluate and make repairs as necessary. For example, install additional circuits and/or electric receptacles being used for permanent wiring in one or more areas. This wiring is not intended to be used as permanent wiring, and poses a safety hazard of shock and fire. A qualified electrician should evaluate and make repairs as necessary.

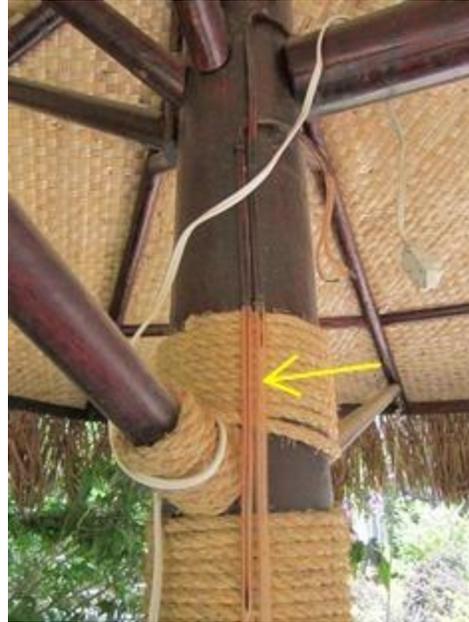
Photo 16
Outside entertainment area, improper electrical line.

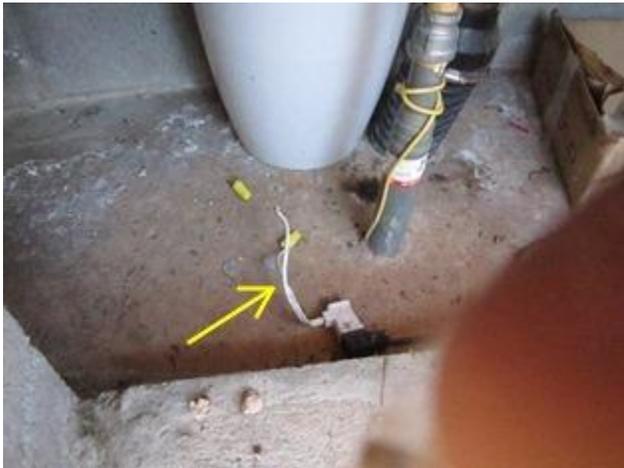
Photo 17
Outside entertainment area, under grill, improper electrical line.

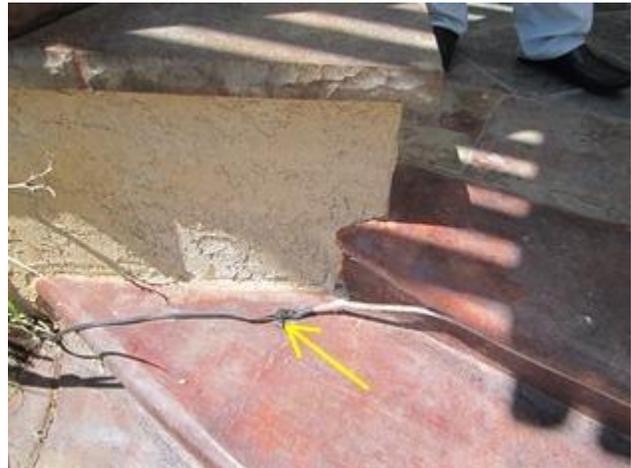
Photo 18
Rear step to pool, improper electrical

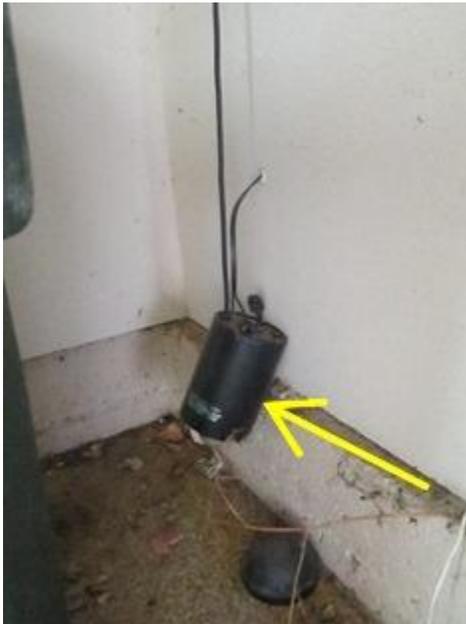
2) A timer controller located on the SE corner of the interior of the garage is detached from its mounting and one of the power lines is detached.

Photo 9
Garage door, east front, detached watering timer.

Almost the entirety of the outside system needs maintenance and by a qualified landscape contractor.

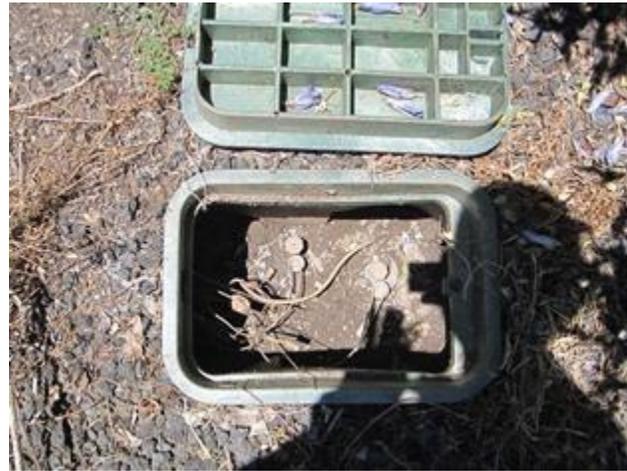
1) There appears to be problems with the electrical relay system and evidenced by the tampering of the below ground junction box (see photo).

Photo 31
SE exterior corner of house.

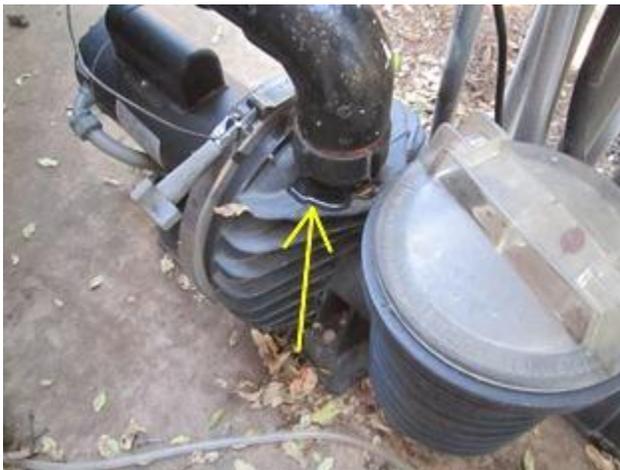
- 1) The pool pump is operational, but the water flow is flowing only marginally.
- 2) The outtake, line a few inches from the pump, is leaking (see photo).
- 3) Under the above conditions, the pools heater was not able to be tested.

Photo 19
Leaking pool plumbing-near pump.

This should be evaluated by a pool specialist. I have not flagged this as a major defect; however, because it cannot be fully tested, there could be very expensive to correct issues.

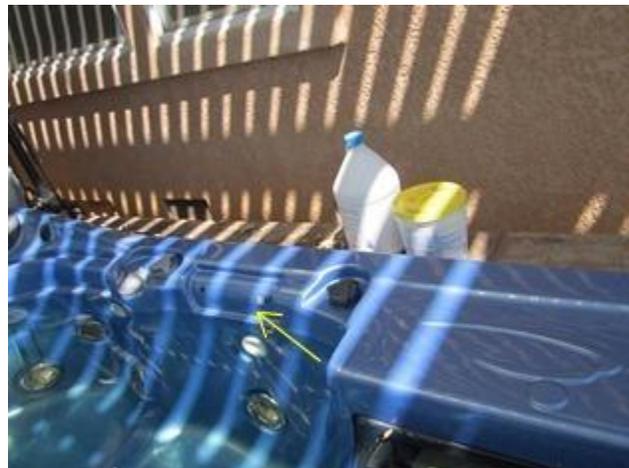
Photo 15

- 1) The spas pump is operational and the water jets functioned adequately.
- 2) The spas heater was not operational.
- 3) 40% of the lighting was functional. This is probably due to burned out bulbs as lighting fixtures had mixtures of working and not working bulbs.
- 4) The sound system (radio/cd/amplifier) has been removed.
- 5) Back rests (near upper rim on each seat) have been removed or broken off from most of the seats.

Spa, missing part, north side

This should be evaluated by a pool or spa specialist. I have not flagged this as a major defect; however, because the heater is not functioning, this could be a moderately expensive repair.

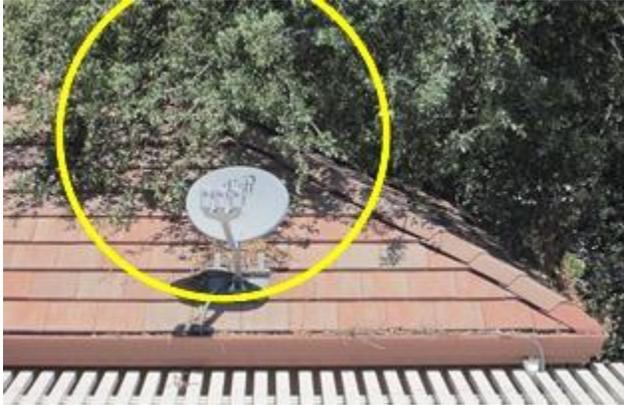
Photo 23

9) 🛠️ The oak tree on the NW corner of the house (rear of house) has covered a significant portion of the roof. The largest problem with this is that it will allow wood destroying insects a means to access the house. Additionally, oak branches can make a significant amount of noise as they brush against the house when it is windy. Vegetation should be pruned back and/or removed as necessary.

N.E section of roof, oak tree should be cut back.

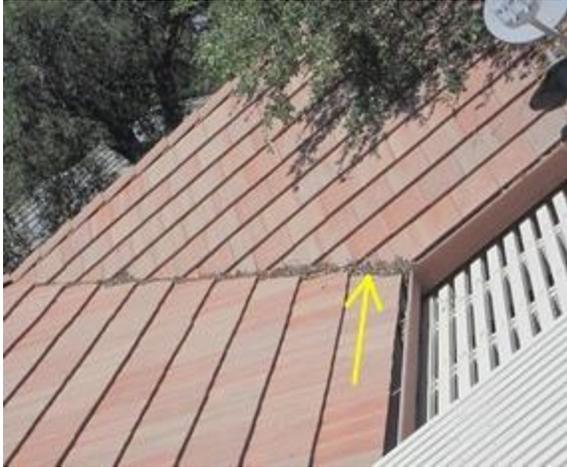
10) 🛠️ Debris has accumulated in one or more gutters. This is conducive for wood destroying insects since gutters may overflow and cause water to come in contact with the structure's exterior or make water accumulate around the foundation. Gutters should be cleaned now and as necessary in the future.

11) 🛠️ Debris such as leaves, needles, seeds, etc. have accumulated in a few of the roof valleys. Since water may not flow easily off the roof, and may enter gaps in the roof surface. Leaks may occur as a result. Debris should be cleaned from the roof now and as necessary in the future.

Photo 22
Roof valley and gutter cleaning needed,

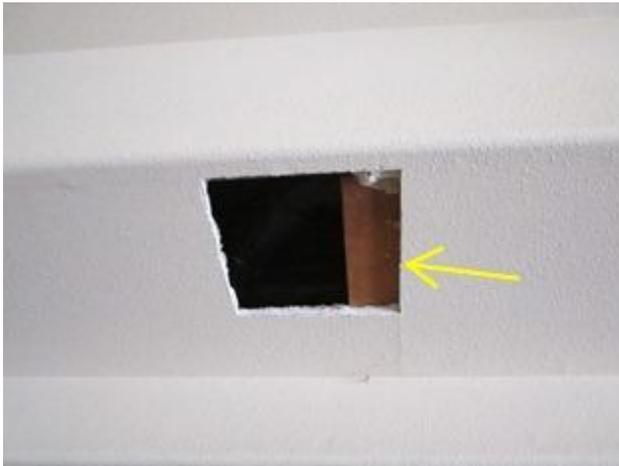
The ceiling surfaces between the attached garage and interior living spaces has missing or inadequate surface materials. A 12" by 12" section of ceiling drywall has been removed. This is in the center of the garage. These surfaces are intended to prevent vehicle fumes from entering living spaces, and to slow the spread of fire from the garage to living spaces. A qualified contractor should evaluate and make repairs as necessary so the attached garage wall and ceiling surfaces that adjoin living spaces are tightly sealed and fire rated as per standard building practices. Typically these surfaces require a one-hour fire rating.

Photo 8
Garage ceiling center, opening.

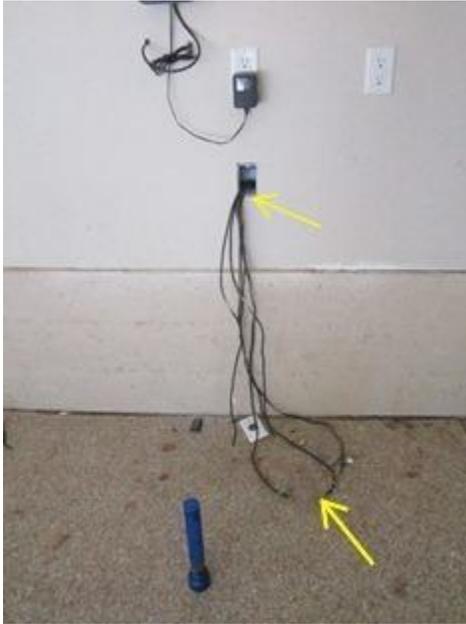
On the back wall of the garage, wiring in two locations is loose, unsupported, or inadequately supported, and wire ends are exposed (no terminated with protective caps (see photo).

Photo 10
Garage rear, loose wiring 2.

A qualified, licensed electrician should evaluate and repair as necessary.

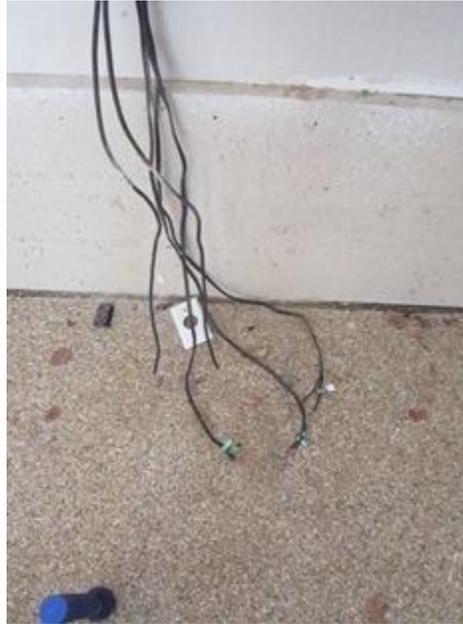
Photo 7
Rear garage, loose electrical

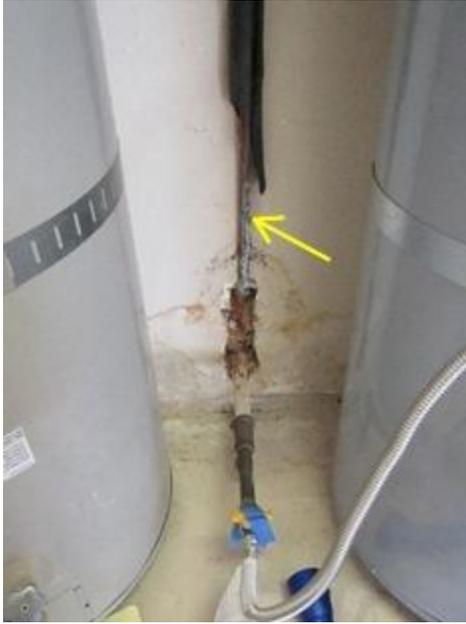
21) 🔧🔍 Corrosion was found on fittings and/or water supply lines for the water heater. The copper pipe was moist in some places, a leaks may exist. A qualified plumbing contractor should evaluate and repair as necessary.

Photo 6
Water heater water supply line.

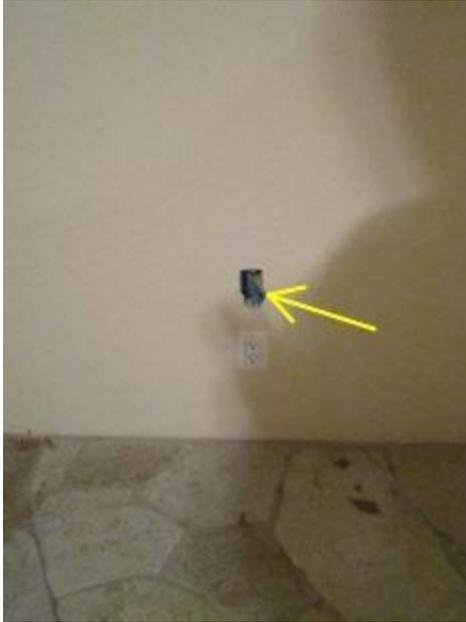
Wire splices are exposed due to not being properly contained in a covered junction box. This box is on the north wall at the base of the entrance stairs. This is a safety hazard due to the risk of shock and fire. Install a securely mounted cover plate over the open junction box. with cover plates where needed to contain wiring splices.

Photo 11
Garage, east lower level storage, open junction box.

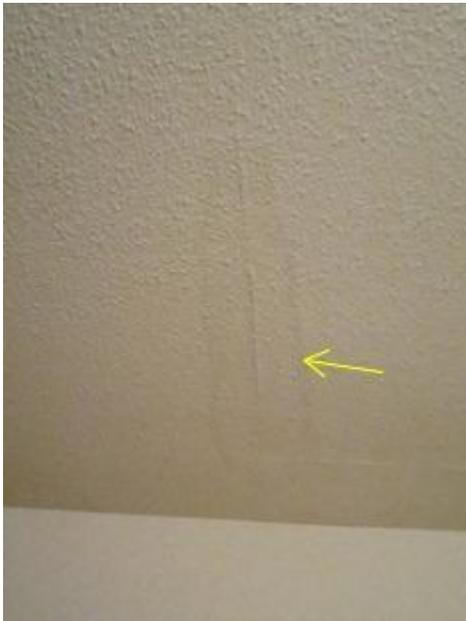
Photo 12

There is a stain in the area of the south side ceiling wall. The moisture content of the stain is 10% which is normal. This indicates that there is not current leaking above the ceiling drywall in this area. The sink plumbing in the laundry room, above the stain, is not currently leaking. The sink could have leaked previously and since been repaired, or water might have been spilled onto the floor above. I recommend that you be cautious about allowing too much water to pool on the laundry room floor and I recommend that the tile in the laundry room be caulked around the edges that meet all walls, sink, and washer and dryer.

Garage, east lower level storage, ceiling stain.

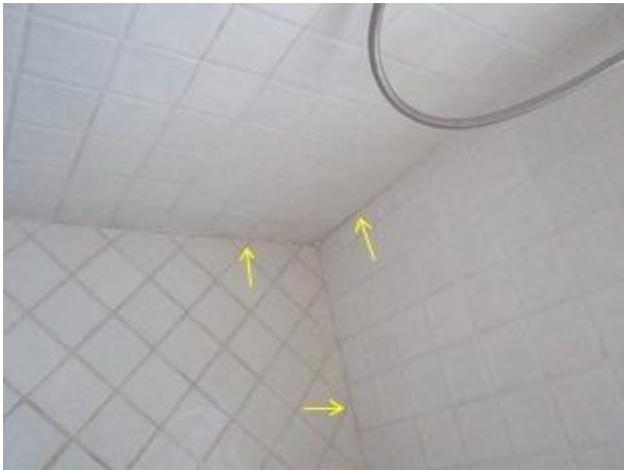
Caulk is deteriorated along the base of the shower in the main first floor bathroom (NE bedroom). It should be replaced where deteriorated and/or applied where missing to prevent water intrusion and damage to the floor structure.

Photo 3
Study bathroom, caulking.

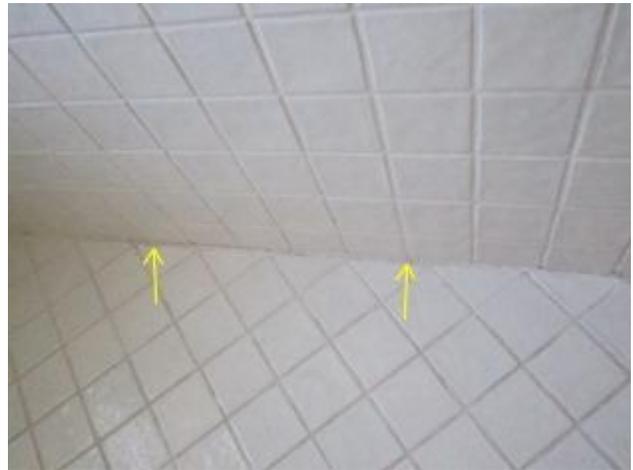
Photo 4
Study bathroom, caulking 2.

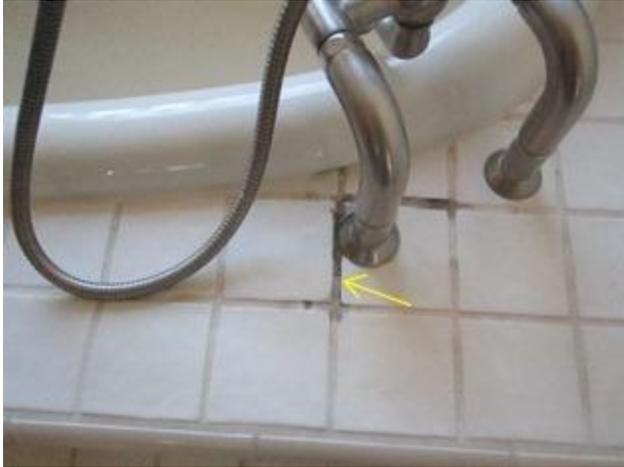
Tile grout is molding around the base the bathtub spout. This type of black mold can be cleaned with a grout specific cleaning agents, such as K-14. After cleaning, I recommend this area be treated with a grout sealant. There are numerous good products available.

Photo 5
Study bath grout mold

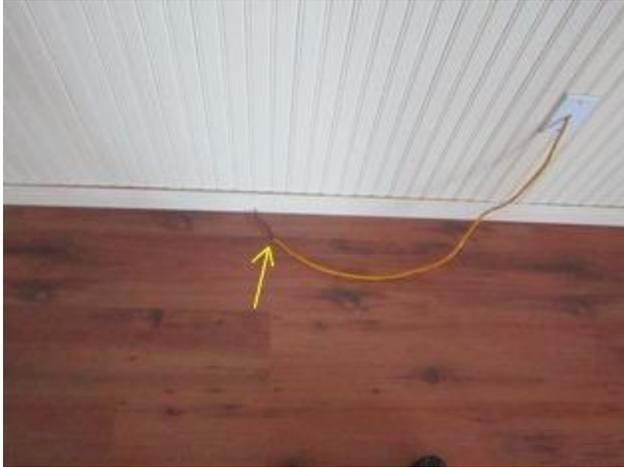
- 1) There are two exposed wires in the entertainment room on the second floor. These need to either be removed or properly terminated and placed in a junction box.
- 2) There is an exposed wired in the first floor study, south wall. This needs to either be removed or properly terminated and placed in a junction box.

Photo 21
Upstairs, entertaining area, north wall, improper electrical.

Recommend that a qualified electrical contractor make this repair.

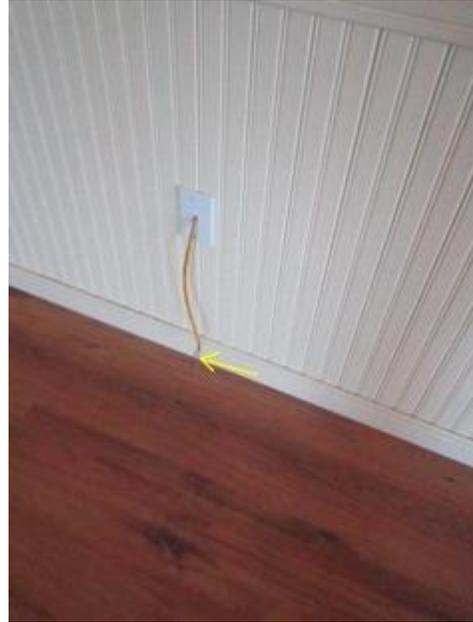
Photo 25
Upstairs, entertaining area, north wall, improper electrical 2.

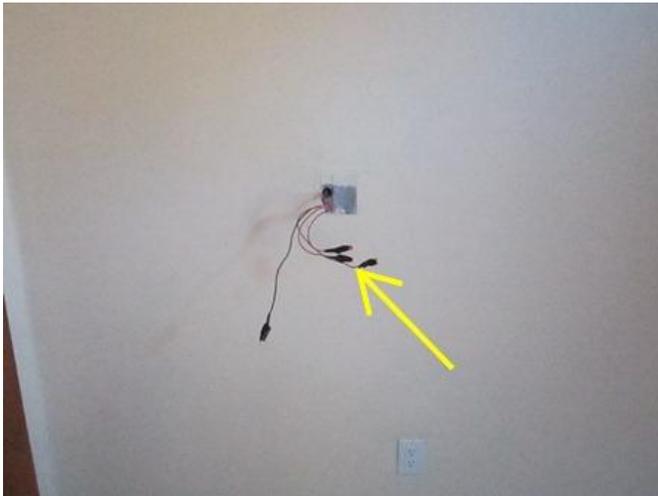
Photo 1
Study, south wall electrical.

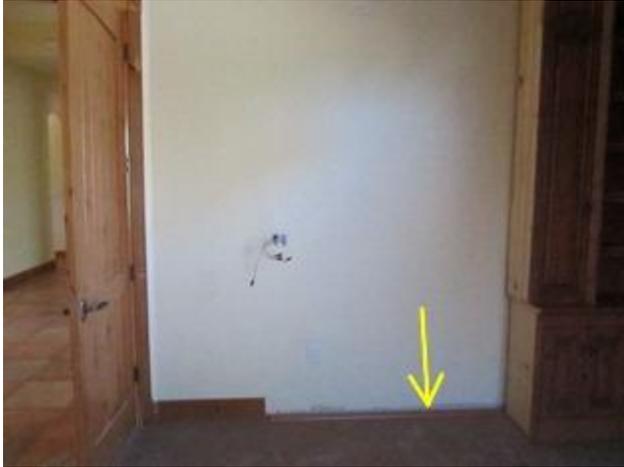
40) 🔧 1) An approximately 7' long section of the bookcase is missing from the first floor study (south wall)--the upper ladder guide was also severed, and the ladder is missing.
2) A built in feature (6' to 7') has been removed from the first floor study (east wall).

Photo 2
Study, south wall bookcase, trim

Recommend having a qualified contractor install these fixtures were missing.

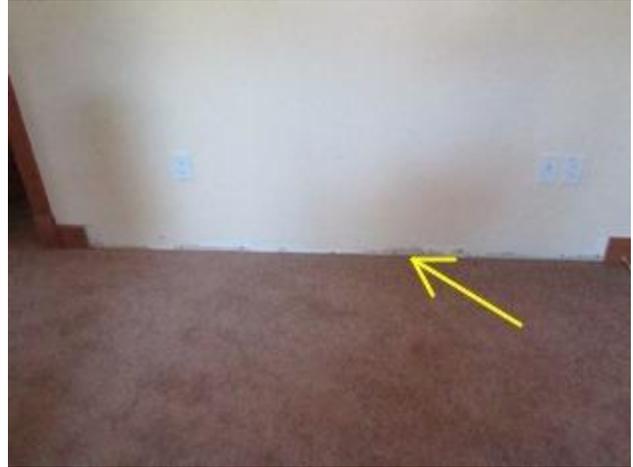
Photo 20
Study, east wall, missing trim.
