# Mercer Inspection Services

## Property Inspection Report

This report published on Monday, June 25, 2012 2:15:22 PM PDT

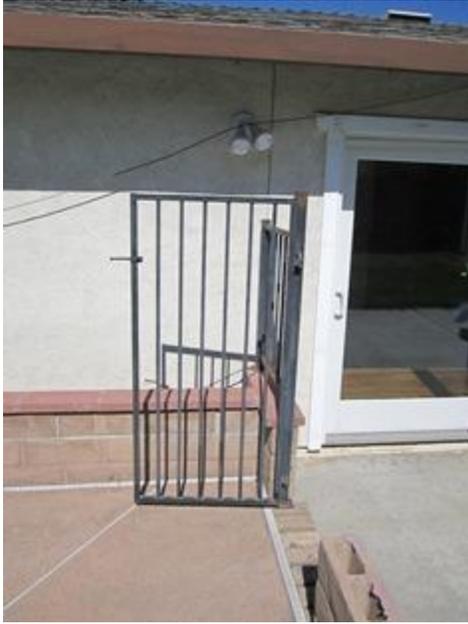
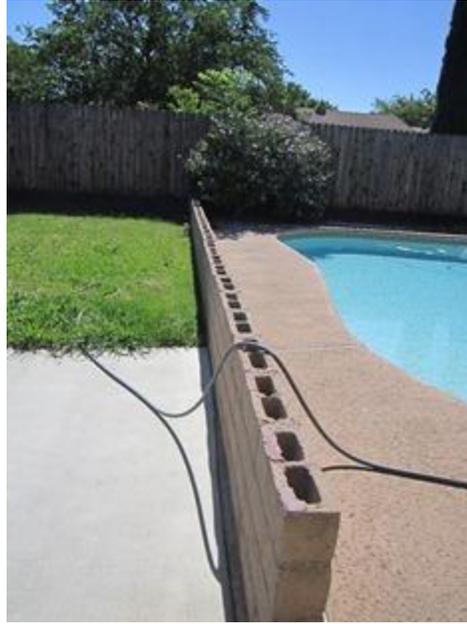
The pool gate is damaged and/or missing. A qualified contractor should evaluate and replace or make repairs as necessary.

Iron fence was removed and is currently stored on the south side of the house.

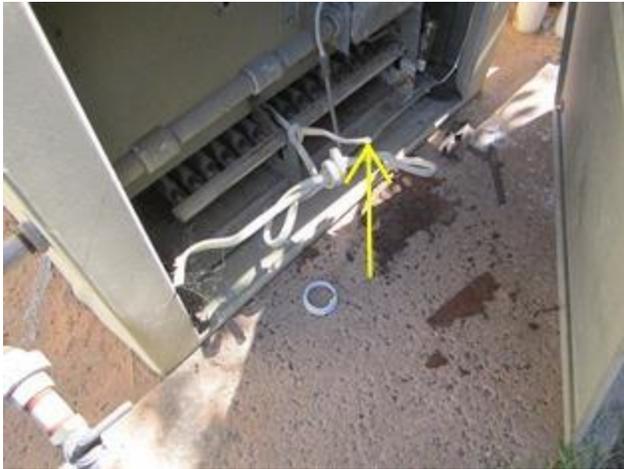
- 1) The pool's water heater is not operational.
- 2) The water heater has an electrical line threaded through it and I was not able to determine if this line is used for anchoring the heating element or if it is an improperly placed potentially energized power line. Additionally, this line is not terminated.

**Photo 12**  
Un-terminated line and is routed through gas furnace.

Recommend that either a licensed electrical contractor or pool service specialist make this repair.

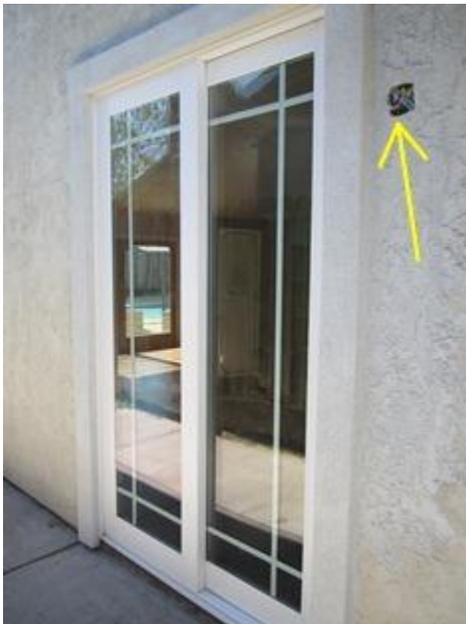
**Photo 10**

Exterior wiring box. The garage door (north side of garage) external light is not installed and the electrical box is not covered. The exposed wiring in this box is hazardous, and at a minimum, a cover needs to be placed on it.

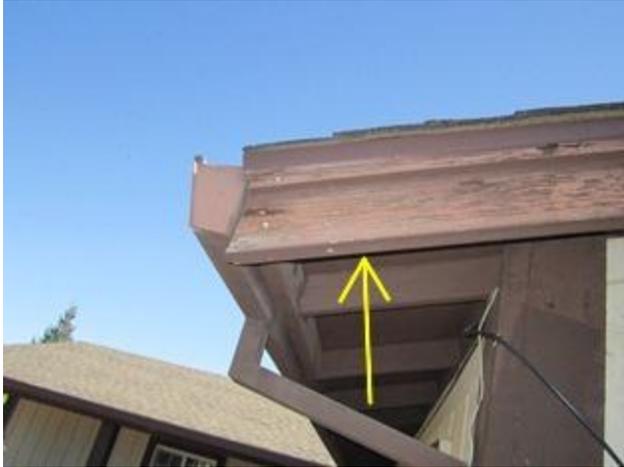
**Photo 4**

South fascia board is deteriorated. Recommend replacing section from base of roof to apex.

A qualified contractor should evaluate and make repairs and/or replace as necessary.

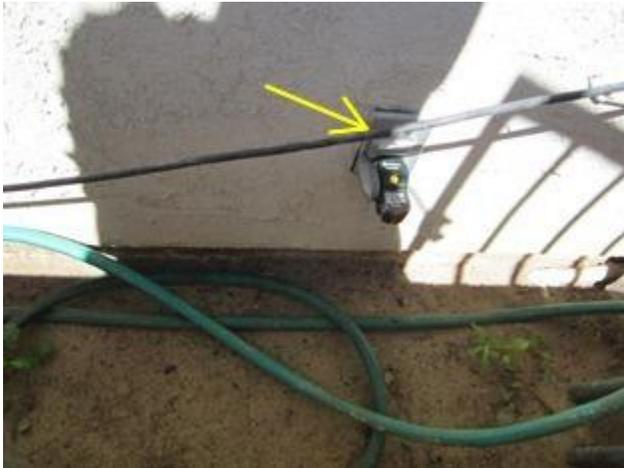
**Photo 27**

The electric receptacles at the rear of the home (south of main patio entrance) have no power. Recommend asking the property owner(s) about this. Switches may need to be operated to make some receptacles energized. If necessary, a qualified electrician should evaluate and make repairs as necessary.

External receptacle, five feet south of patio sliding door.

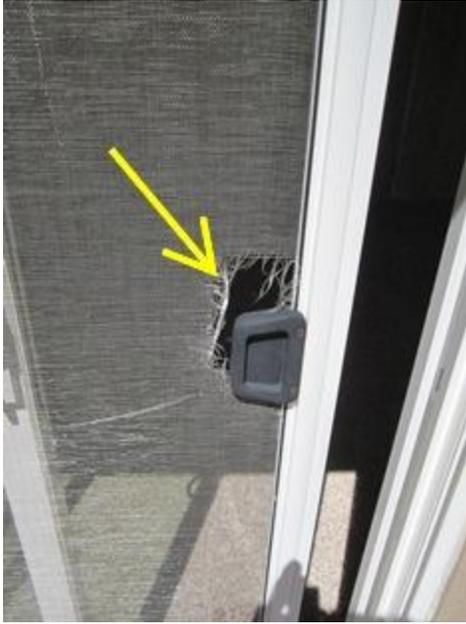
Screen door. The master bedroom's sliding screen door to the patio is torn and needs to be replaced. A new screen can be fitted into the original framing.

**Photo 26**  
Torn screen, master bedroom.

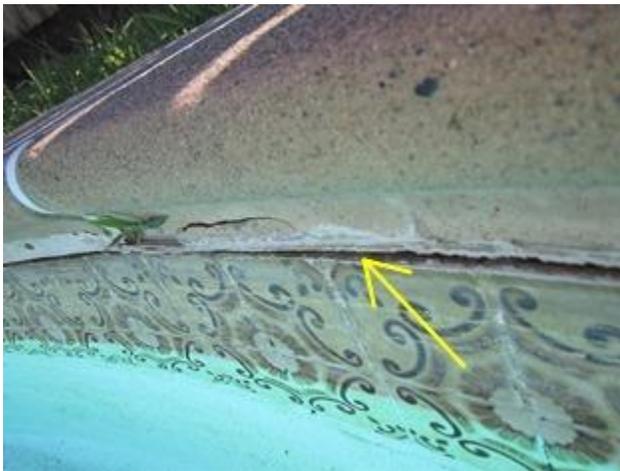
**Photo 36**

The caulking between the cement deck (upper) and tile (lower) is cracking and missing in many areas.

Recommend removing and replacing with new caulking.

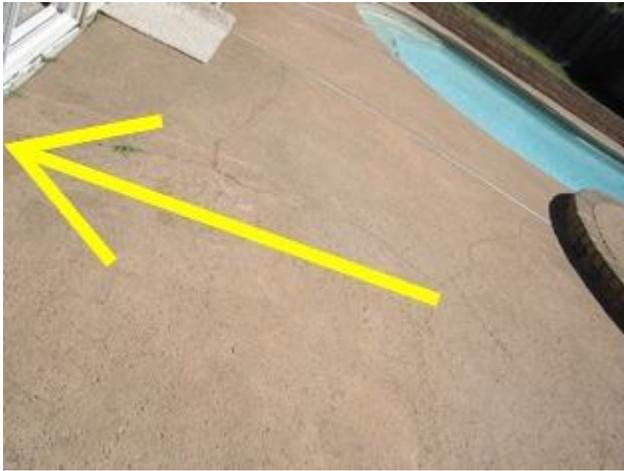
**9)** ⓘ Minor cracks were found in one or more sidewalk or patio sections. However they don't appear to be a structural concern and no trip hazards were found. No immediate action is recommended in the front of the home; however in the rear of the home, the patio may be slumping towards the home. This appears to be due to erosion cause by the

improper drainage of water from the patio service to the southwest region of the house (just outside of the master bedroom). Client(s) should have a proper drainage system installed to remove standing water from this area and reduce erosion of underpinning soils. Clients(s) should also have repairs made to existing cracks for aesthetic reasons.

**Photo 15**  
Slopes in direction of arrow towards the house.

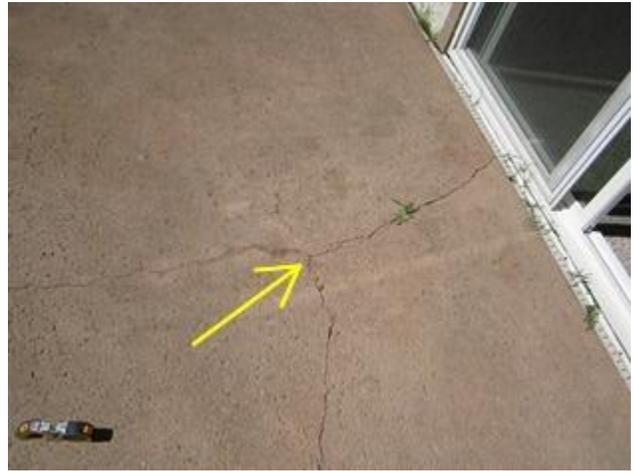
**Photo 16**  
Cracking and slope following direction of arrow.

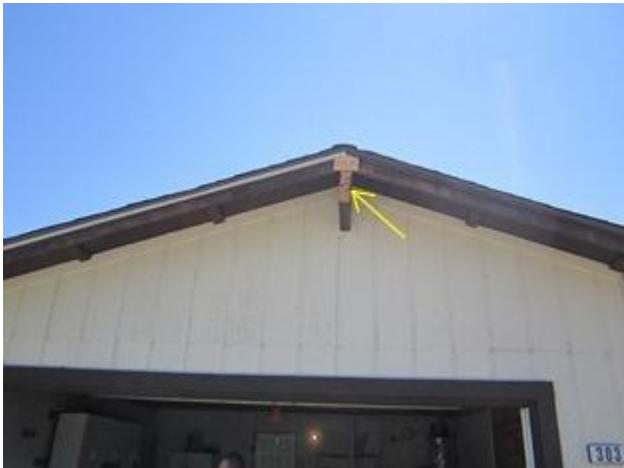
The terminal end of the garage main overhead beam has been cut by several inches and is exposed to weather. The beam had most likely rotted and a former owner cut the rotted section off. This possesses no risk to the structural integrity; however, the end of the beam is exposed wood and need to be covered by a suitable primer and paint.

**Photo 29**  
Exposed beam end.

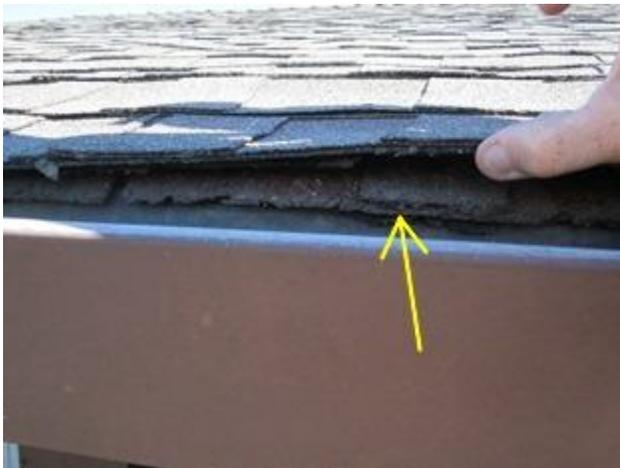
**Photo 9**

This asphalt or fiberglass composition roof surface has two or more layers of roofing materials. When this roof is replaced, recommend a complete "tear off", where all existing layers of roofing are removed before installing new roofing materials. For 20-year rated composition shingles, additional layers of material reduce the new roof material's lifespan as follows:

Two roofing layers.

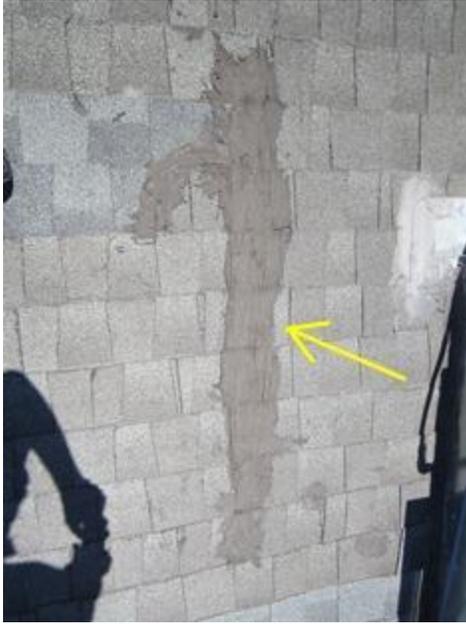
**Photo 8**

Asphalt or tar sealant has been used on metal roofing in one or more areas. This is not a standard building practice since it can trap moisture between the metal and the sealant and accelerate rusting and/or corrosion. It's likely this roof has had active leaks and was repaired by someone other than a qualified roofing contractor. A qualified roofing contractor should evaluate and make repairs as necessary.

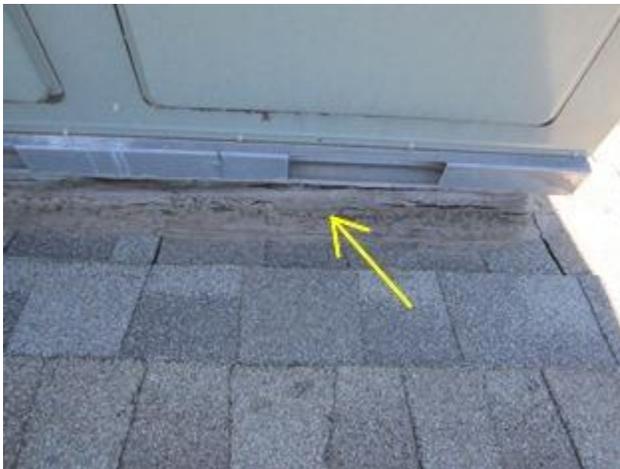
**Photo 34**

Cracking sealant. Roofing sealant is cracking around some vents and the air conditioner compressor.

Sealant cracks.

Recommend resealing with a suitable sealant.

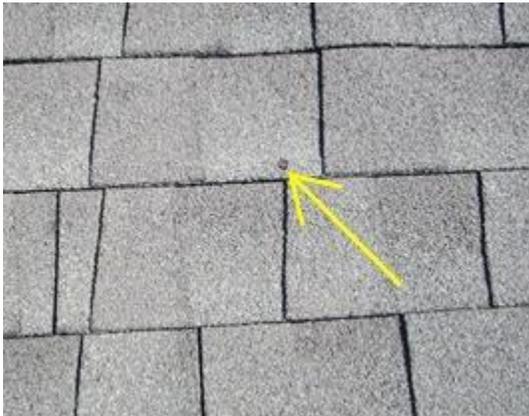
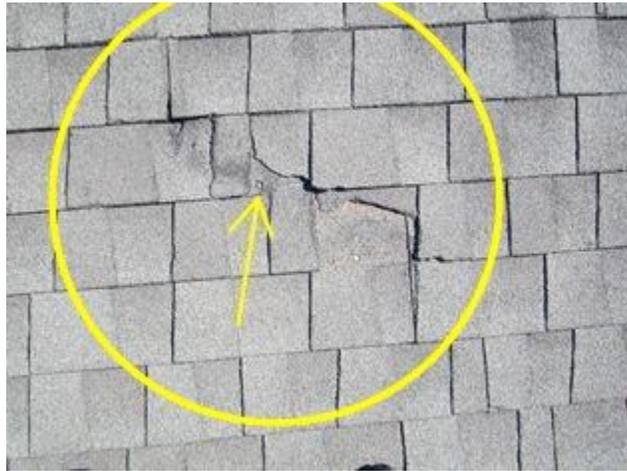
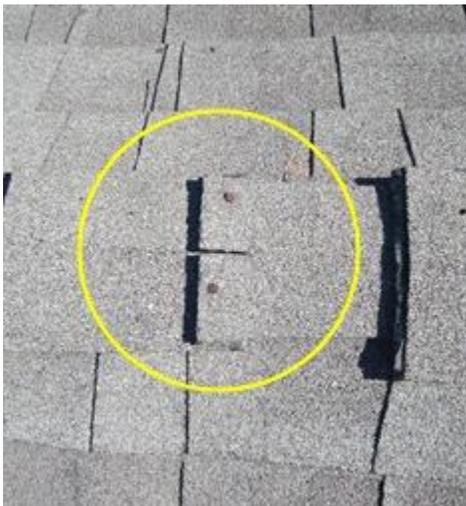
**15)** Roofing section that covers the garage has been improperly installed. Nailing's were performed on shingles below the overlay line. When nails are applied below the over lay line, leaking is likely to occur.

Additionally, in this region there is a region where the shingles are damaged and need to be replaced.

Recommend having a qualified roofing contractor should remove this section and replace it as soon as possible.

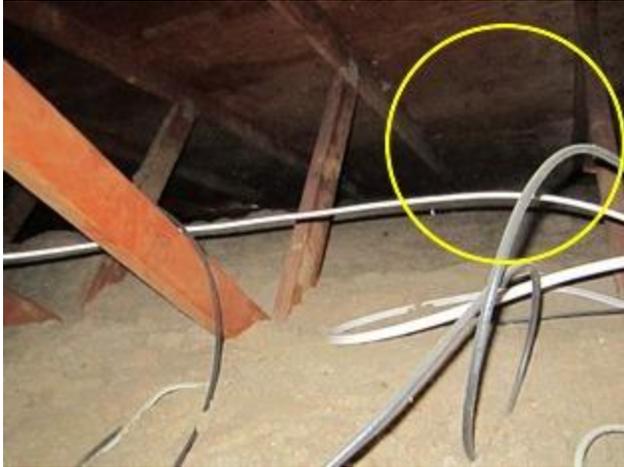
**Photo 17**

Areas of the sheathing are water stained and there is evidence of some previous mildew growth. The inspector transverse the stained areas from the surface of the roof and the areas did not appear weak (flex under bouncing weight). From the vantage point of the attic entrance the sheathing does not appear to be splitting or cracking. Moisture content was taken from two accessible stained areas and was 10%. This is normal.

Some discoloration from previous roof leakage. Sheathing is currently dry and structurally sound.

Recommend replacing roof to prevent or lower the potential for any further moisture from contacting the roof sheathing.

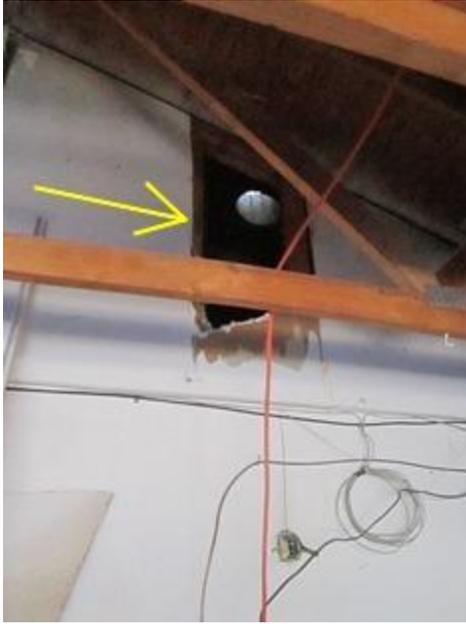
1) The surface between the attached garage and interior living spaces has an approximate 18" x 24" gap in the surface materials.

**Photo 18**  
Firewall to be replaced.

These surfaces are intended to prevent vehicle fumes from entering living spaces, and to slow the spread of fire from the garage to living spaces. A qualified contractor should evaluate and make repairs as necessary so the attached garage wall and ceiling surfaces that adjoin living spaces are tightly sealed and fire rated as per standard building practices. Typically these surfaces require a one-hour fire rating.

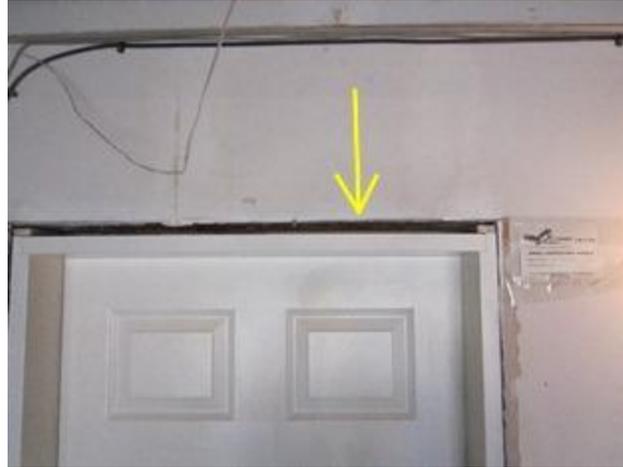
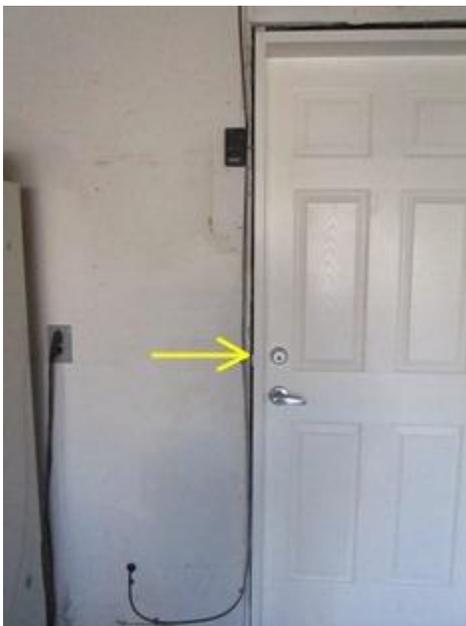
2) The perimeter of the garage/house door has large gaps surrounding the frame. These need to be filled.

**Photo 19**  
Gap

**Photo 20**  
Gap

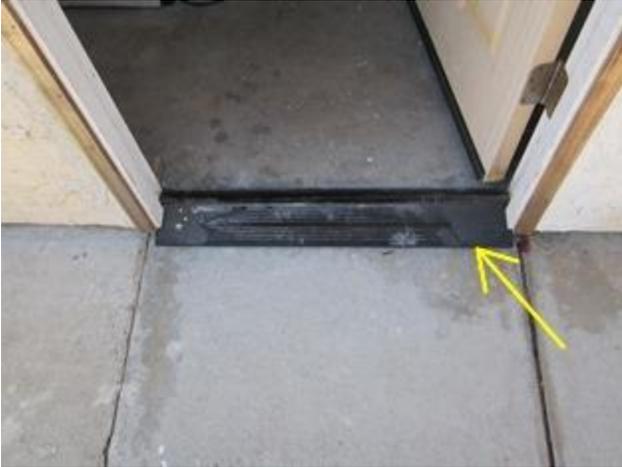
The kick/step plate at the base of the garage/external door is wobbly. This aluminum plate needs to be attached so that there is not play when it is stepped upon.

**Photo 33**  
Plate wobbly and poorly attached.

A qualified contractor should evaluate and repair as necessary.

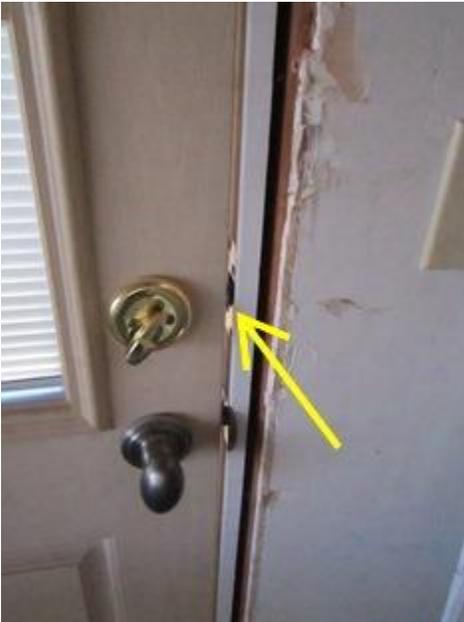
The lock mechanism on the garage to external door is very difficult to operate. A qualified contractor should evaluate and repair as necessary so vehicle doors can be easily secured.

**Photo 22**  
Hard to open lock.

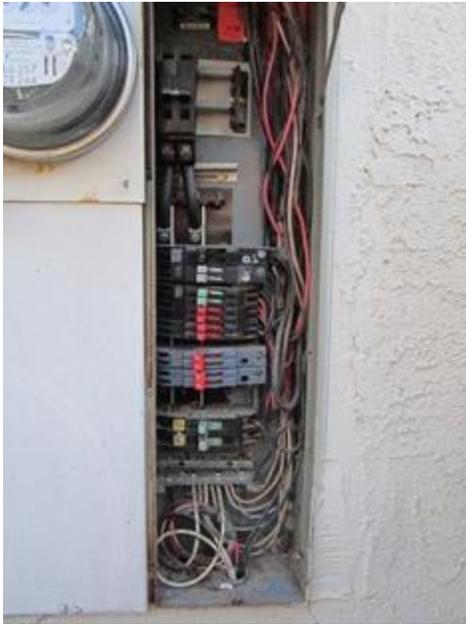
This property has a main service panel that uses Zinsco brand circuit breakers. This panel and circuit breakers have a variety of problems including:

- Bus bars possibly made from aluminum that tends to oxidize and corrode
- Breakers that don't trip under normal overload conditions
- Breakers that appear to be tripped when they're not

These problems are a safety hazard due to the risk of fire. Recommend having a qualified electrician replace any and all panels that use Zinsco brand circuit breakers.

**Photo 3**  
Un-terminated wire.

If the panel is not replaced, then a qualified electrician should thoroughly evaluate the panel and components within and make repairs as necessary. Recommend installing smoke detectors above such panels.

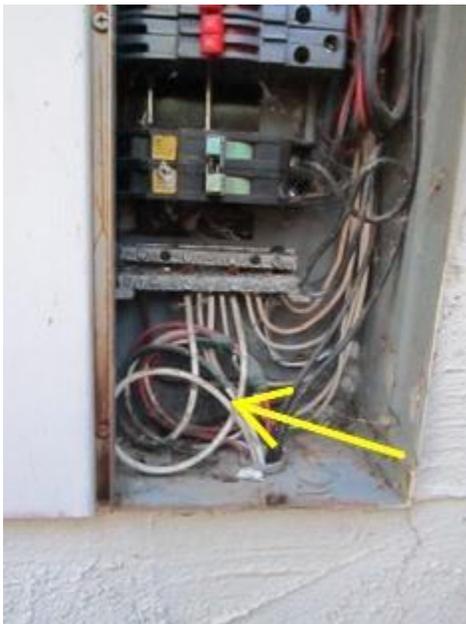
There is a loose conductors in the main service panel have bare ends and are not connected to an overcurrent protection device (circuit breakers or fuses). This is a safety hazard due to the risk of fire if the bare conductors come into contact with other components in the panel. A qualified electrician should evaluate and repair as necessary. For example, removing wires that aren't terminated or installing wire nuts.

**Photo 35**  
un-terminated wire

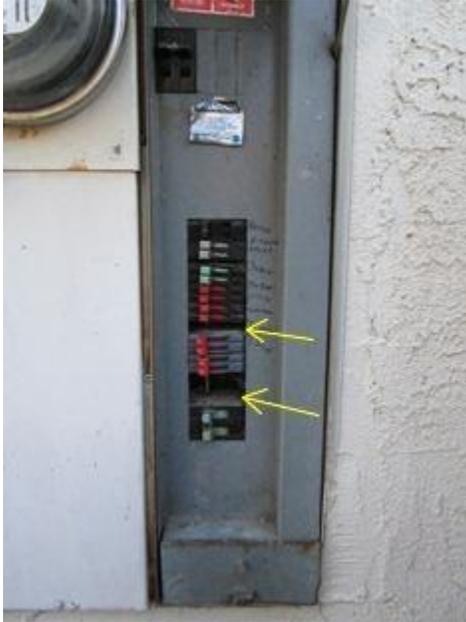
Exposed wiring and/or bus bars exist in the main service panel due to closure covers missing (slots where circuit breakers fit through the panel cover). This is a safety hazard due to the risk of shock. Closure covers should be installed where missing to eliminate exposed wiring, and by a qualified electrician if necessary.

**Photo 1**  
Missing covers.

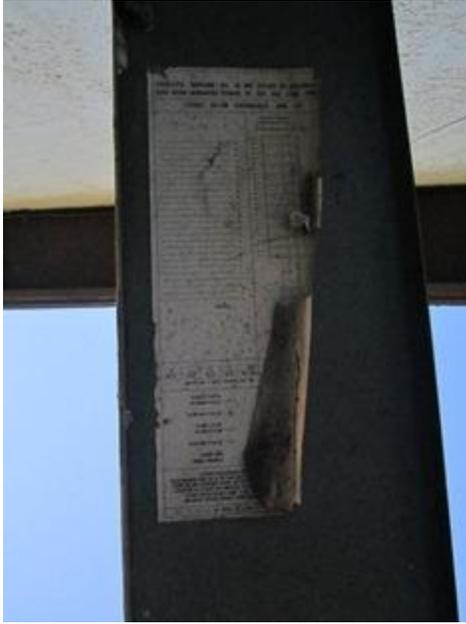
The legend for overcurrent protection devices (breakers or fuses) in the main service panel is missing, unreadable or incomplete. Although the breakers have been labeling with a marking pen, I recommend installing, updating or correcting the paper legend as necessary so it's accurate.

**Photo 2**  
Unreadable and incomplete legend.

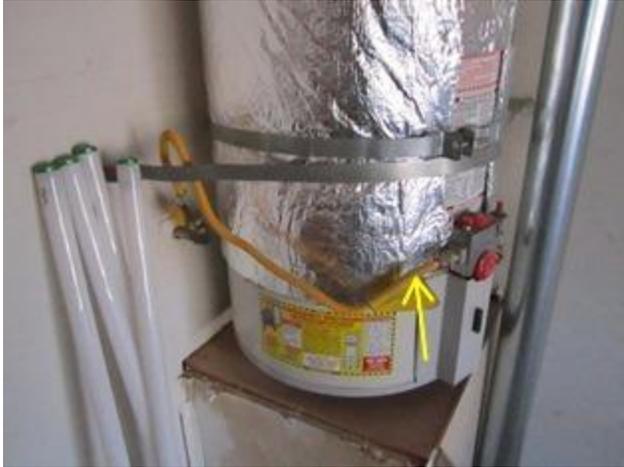
No drip leg is installed on the water heater gas supply line. Drip legs are intended to trap oil, scale, water condensation and/or debris from the gas supply lines before they reach and damage the water heater components. A qualified contractor should install a drip leg as per standard building practices.

**Photo 21**  
No drip leg.

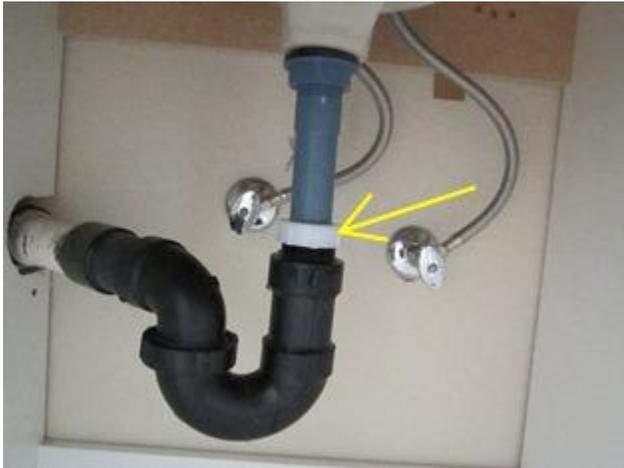
**Photo 23**

The sink in the master bathroom is leaking just before the P-trap. This fitting should be repaired by a qualified plumber.

Leaking at this location.

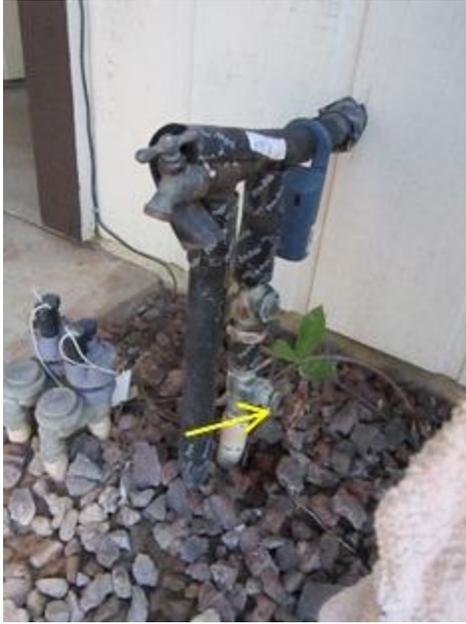
The main shutoff valve has a slow leak. This can attract wood destroying insects.

**Photo 11**  
Dripping.

Recommend that a licensed plumber make repairs to this valve.

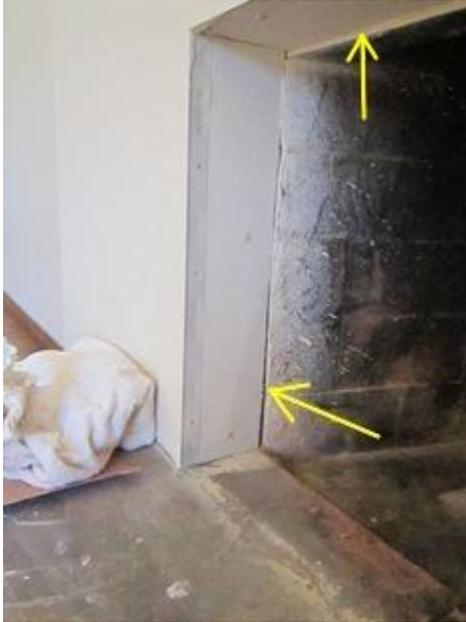
One or more gaps exist between the fireplace face and the fire box. More specifically, there is a continuous gap between the internal hearth masonry and the cement

board lining the hearth. This is a fire hazard since heat from fires may reach wood wall cavities surrounding the fireplace. A qualified chimney service contractor should evaluate and repair as necessary.

**Photo 30**  
Gaps

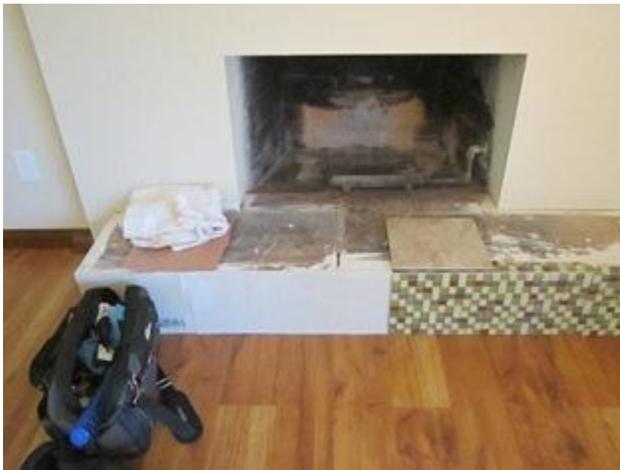
**Photo 31**

The hearth extension is in disrepair/or in the middle of remodeling.

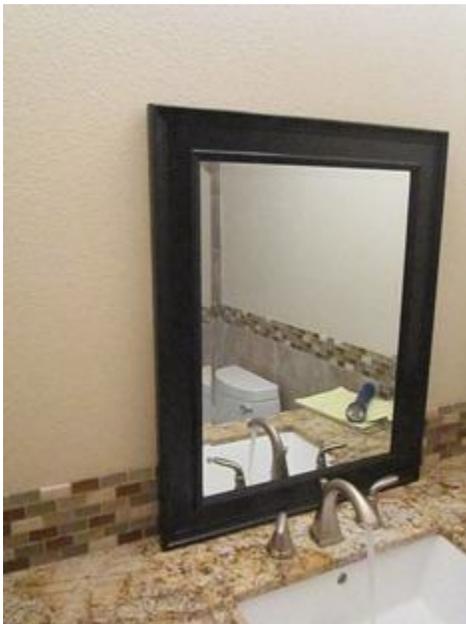
**Photo 32**

**40)** Mirror in main bathroom is detached.

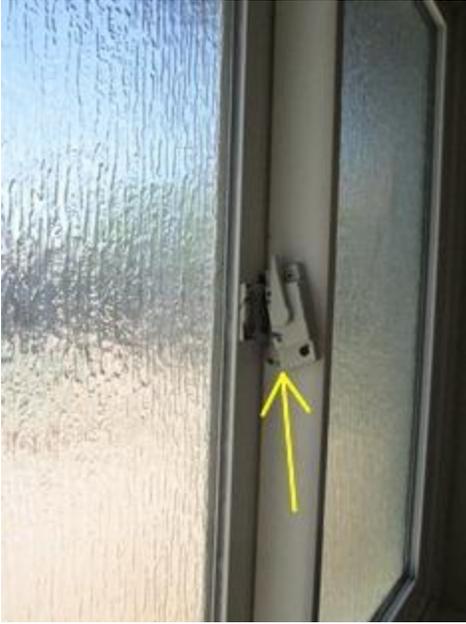
**Photo 37**

**41)** The lock mechanism on the master bathroom window is broken.

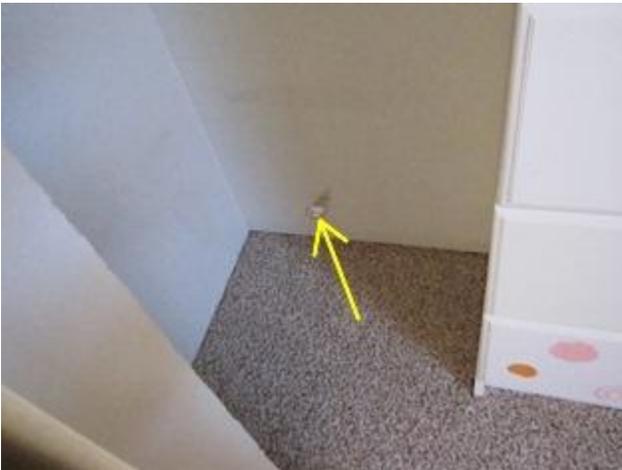
**Photo 24**

42) 🔍 There is surface damage to a small section of drywall of the closet in the southwest bedroom.

Drywall damage.

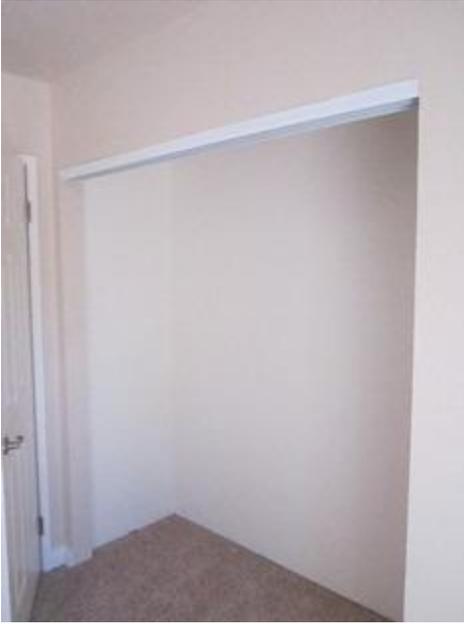
43) ⓘ Sliding glass doors are missing from the master bedroom.

**Photo 25**  
Missing sliding door.

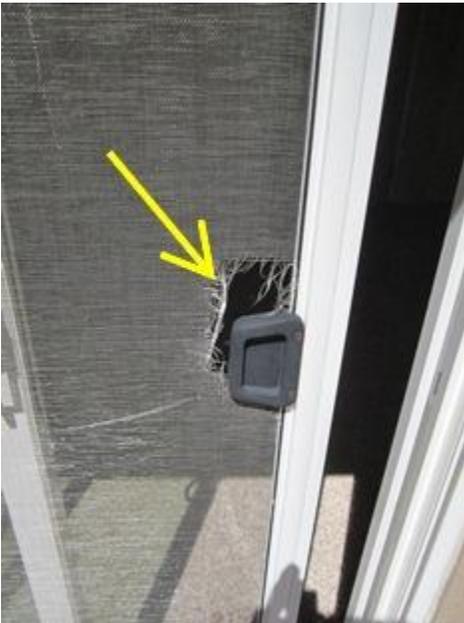
45) 🛠️ The master bedroom screen door has a tear in it. The screen should be replaced.

**Photo 26**  
Torn screen, master bedroom.
