# Mercer Inspection Services

## Property Inspection Report

This report published on Monday, April 16, 2012 3:03:05 AM PDT

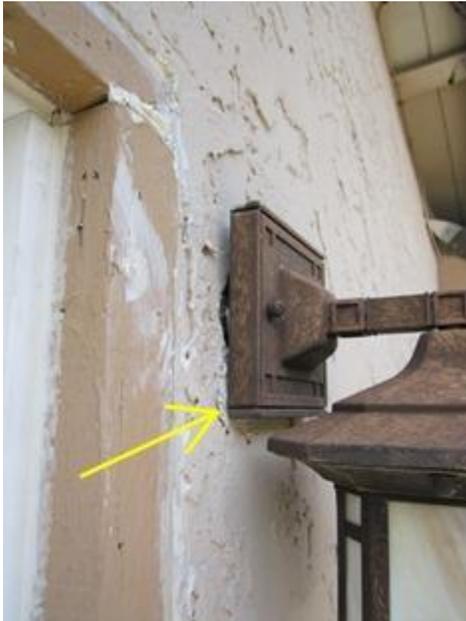
**Photo 8**

The light adjacent to the garage door on the east side of the house is loose. This can cause water penetrate into the electric receptacles and is a fire hazard. . Wire conductors may be damaged due to repeated movement and/or tension on wires, or insulation may be damaged. This is a safety hazard due to the risk of shock and fire. A qualified electrician should evaluate and repair as necessary.

Loose fixture, east exterior garage door

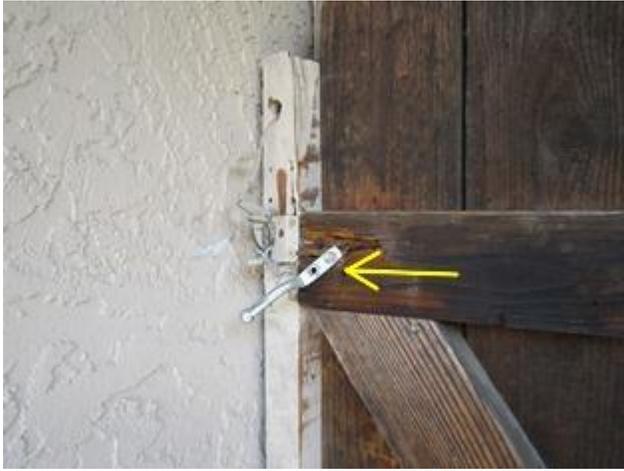
Portions of the fence and the west side gate are damaged and/or deteriorated in some areas. In general the east, south side, and west front sides of the perimeter fence appear to be near the 75% lifespan point.

- 1) The latch to the gate requires repair.
- 2) The latch post has pulled away from the exterior wall and it is loose. It should be reattached.
- 3) The gate will not open because a wooden board has been attached to the latch post.
- 4) The perimeter fence on east side has areas where splitting and cracking of top and bottom rails has occurred.

**Photo 6**  
Gate latch

A qualified contractor should evaluate and make repairs or replace sections as necessary.

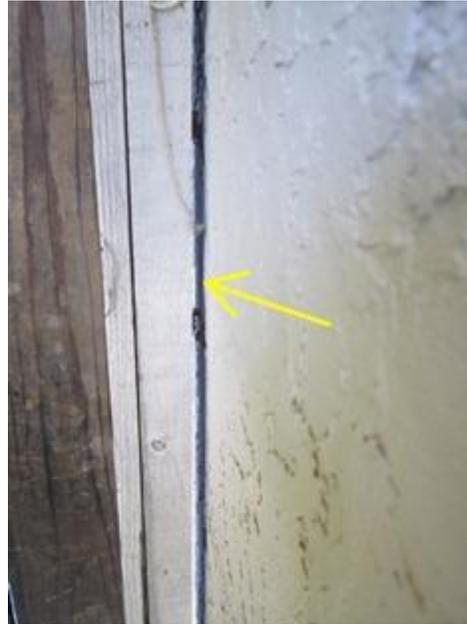
**Photo 10**  
East exterior wall latch post

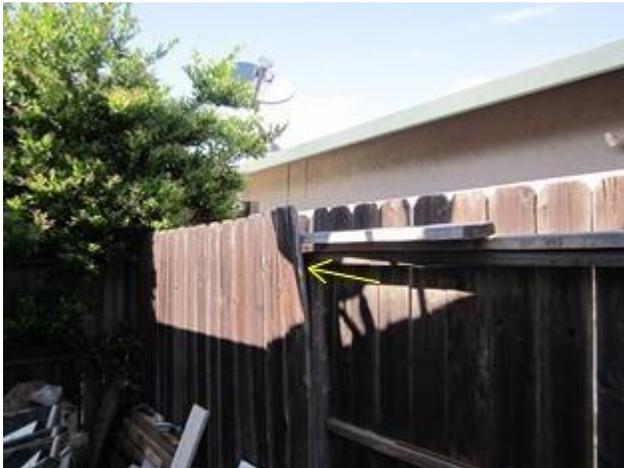
**Photo 11**  
East perimeter fence pickets

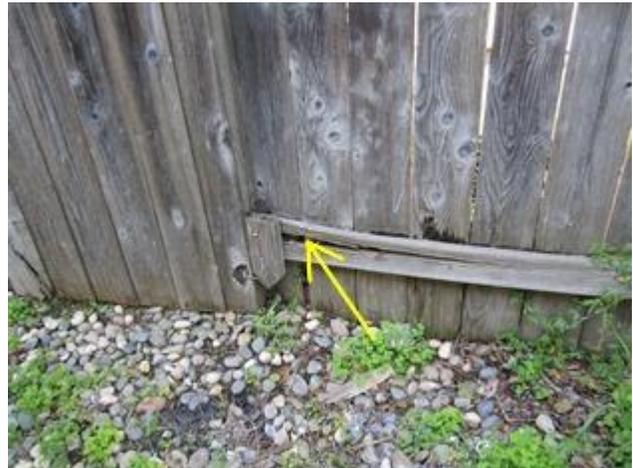
**Photo 12**  
East perimeter fence rail

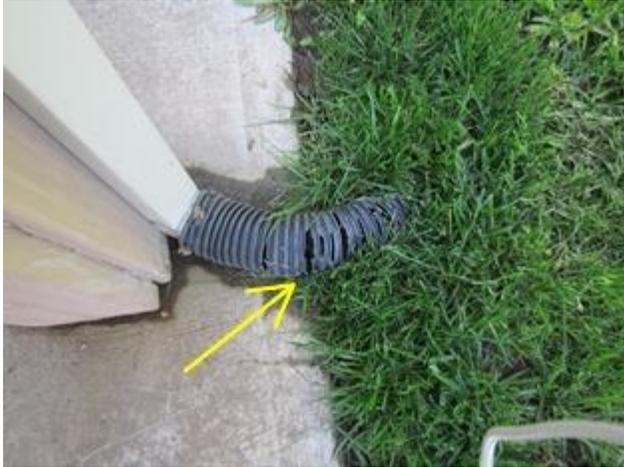
The ground around the southeast edge of the patio has significantly soggy soil, standing water. The flexible plastic drain that connects to the patio roof downspout has deteriorated significantly, which may be allowing water to flood into the yard/or the drainage may be stopped up due to debris accumulation in the plastic pipe.

**Photo 9**  
South patio drainage

Recommend consulting with a qualified contractor who specializes in drainage, to determine if or what repairs are needed to provide adequate drainage. Possible repairs may involve installing, repairing and/or replacing underground drains.

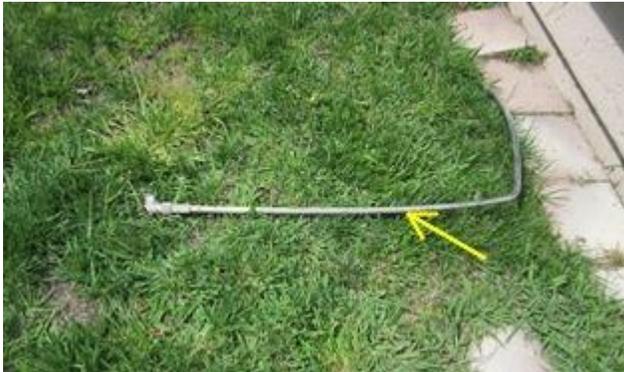
There is plastic pipe that is broken and exposed in the backyard approximately 2 feet from the south exterior wall. The origin of this pipe is unknown. The origin of this pipe should be determined and either capped at the origin or repaired.

**Photo 3**  
Plastic pipe of unknown origin

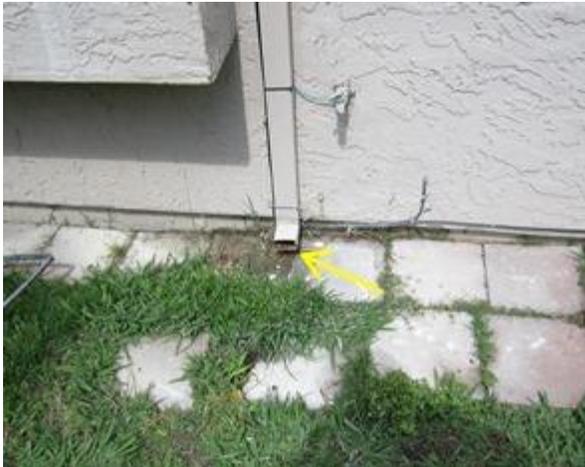
The downspout west of the air conditioner at the rear of the house needs an extension. This can result in water accumulating around the structure's foundation. Minimally, I recommend installing a diverter to move water several feet from the foundation. Ideally a downspout should be tied into an underground drain line to carry rainwater away from the house.

Accumulated water is conducive for wood destroying insects and organisms, and may also cause the foundation to settle and possibly fail over time.

**Photo 1**  
South exterior wall center downspout

A qualified contractor may be necessary for this repair, especially for underground drain work.

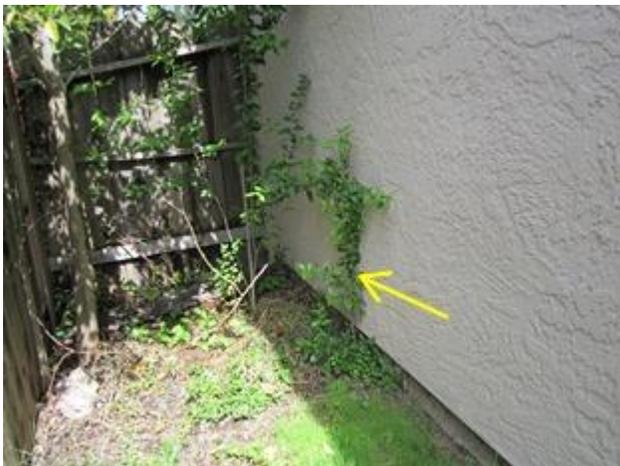
Vegetation such as trees, shrubs and/or vines are in contact with or less than one foot from the structure's exterior. Vegetation can serve as a conduit for wood destroying insects and may retain moisture against the exterior after it rains. Vegetation should be pruned and/or removed as necessary to maintain a one foot clearance between it and the structure's exterior.

**Photo 5**  
Vegetation growth and fence issues

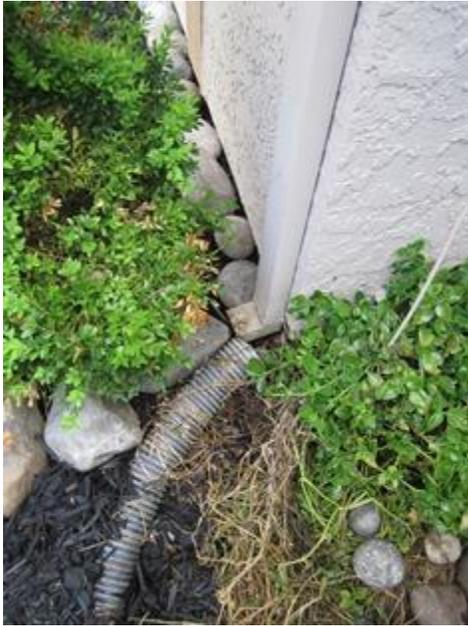
The west side front downspout is not connected to the flexible plastic drain.

**Photo 2**  
North exterior wall west corner downspout

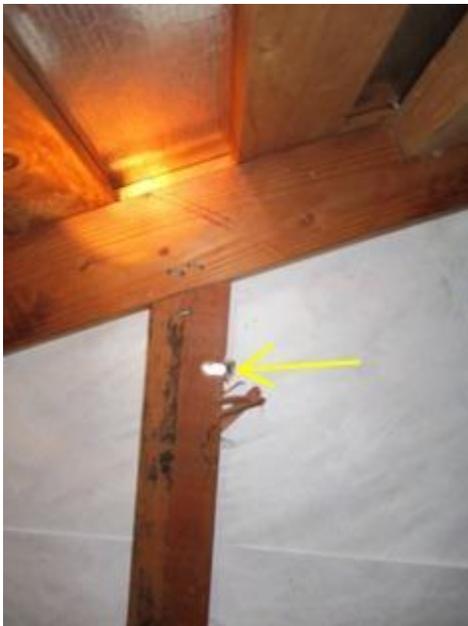
A gap exists on the east exterior wall. It is likely that an antenna cable was run through this opening. This gap should be sealed to prevent moisture intrusion and entry by insects, particular hornets and wasps.

**Photo 27**  
1/2 x 1" hole in east wall of home, approx. twelve feet elevation.

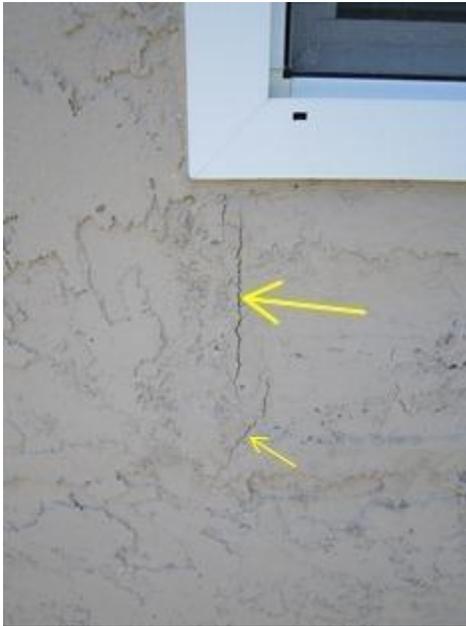
Two minor vertical cracks in the stucco were found below each of the bottom corners of the kitchen window located on the east side of the house. The attached photo

shows only one side where this has taken place.

**Photo 7**  
Minor cracks

A qualified contractor should evaluate and make repairs as necessary to prevent water intrusion and further deterioration in the future.

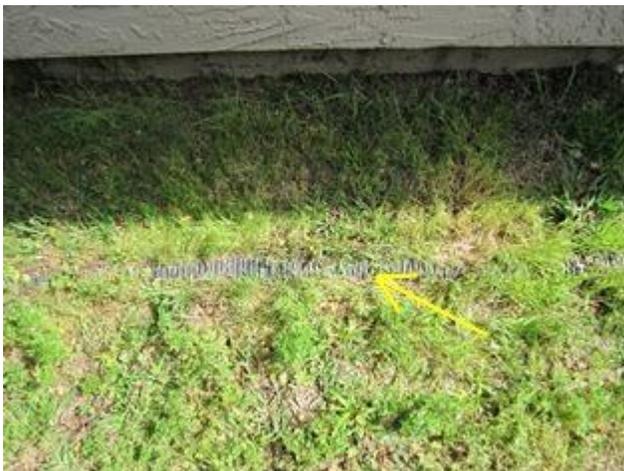
**11)** 🛠️ There is an area of exposed/partially buried flexible plastic drain pipe on the west side of the house. The plastic will deteriorate at an accelerated rate when exposed to sunlight. This section should either be covered with soil or it should be reburied.

**Photo 4**  
West exterior partially buried plastic pipe

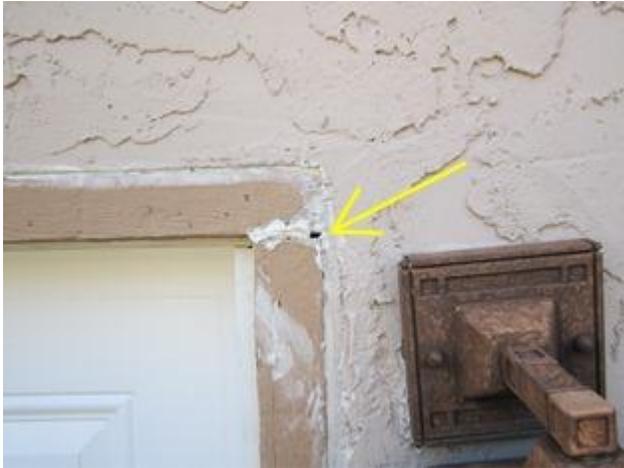
**Photo 23**

**13)** 🛠️✅ Caulking Missing:

On the top north side of the east side garage door, there is a small opening that water can enter into. It needs to be filled with water resistant caulking.

Garage door, east side of house. Note on improperly caulked door jam.

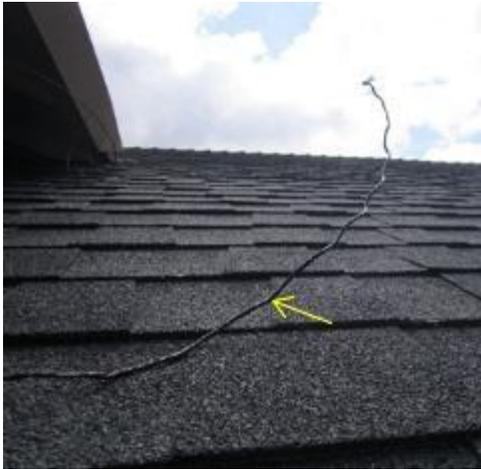
**14)** 🛠️❌✅ Antenna guy wire is disconnected. The guy wire running from the north center side of the roof of the house is disconnected from the antenna mast. This is a safety concern. High winds or the failure of other guy wires may lead to the collapse of the antenna.

**Photo 14**  
Detached guy wire

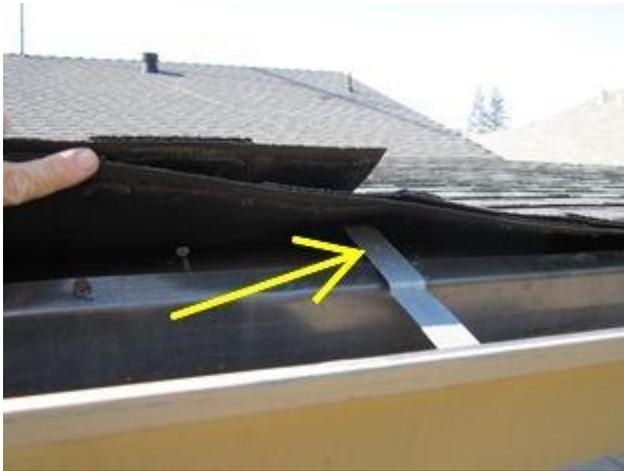
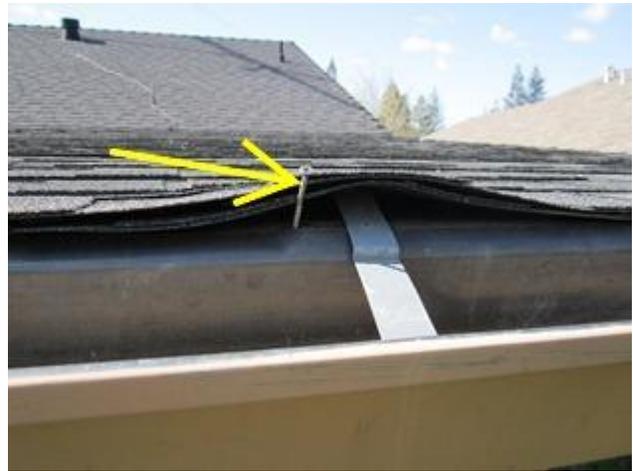
**15)** 🛠️👉 The gutter on the patio roof is improperly attached and has uplifted shingles and exposed roof sheathing. Additionally, there are several large wood screws that are in contact with the shingles and this will cause damage to them. This is typical of a gutter add on done by an unqualified contractor.

**Photo 16**  
Improperly attached patio roof gutter

A qualified roofing contractor should evaluate and repair as necessary.

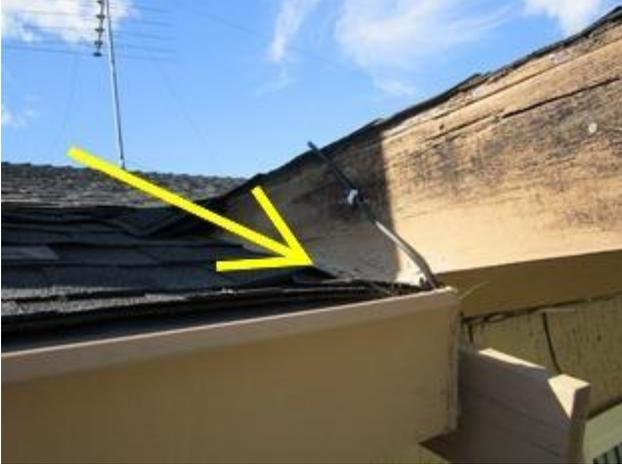
**16)** 🛠️✅ Kickout flashing should be installed on sections where water is likely to stream into contact with the roofing/ exterior wall or other wood interface. Due to the contortions in the shingles around the roof/patio west side interface, moisture is likely an able to penetrate to the roof sheathing. I recommend that a kick out flashing be installed in that location.

**Photo 18**  
Kickout flashing needed

A qualified roofing contractor may be needed for this repair.

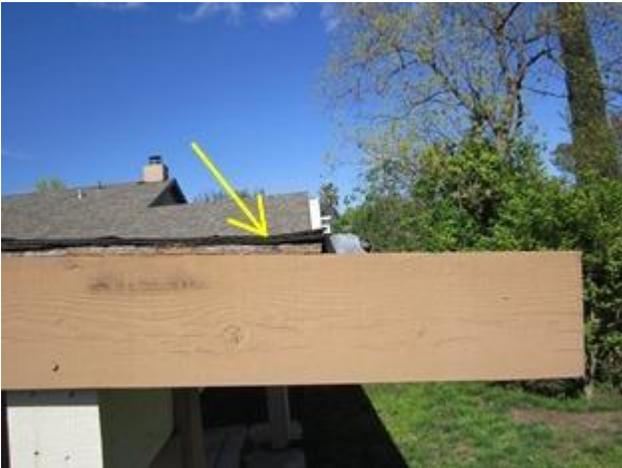
**17)** 🏠🔍👷 Composition architectural shingles are installed on the patio roof that has a slope less than 3/12 (three inches rise for every 12 inches run). Most shingle manufacturers won't warranty composition shingles if used on a roof with a slope less than 3/12. Water penetration, especially as the roof progressively ages is an issue.

For example, currently, the shingles at the lower terminus of the patio roof are curling and is allowing water to build up (ponding) potentially contacting the roof sheathing.

**Photo 15**  
Low roof pitch and end shingle curling

At a minimum, the client(s) should consult with a qualified roofing contractor regarding this and monitor these roof section(s) and interior spaces below for leaks in the future. Ideally, or if leaks occur, a qualified roofing contractor should replace the roof surface with materials intended for low slopes such as a "torch down" roof.

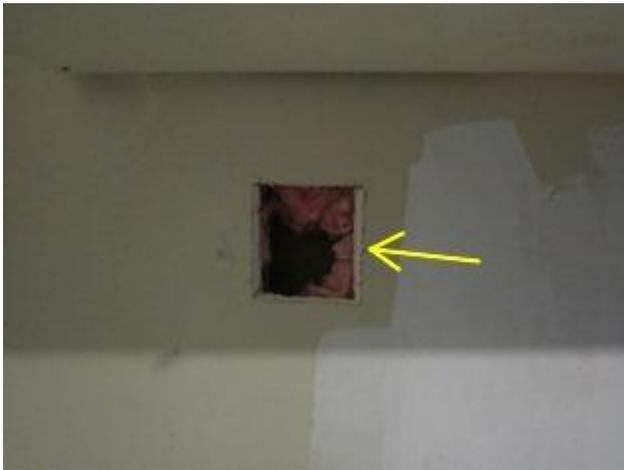
**19)** 🛠️🔍 One or more wall and/or ceiling surfaces between the attached garage and interior living spaces have gaps, holes, or missing or inadequate surface materials. These surfaces are intended to prevent vehicle fumes from entering living spaces, and to slow the spread of fire from the garage to living spaces. A qualified contractor should evaluate and make repairs as necessary so the attached garage wall and ceiling surfaces that adjoin living spaces are tightly sealed and fire rated as per standard building practices. Typically these surfaces require a one-hour fire rating.

**Photo 25**  
Cut out of drywall/garage firewall east of garage/kitchen door.

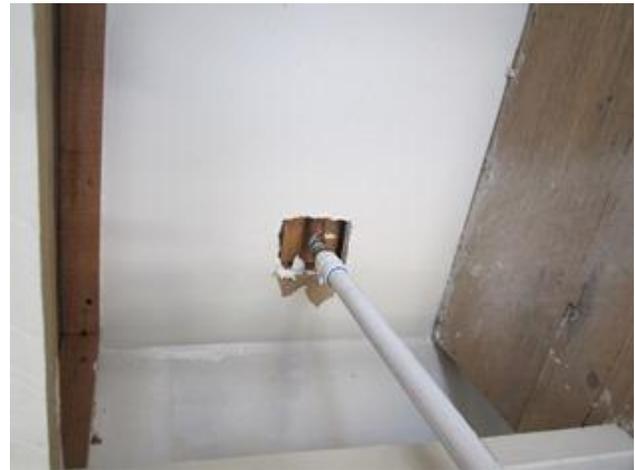
**Photo 28**  
Drywall clearance around pipe not to exceed 1/4"

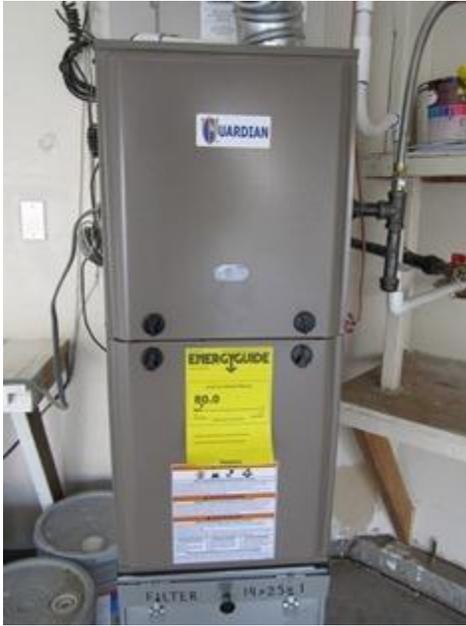
**20)** 🛠️🔍 The water heater and the furnace are subject to damage from vehicles because no protective barrier is installed in front of them.

According to the 2010 California Plumbing Code, California Code of Regulations, Title 24, Part 5, 508.14: Such appliances shall be located or protected so it is not subject to physical damage by a moving vehicle. [NFPA 54:9.1.10.2]

**Photo 34**  
Unprotected heating/ac unit

A qualified contractor should install an adequate barrier as per standard building practices (steel post anchored in concrete, wood partition, etc.).

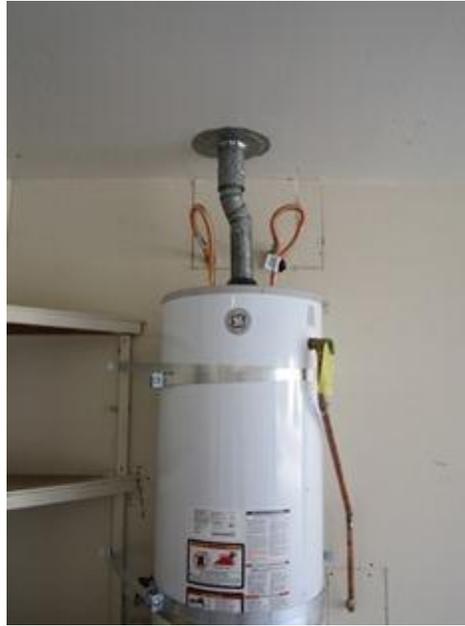
**Photo 35**  
Un protected water heater

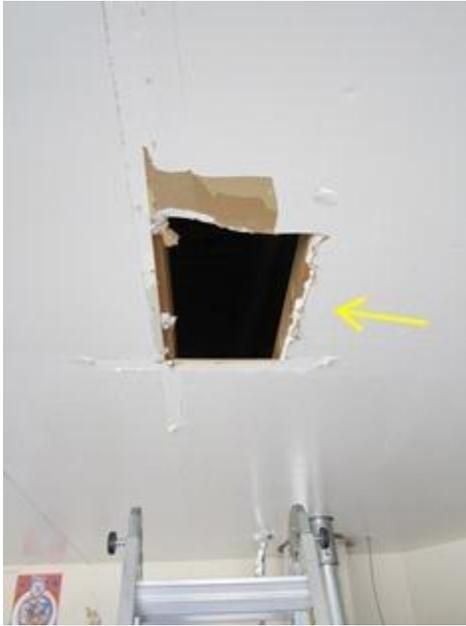
**Photo 26**

The current opening measures 8.8" x 11" and there is no hatch.

According to 2006 IRC (Residential Construction): R807.1 Attic Access. Buildings with combustible ceiling or roof construction shall have an attic access opening not be less than 22 inches by 30 inches. A 30-inch (762-mm) minimum unobstructed headroom in the attic space shall be provided at some point above the access opening.

The 2006 edition of the IRC, section R309.2 requires that for garages that have access to the attic, a hatch cover made from an approved, fire-rated material should protect this access at all times. Garage attic door must be constructed such that the 45 minute rating is maintained; any drywall edges on both the hatch and the surrounding area exposed to physical damage are protected. The cover or door is installed so that it is permanent (not removable) with hardware to maintain it in a closed position with latching hardware to maintain it in a closed position. This could be accomplished by the use of spring loaded hinges, door closer, or hardware that will not allow it to be left in an open position when not in use. A single bolt type or hook and eye hardware does not provide a positive closure since these would allow the door to be left open. Likewise drywall screws are "fasteners" and not hardware so they cannot be used as the only means of keeping access doors closed.

Attic entrance. Too small and not equipped with a fire resistant, self-closing hatch.

I recommend that you strictly follow the IRC requirements on this matter.

This should be done by a qualified contractor.

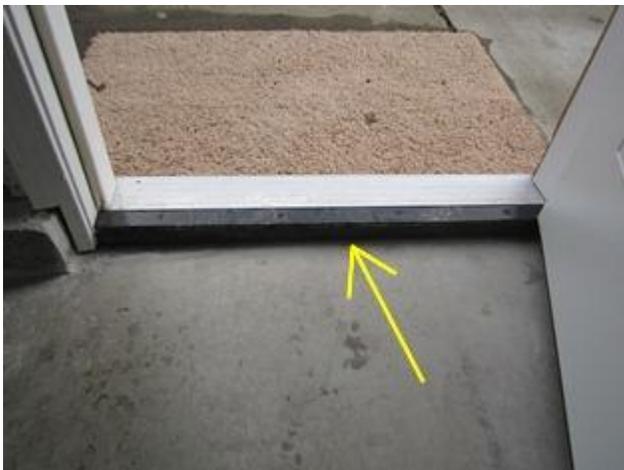
**Photo 36**

The step plate/cover plate located on the east garage egress is poorly supported and is unstable when stepped on. The flex in this plate from foot pressure is likely to cause it to become detached or crack. The gap between the aluminum plate and cement should be spaced with a suitable material.

Wobbly/flexing step plate

A qualified contractor should evaluate and make repairs as necessary.

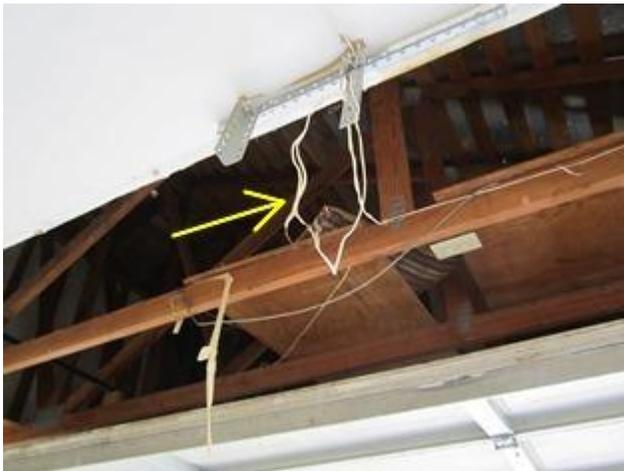
The vehicle door was formerly intended to be operated by an automatic, electric opener. This has been removed. The door is currently in balance and operates manually without any problems. If the opener is not going to be replaced, I recommend that the overhead electrical control wires be removed.

**Photo 37**  
Loose garage door opener wiring

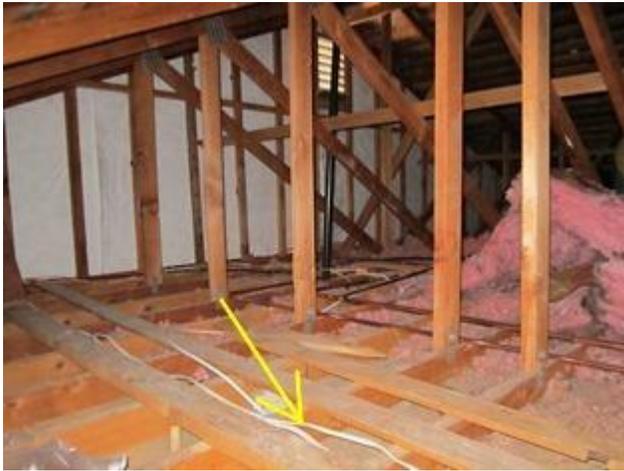
1) Electrical cables within 4 feet from attic entrance without adequate protection from abrasion. Additionally, electrical cables should not be running along a walkway unprotected. These can be damaged by movement in the attic and lead and become a fire and electrical shock hazard. Cables should be moved.

2) Electrical cables should be secured at intervals no more than every 4 feet in length. Cables should also not be strung over water and gas pipes or other such objects.

**Photo 19**  
Attic view from entrance. Note on insulation and wiring

A qualified electrical contractor should evaluate and make repairs as necessary.

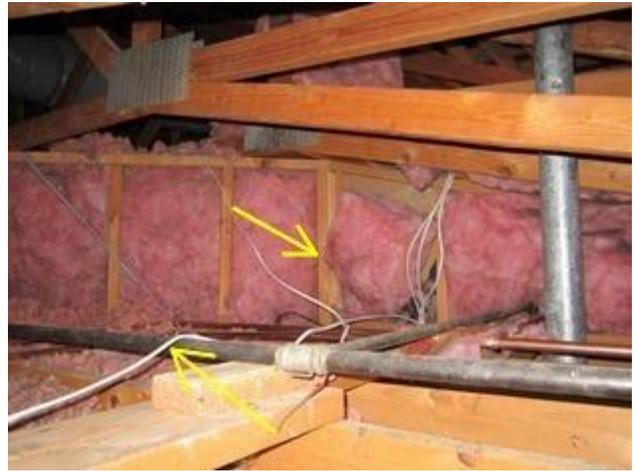
**Photo 20**  
Attic view looking west. Note on insulation and wiring leaping over water pipe and not secured.

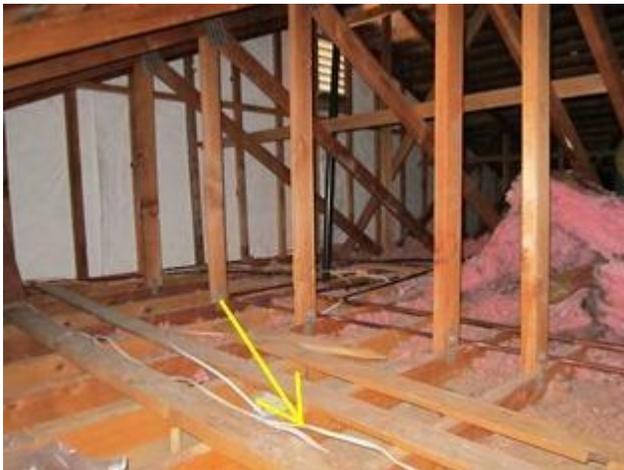
It appears that a partial walkway was laid down in part of the attic. There should be no spacing in the walkway planking. This existing attic walkway needs fortification. As noted elsewhere in this section, electrical cable travel along the center of the walkway should be relocated. Although the photo below illustrates the electrical wiring issue, it also shows the issue with the planking.

**Photo 19**  
Attic view from entrance. Note on insulation and wiring

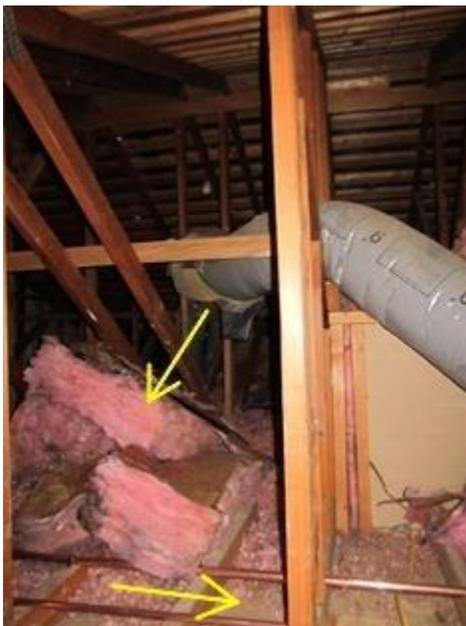
**Photo 21**

**30)** 🛠️👉 Ceiling insulation is uneven or missing in some areas. This is likely due to improper installation or someone having walked on or through the insulation.

Attic looking into far west side of house. Note on unevenly piled up and unevenly distributed insulation.

Having a qualified licensed contractor add insulation to the recommended R rating will remedy this issue.

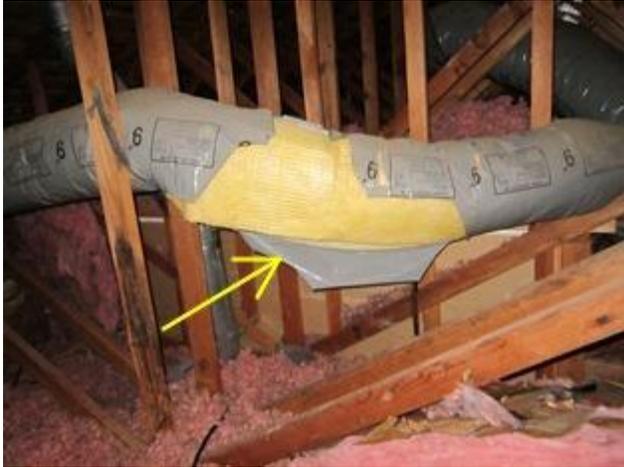
**Photo 22**

**31)** 🛠️👉 Insulation on air duct is damaged, deteriorated and/or missing in one or more areas. Recommend repairing insulation where necessary for better energy efficiency.

Attic looking down the center of home to the west. Note on torn insulation around flexible duct.

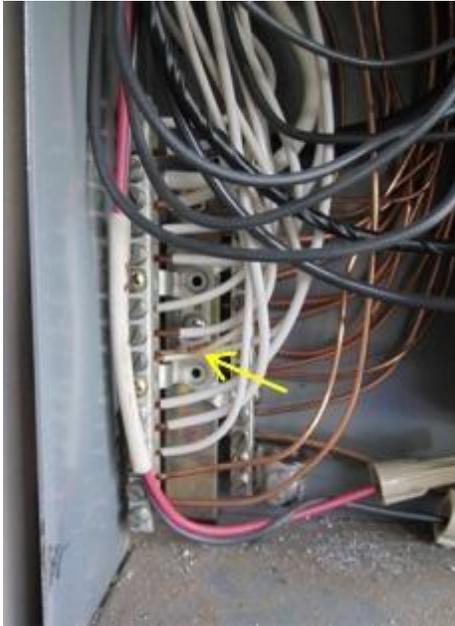
One or the neutral wires is burned or heat-damaged, and has melted insulation.

**Photo 32**  
Overheated neutral wire.

A qualified electrician should evaluate and repair or replace wiring as necessary.

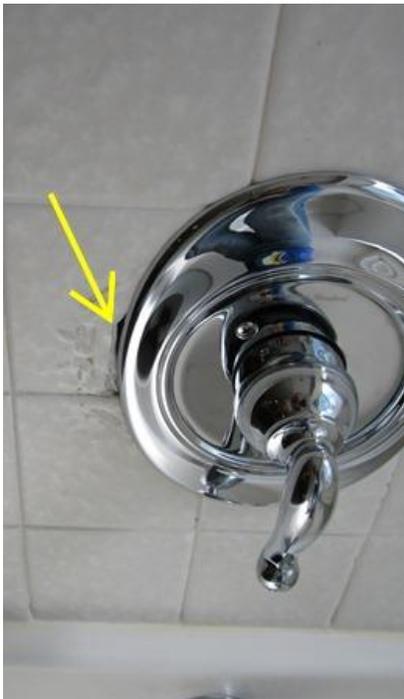
**Photo 33**

43) 🛠️🔍 There is a gap between the tile and the shower mixer in the master bathroom. The gap is large enough to allow a significant amount of moisture in the wall. This type of water intrusion promotes mold growth and wood rot.

Gap between tile and mixer assembly

The gap 'might' be able to be repaired using color matching or clear silicon, but a specialist should be consulted to determine the suitability and durability of this method. Replacement of this area of the mixer side wall may be necessary. If this is necessary, consider having this repair made by a qualified contractor

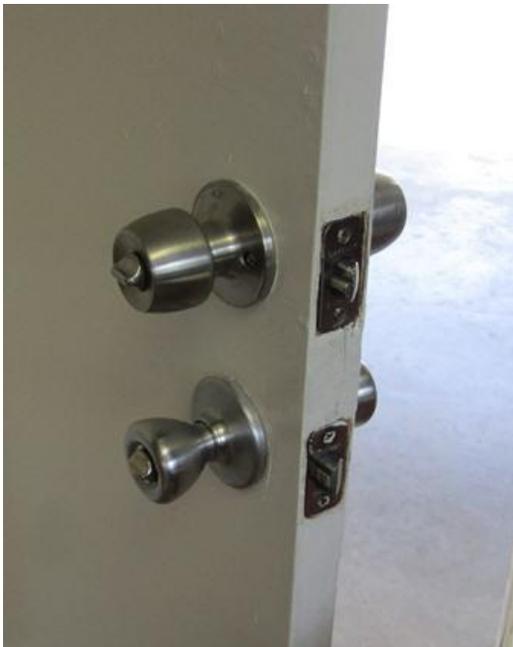
**Photo 24**

There are two sets of door knobs on the kitchen-garage door. This poses a potential hazard for certain disabled individuals and small children when fast egress from the house is necessary.

Double door knobs is a hazard for certain disabled individuals and can pose an obstacle for children who may need to use this egress in the event of an emergency.

I suggest removing one set of hardware. A dead bold can be installed, instead.

This may require the services of a licensed contractor or locksmith

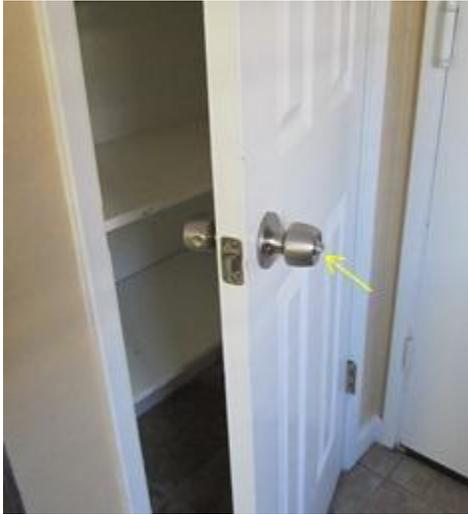
**Photo 29**

This door locks from the outside. A child could get locked in this small enclosed space. Without an interior light, it would be difficult for them to operate the emergency release on the inside handle.

Kitchen pantry door locks from the outside. This is a hazard for small children who may be trapped in this confined space.

This door hardware should be replaced with a standard, non-locking set.

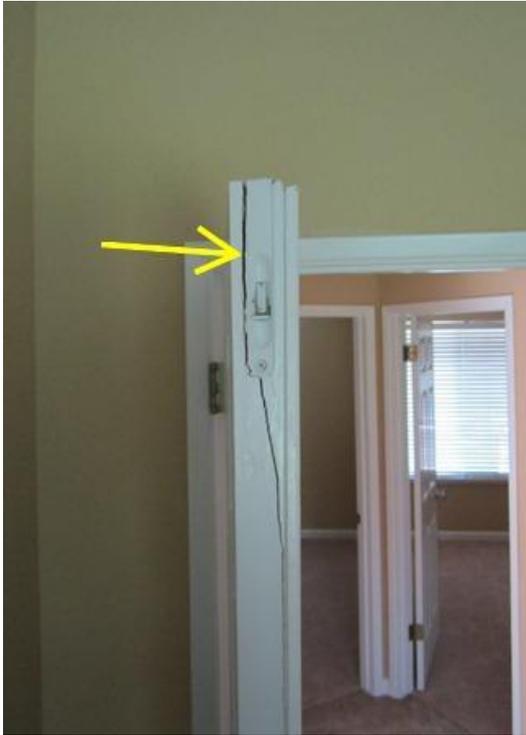
There is a vertical crack beginning at the top side edge of the west side entrance door to the master bedroom.

**Photo 30**  
Vertical split in master bedroom west entrance door.

This 'might' be able to be repaired using wood glue and clamps. A licensed contractor should evaluate/repair this door.

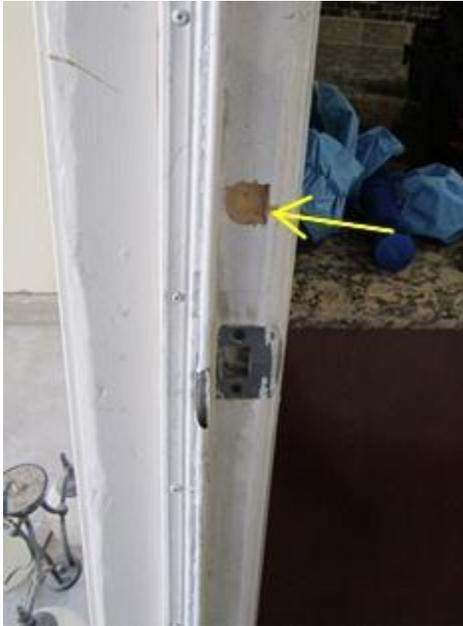
A strike plate is missing on the kitchen-garage door.

**Photo 31**  
Strike plate is missing.

Since one set of hardware needs to be removed from this door, I suggest that the set that goes with this raw wood boring be removed.
