Mercer Inspection Services

Property Inspection Report
Client(s): XXXXXXXXX
Property address: XXXXXXXXXXXXXXXXX
Inspection date: XXXXXXXXX

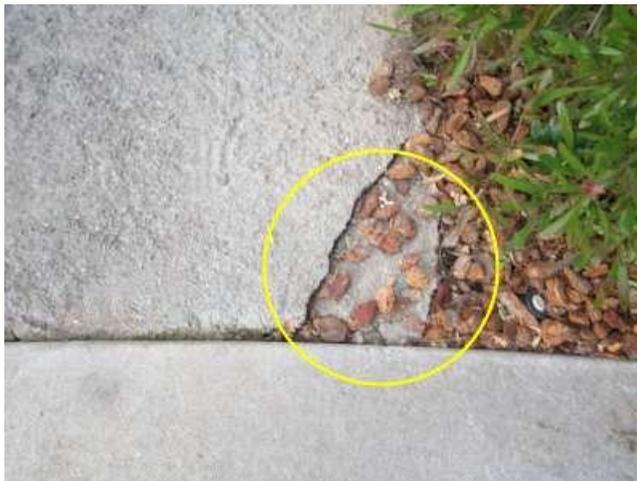
**Photo
20**

There are two trip hazards in concrete walkways. One trip hazard was found in the driveway and one in the walkway leading to the rear gate on the west of the house. These are due to settlement and/or heaving. Recommend having a qualified contractor evaluate and repair or replace driveway sections as necessary to eliminate trip hazards.

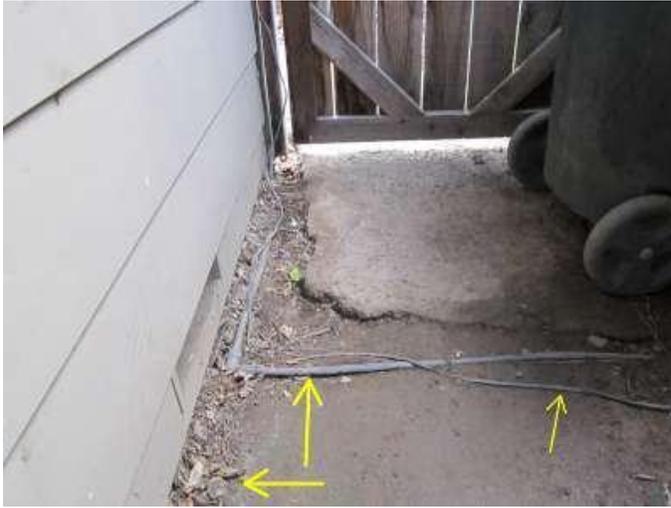
Low voltage wiring and sprinkler water pipe is exposed on the north side of the home. This is a trip hazard. The water pipe should be covered with soil or other suitable ground coverings and the low voltage wiring should be routed through a PVC or metal conduit anchored to the side of the outside wall.

Additionally, the soil has been eroded because there is no gutter. See the exterior section of this report for more on gutters.

Photo 11
Erosion caused by lack of a gutter has exposed the plastic pipe and wires.

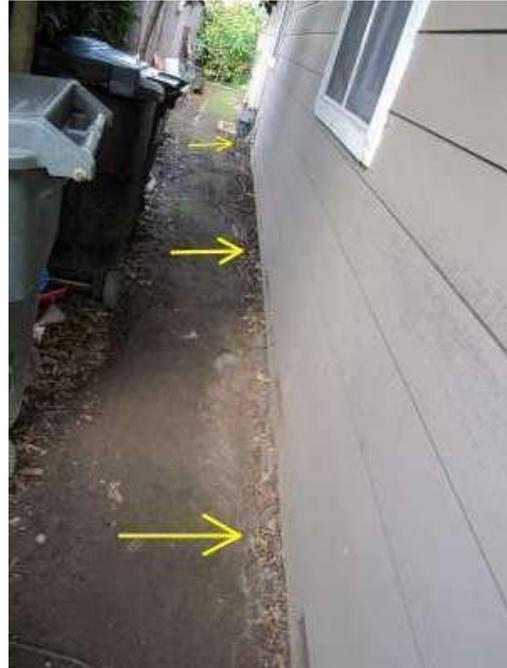
Photo 19
Conduit containing low voltage wires should be placed along the side of the house.

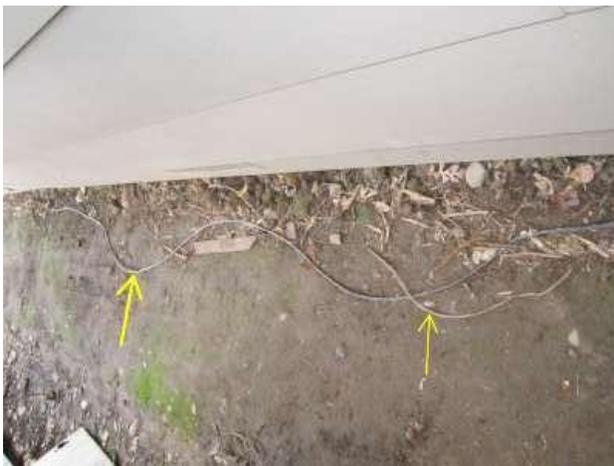
Photo 12
Exposed low voltage wiring on west side of house.

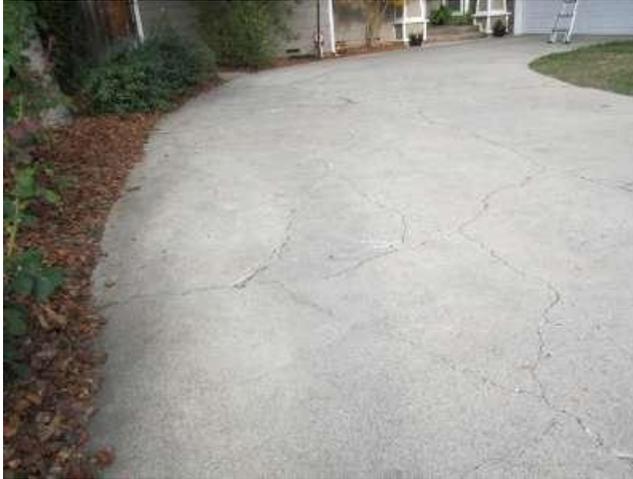
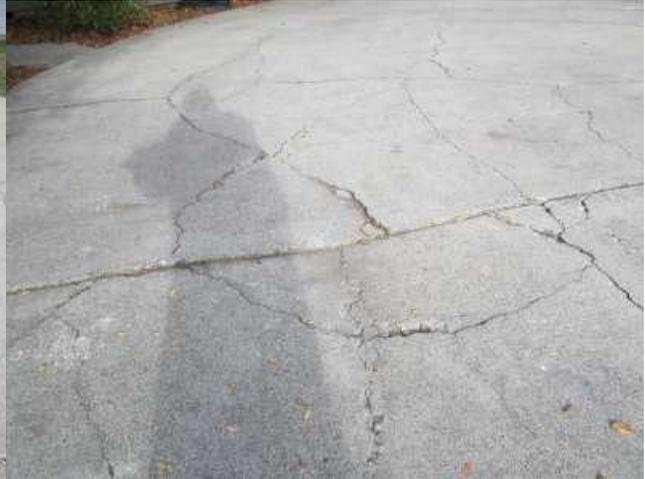
The driveway has significant cracks and/or deterioration in one or more areas. A qualified contractor should evaluate and repair or replace driveway sections as necessary.

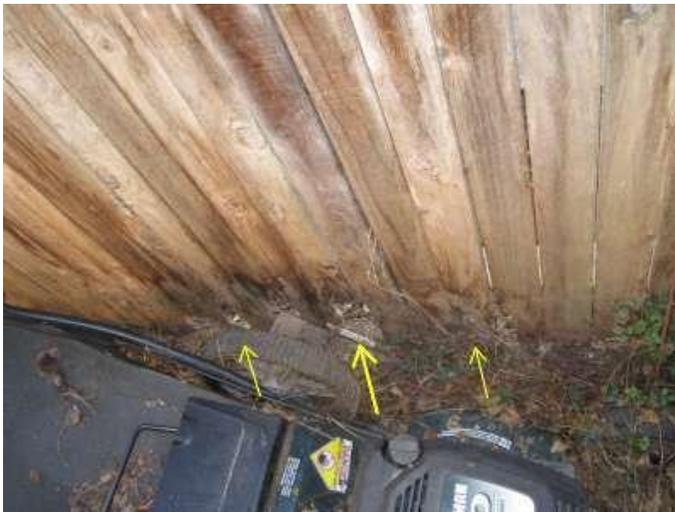
A 15 foot section of the fence on the west side of the property is deteriorated in some areas. A qualified contractor should evaluate and make repairs or replace sections as necessary.

Photo 33
Rotting at base of fence.

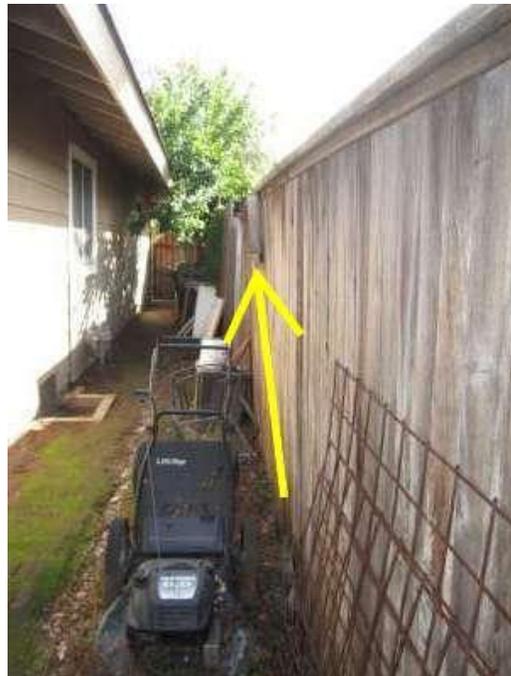
Photo 34
Fence is leaning and needs additional supports to right it.
Also note the line of erosion on the left side of the lawn mower. This is because there is no gutter.

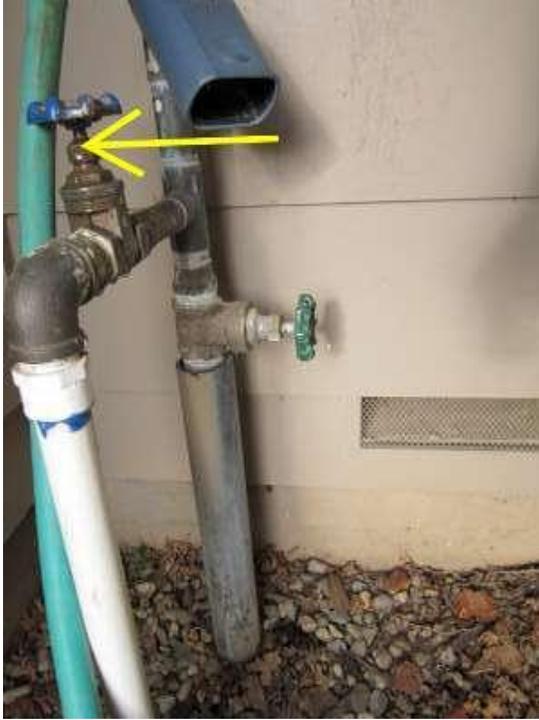
Photo 9

The main control valve that services the water to the front sprinkler system leaks when in the off position. The seals in the valve need to be replaced. This valve is located in the front of the house adjacent to the main water shutoff. Note: the leak is not high enough to cause water pooling, but the moisture level is high enough to attract wood destroying insects.

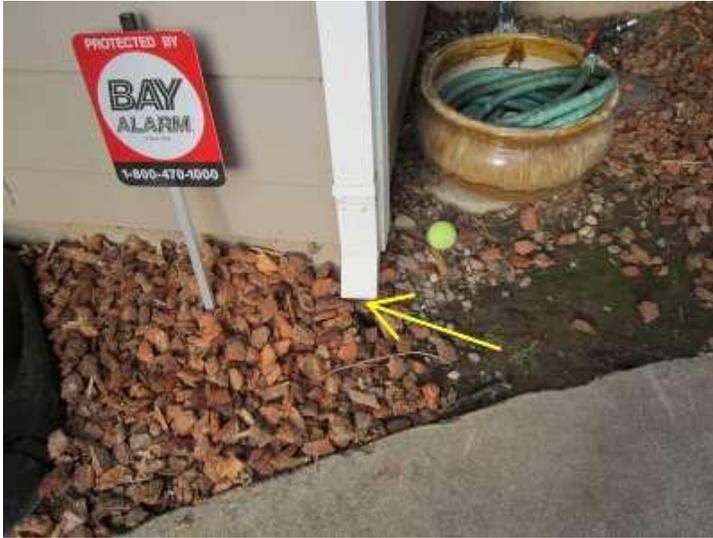
Photo 10

The downspouts on the front of the home need extensions or splash blocks. This can result in water accumulating around the structure's foundation, or in basements and crawl spaces if they exist. Accumulated water is a conducive condition to wood destroying insects and organisms, and may also cause the foundation to settle and possibly fail over time. Repairs should be made as necessary, such as installing or repositioning splash blocks, or installing and/or repairing tie-ins to underground drain lines, so rain water is carried at least several feet away from the structure to soil that slopes down and away from the structure.

Need a splash block to carry water to driveway.

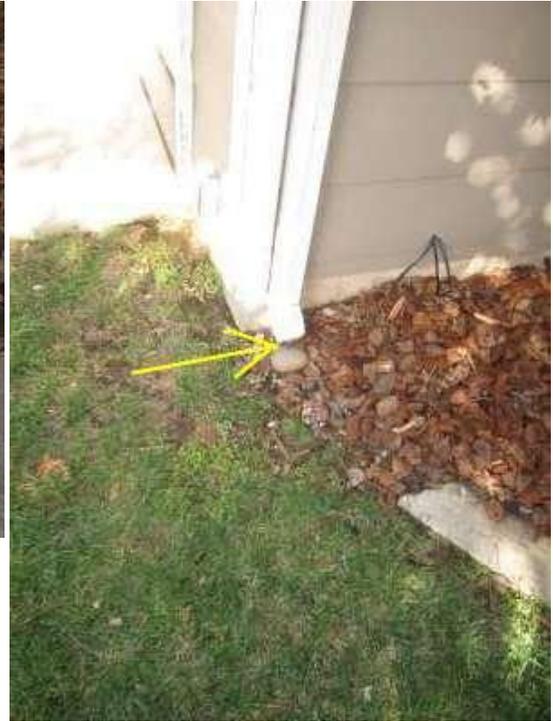
Photo 30

Need a splash block to prevent water from pooling around the foundation and to prevent water from washing away soil and bark.

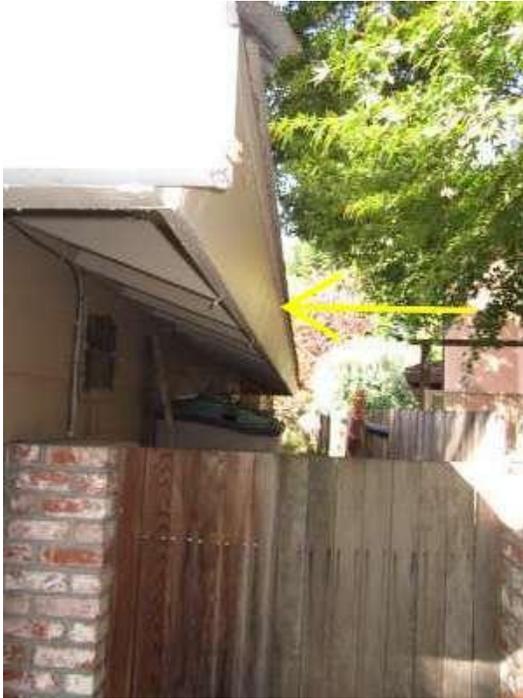
One or more gutters are missing. This can result in water accumulating around the structure's foundation, or in basements and crawl spaces if they exist. On the west side of the house where there is no concrete a significant amount of erosion has been caused because there is no gutter. Additionally, accumulated water is a conducive condition to wood destroying insects and organisms, and may also cause the foundation to settle and possibly fail over time. A qualified contractor should install gutters and downspouts where missing. Also, extensions such as splash blocks or tie-ins to underground drain lines should be installed as necessary to carry rain water away from the house.

Photo 31
Gutters needed on both east and west side of house.

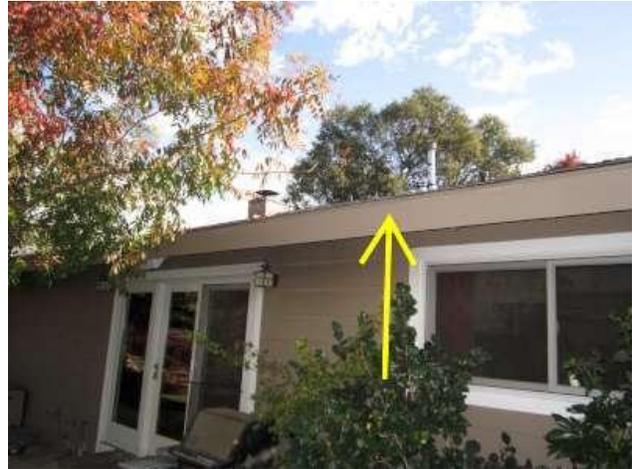
Photo 32
Gutters needed on back of house.

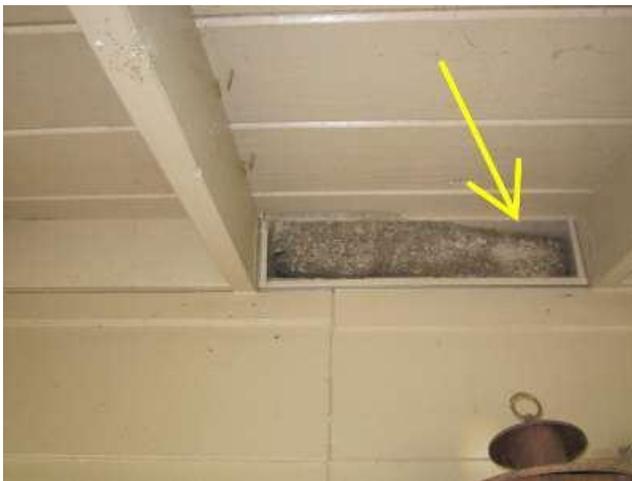
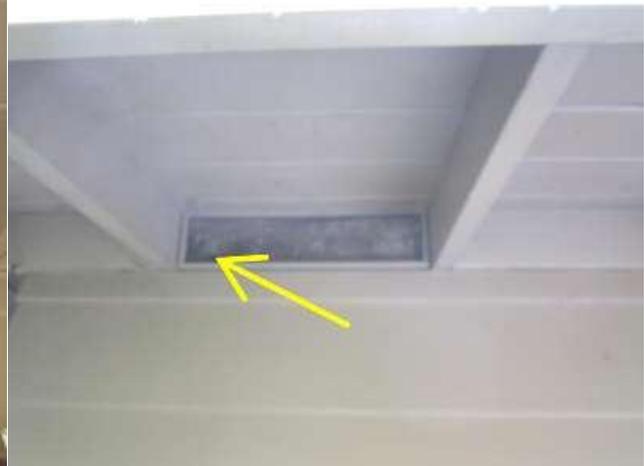
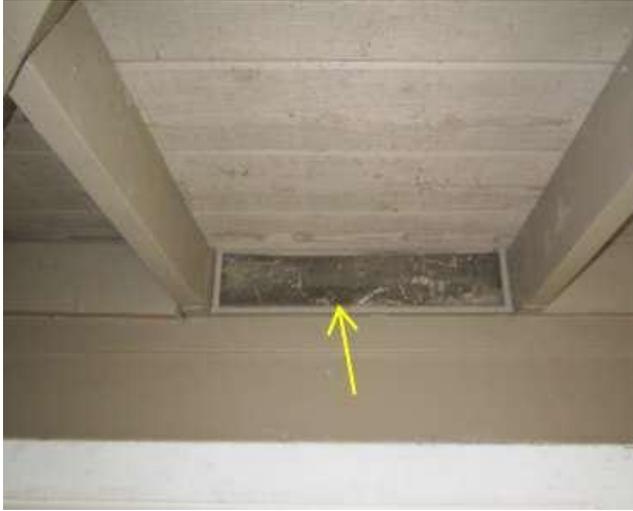
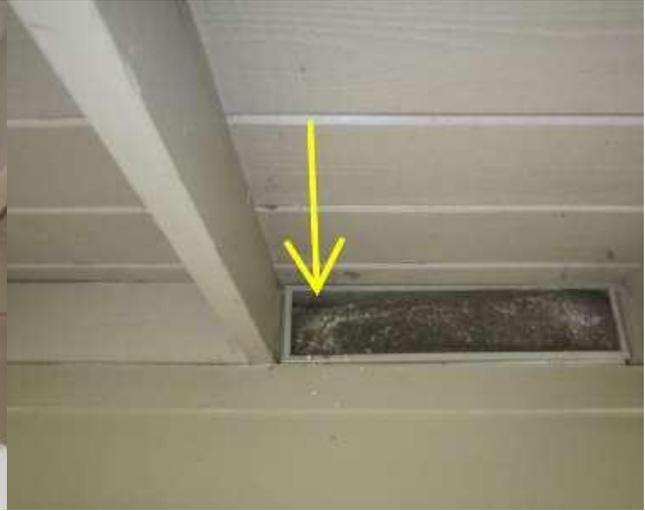
One or more soffit vent screens are missing and/or deteriorated. Birds and vermin may enter the attic because of this. Screens should be replaced or repaired where necessary, or installed where missing.

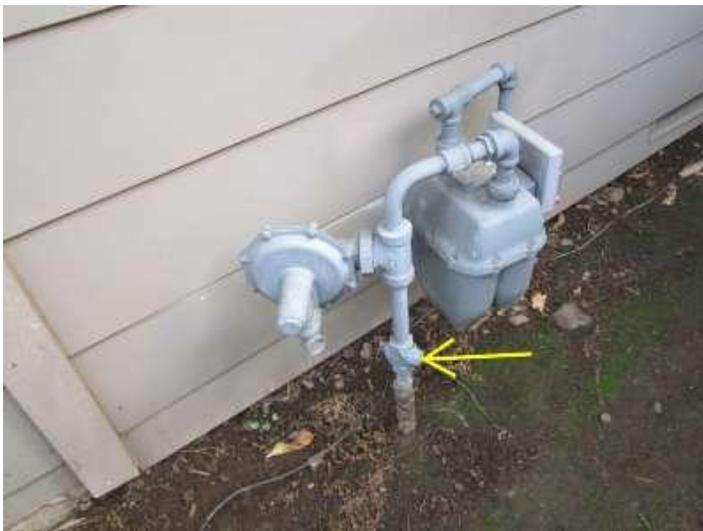
Photo 13

11) ⓘ Location of main fuel shutoff valve. West side of house (see photo below)

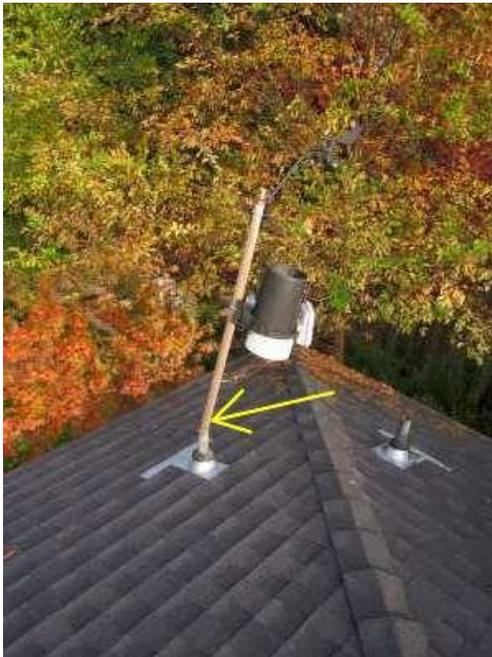
Photo 6

A weathervane has been mounted using one of the vent stacks on the northeast section of the roof. Vent stacks are used to prevent harmful sewer gasses from entering the home through plumbing drains. The weathervane needs to be removed.

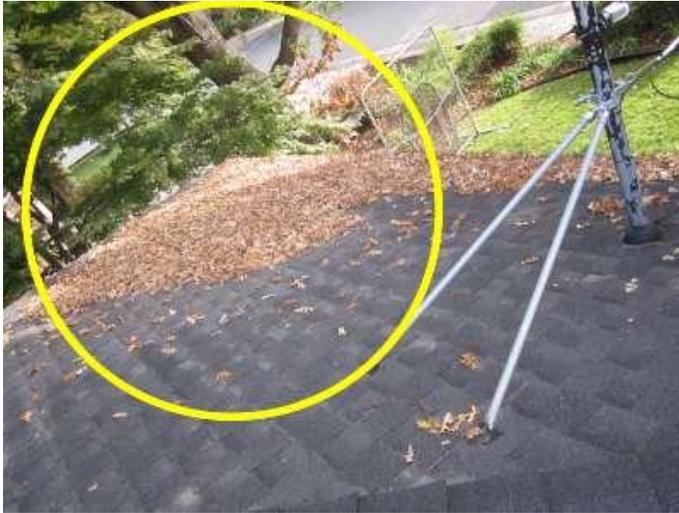
Photo 5

Debris such as leaves, needles, seeds, etc. have accumulated on the roof. This is a conducive condition for wood destroying insects and organisms since water may not flow easily off the roof, and may enter gaps in the roof surface. Leaks may occur as a result. Debris should be cleaned from the roof now and as necessary in the future.

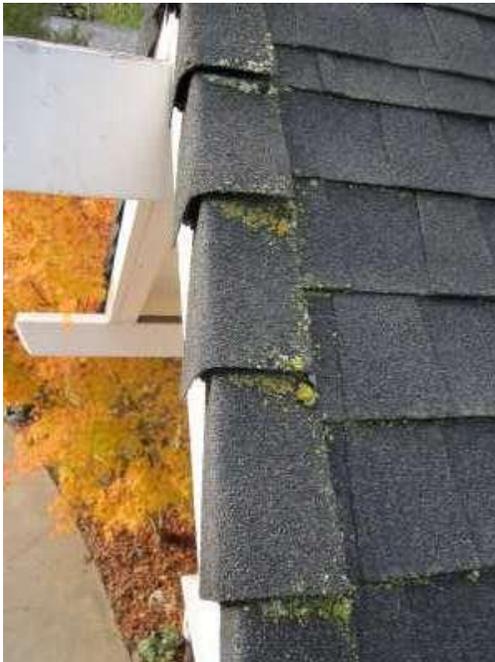
Photo 8

Moss is growing on the roof in the area above the front entrance way. As a result, shingles may lift or be damaged. Leaks may result and/or the roof surface may fail prematurely. This is a conducive condition for wood destroying insects and organisms. Efforts should be taken to kill the moss during its growing season (wet months). Typically zinc-based chemicals are used for this, and must be applied periodically. For information on various moss treatment products and their pros and cons, visit:

This is the only area where there is a significant amount of moss growing. It is directly above the entry way.

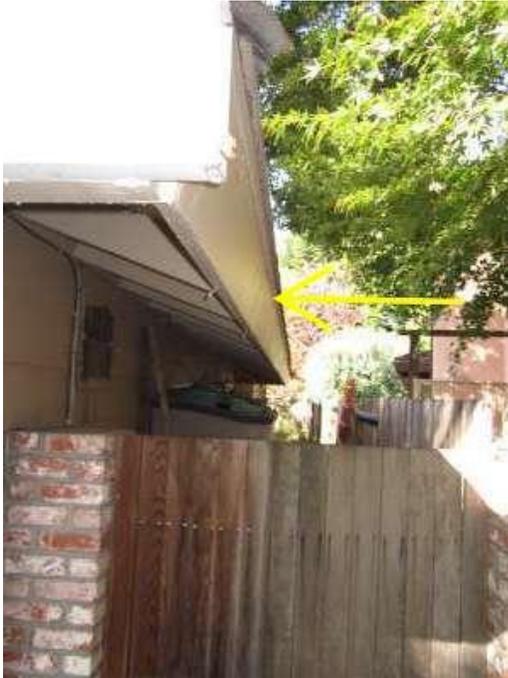
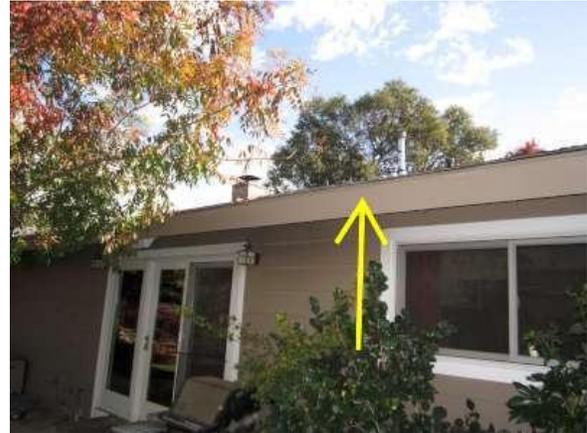
16) 🗝️ Trees are overhanging roof and are within 10 feet of roof vertically. This is a conducive condition for wood destroying insects and organisms since organic debris such as leaves or needles are more likely to accumulate on the roof surface. Accumulated debris may cause water to enter gaps in the roof surface and leak into attic and/or interior spaces. Trees should be pruned so they are at least 10 feet above roof, or don't overhang the roof.

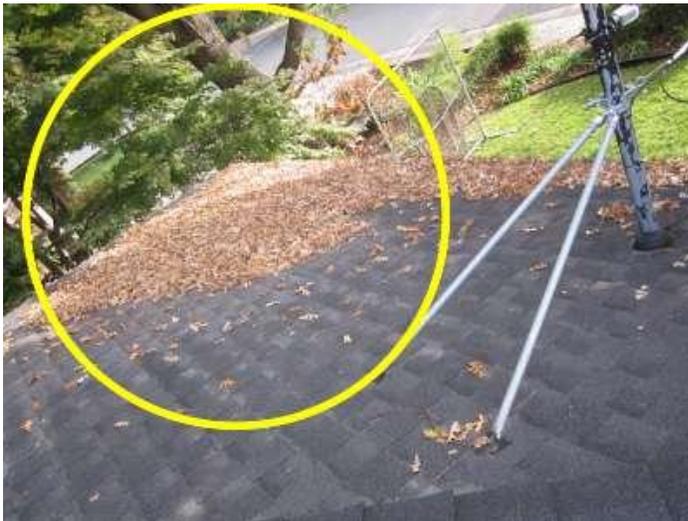
Photo 5

17) ⓘ The roof was partially obscured by accumulated debris and couldn't be fully evaluated.

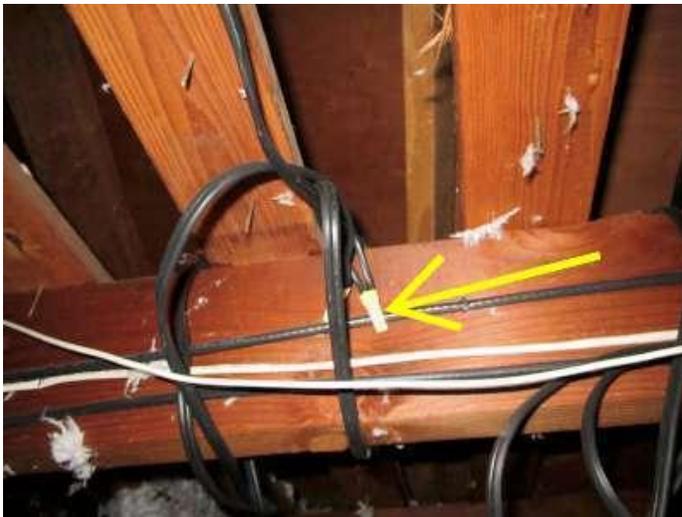
Photo 24

20) **+ 🔧 🔍** Wire splices near the attic hatch are exposed due to not being contained in a covered junction box. This is a safety hazard due to the risk of shock and fire. A qualified electrician should evaluate and make repairs as necessary. For example, install securely mounted junction boxes with cover plates where needed to contain wiring splices.

Near the entrance hatch. Needs to be in a junction box.

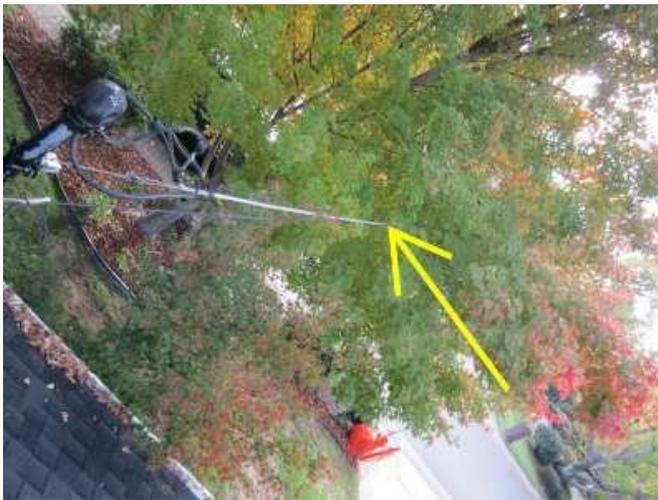
Photo 7

The service drop wires are in contact with trees or vegetation. Recommend having a qualified tree service company or arborist prune or remove trees as necessary to prevent straining or abrading the service drop wires.

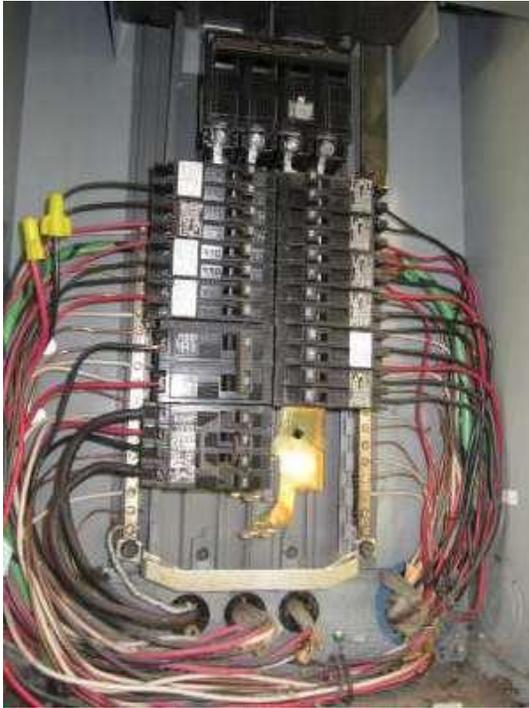
Photo 28
Correctly wired. No issues.

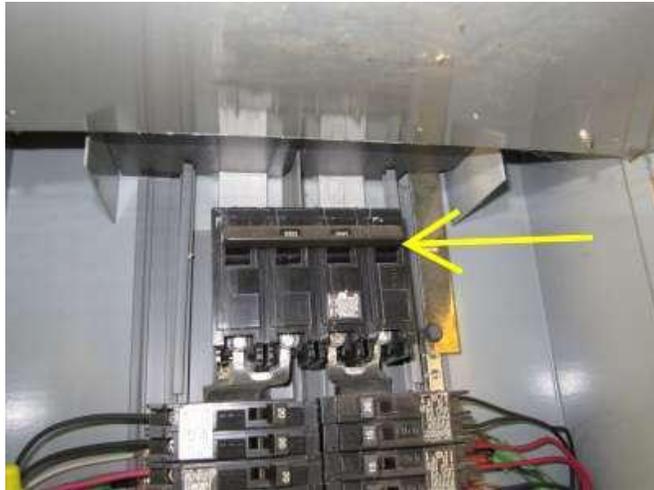
Photo 29
Arrow shows main breaker at top of panel.

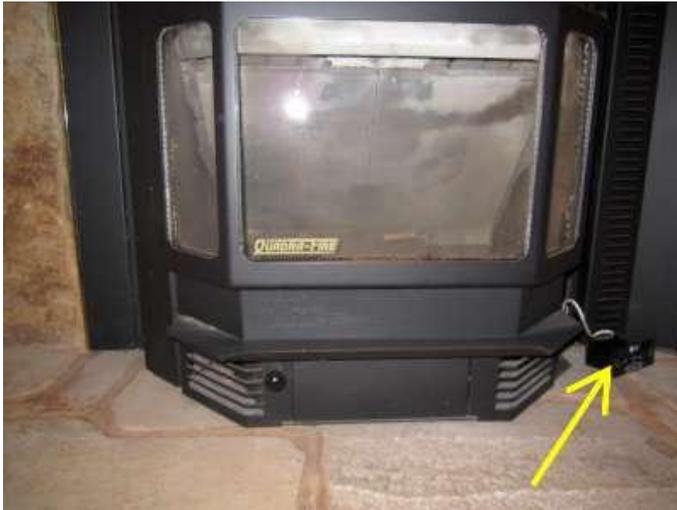
Photo 26

The off/on switch for the pellet stove is not securely mounted. In this condition the control wires are susceptible to abrasion and tension. The switch should be mounted to a sturdy structure.

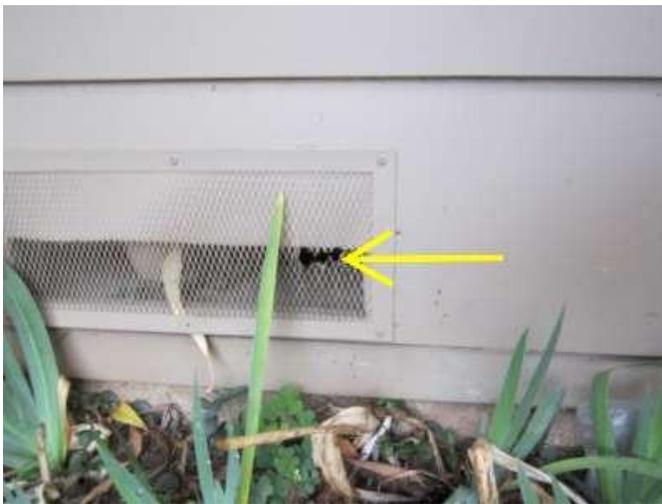
Photo 14

One of the crawlspace vent screens at the rear of the house has a hole in it. Soffit screen are meant to prevent the entrance of rodents, pets, and vermin from entering the crawlspace. The hole is large enough to allow the entrance of rodents.

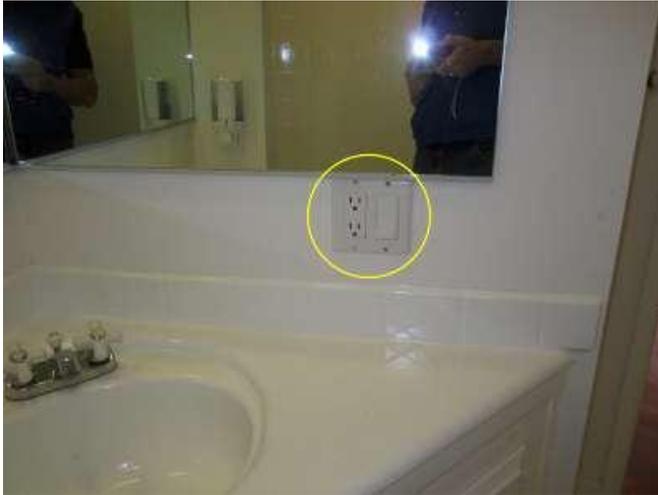
Photo 1

Central/ north bathroom: One or the electric receptacles that serve the countertop surface within six feet of a sink appears to have no ground fault circuit interrupter (GFCI) protection. This is the outlet to the right of the sink. This is a safety hazard due to the risk of shock. A qualified electrician should repairs so that all receptacles that serve countertop surfaces

within six feet of sinks have GFCI protection. For example, install GFCI receptacles or circuit breaker(s) as needed.

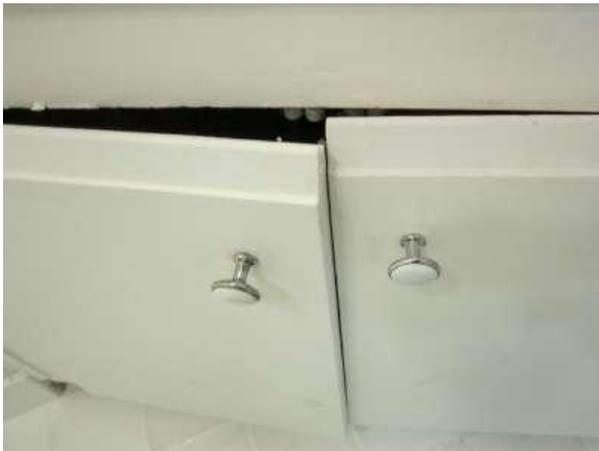
Central/ north bathroom: One or more cabinets and/or drawers are damaged and/or deteriorated. A qualified contractor should evaluate and repair or replace cabinets and/or components as necessary.

Photo 2
Hinges or not aligned.

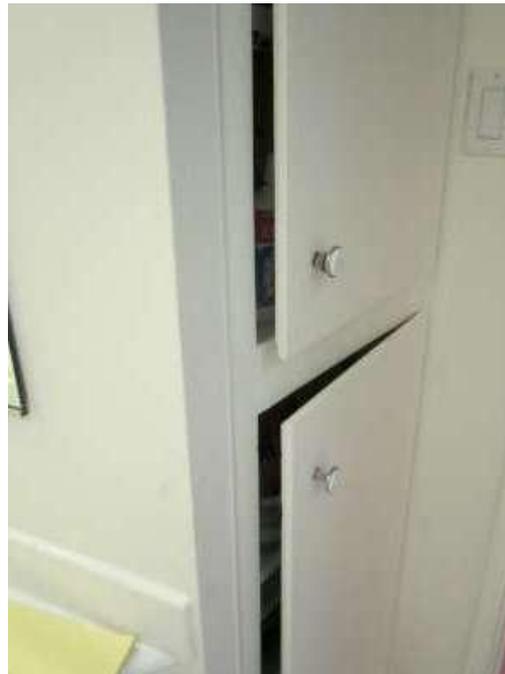
Photo 3
Magnetic retainers are deteriorated and will not hold doors shut.

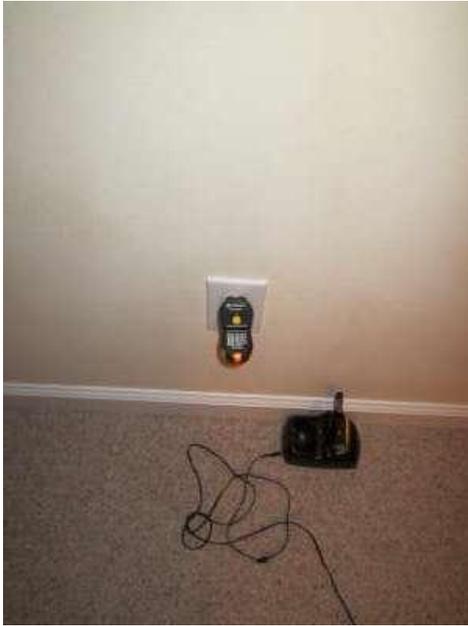
Photo 4

One open ground, three-pronged electric receptacles were found in the northwest bedroom. Other receptacles in this room may be in this same condition, but the inspector was unable to evaluate due to the presence of heavy furniture.

This is a safety hazard due to the risk of shock. A qualified electrician should evaluate and make repairs as necessary. For example, replacing receptacles or correcting wiring circuits.

This open ground is located on the east wall of the NW bedroom. Other receptacles in this room could not be evaluated due to heavy furniture.

Grounding type receptacles began being required in residential structures during the 1960s. Based on the age of this structure and the presence of 2-pronged receptacles in some areas of this structure, an acceptable repair may be to simply replace the ungrounded 3-pronged receptacles with 2-pronged receptacles. However the following appliances require grounding type receptacles:

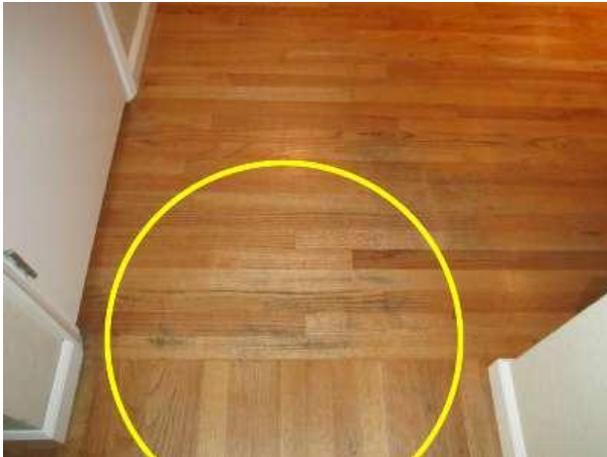
Photo 25

Wood flooring is worn at the entrance to the hallway leading to the west side of the house. Recommend having a qualified contractor evaluate and refinish wood flooring as necessary.
