Mercer Inspection Services

Property Inspection Report

This report published on Sunday, July 15, 2012 1:09:11 AM PDT

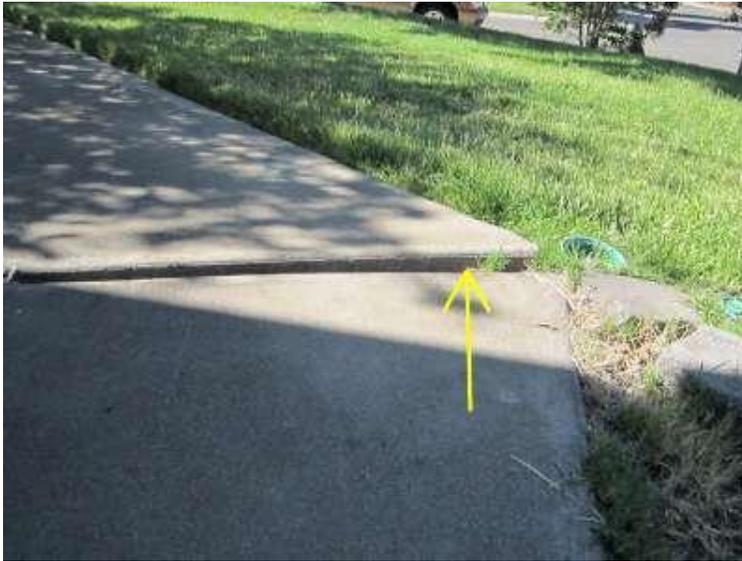
Photo 30

One trip hazards was found in the walkway to the house due to settlement and/or heaving. Recommend having a qualified contractor evaluate and repair (possibly lift) or replace walkway section as necessary to eliminate trip hazards.

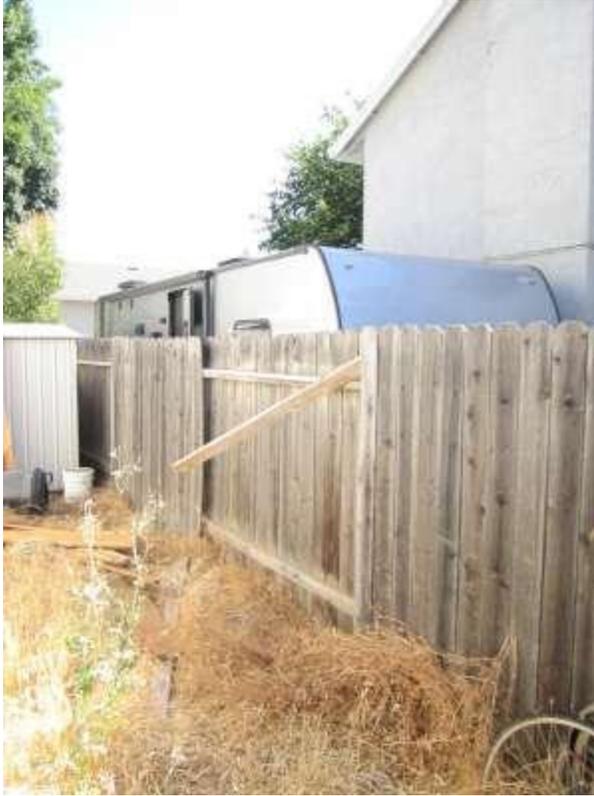
Fences and/or gates are damaged and/or deteriorated in some areas. Fence post anchoring in several places is loose and the fence is wobbling in that area. Typically a wooded fences lifespan is 25 years. This fence is at or near the point of a full replacement. A qualified contractor should evaluate and make repairs or replace sections as necessary.

Photo 23
Wobbly sections of fence.

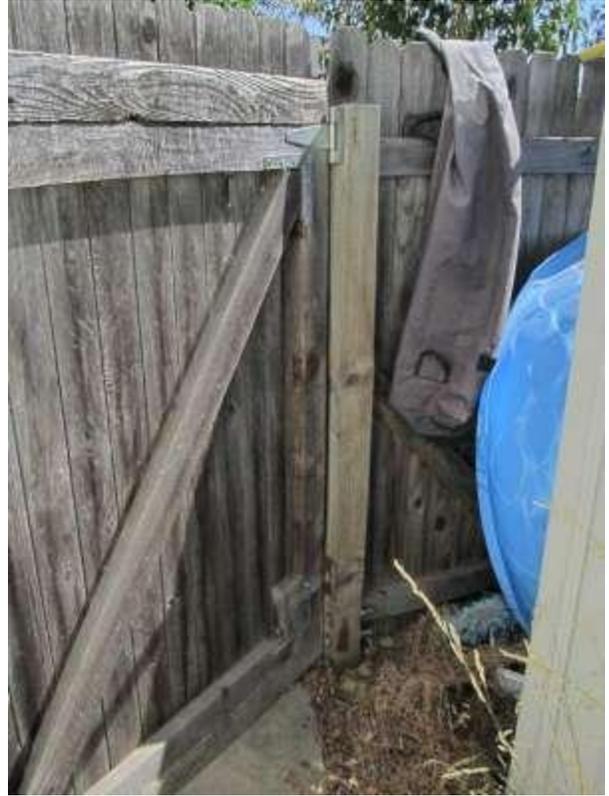
Photo 24
Wobbly gate and is difficult to open.

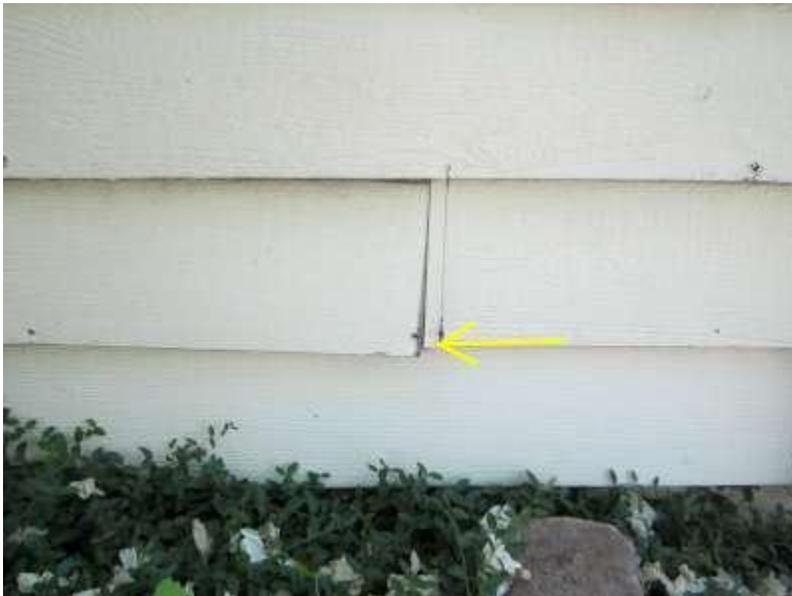
Photo 28

Siding is deteriorated in one area. A qualified contractor should evaluate and make repairs and/or replace siding as necessary to prevent water and vermin intrusion.

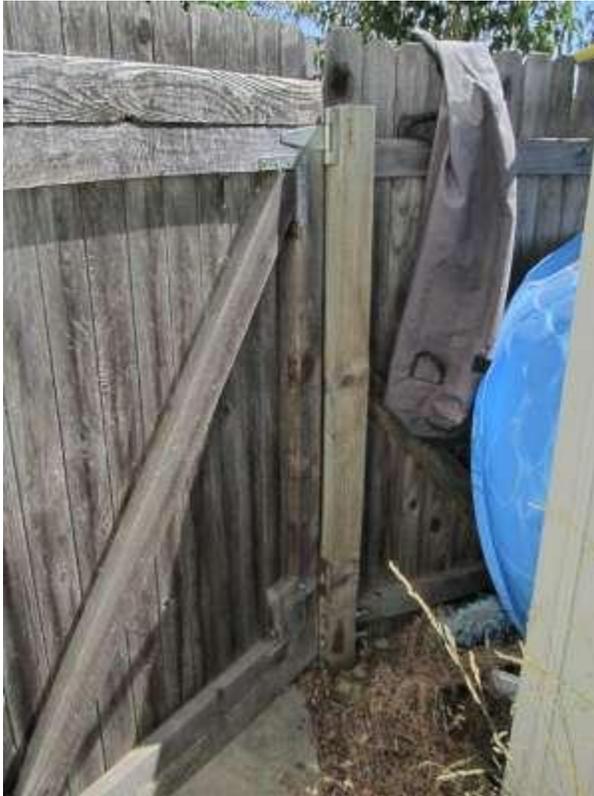
One or more fence gates are difficult to open, close and/or latch, or are damaged and/or deteriorated. Repairs should be made as necessary, and by a qualified contractor if necessary, so gates operate easily.

Photo 24
Wobbly gate and is difficult to open.

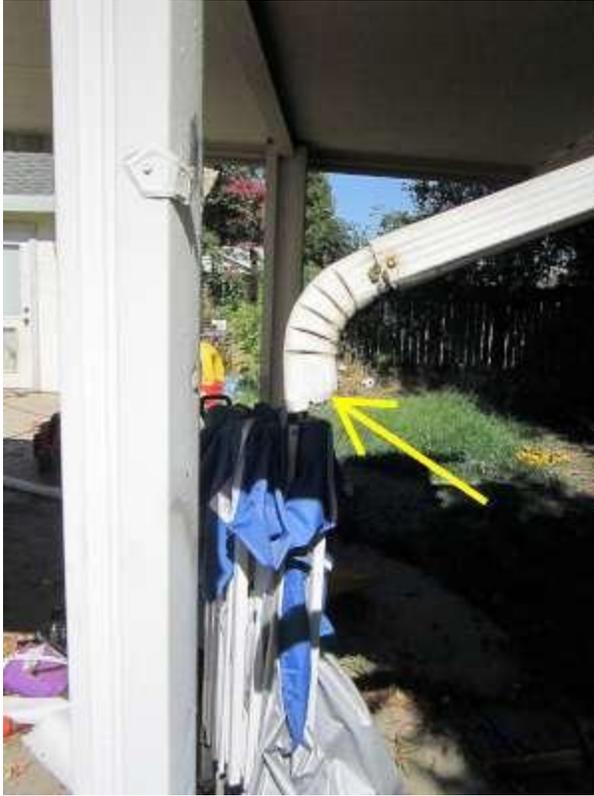
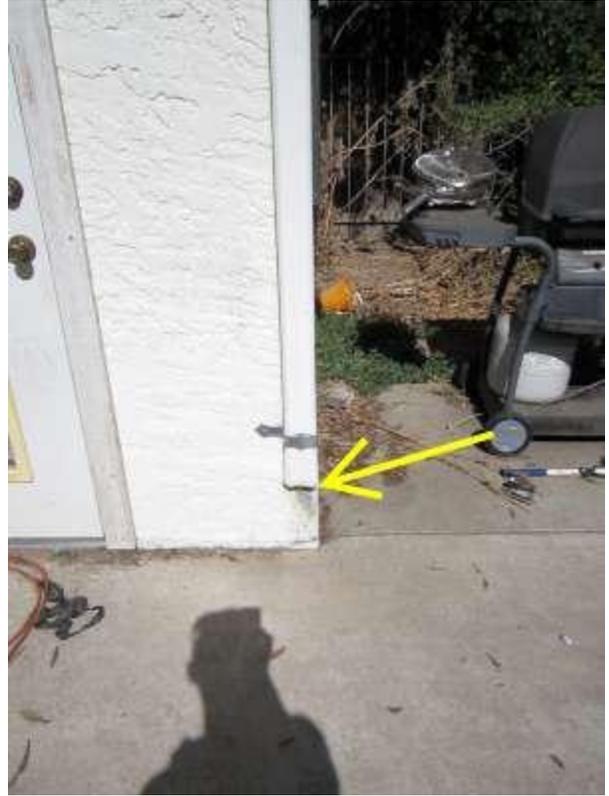
One or more downspouts are loose or detached. This can result in water accumulating around the structure's foundation, or in basements and crawl spaces if they exist. Accumulated water is conducive for wood destroying insects and organisms, and may also cause the foundation to settle and possibly fail over time. Repairs should be made as necessary so downspouts are securely anchored and functional.

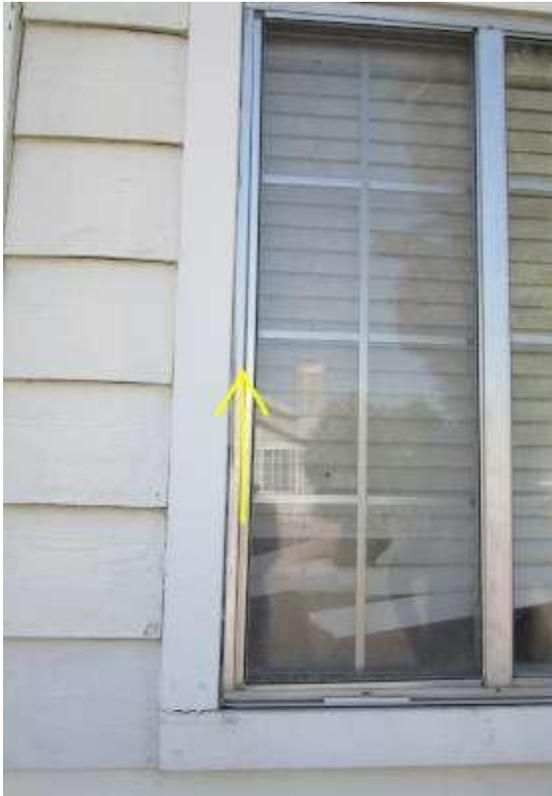
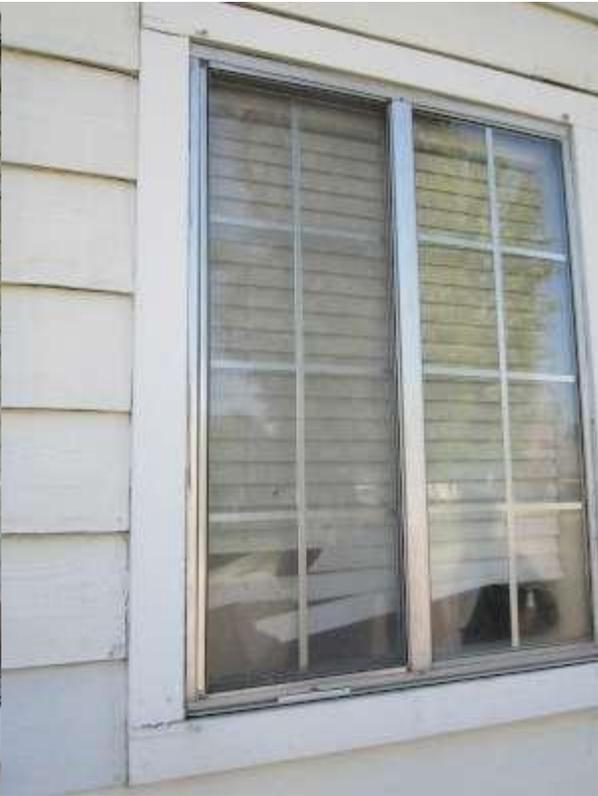
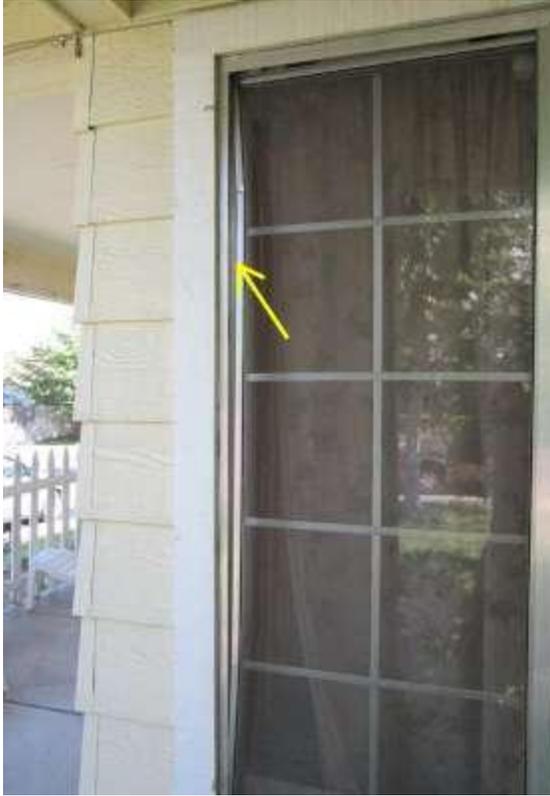
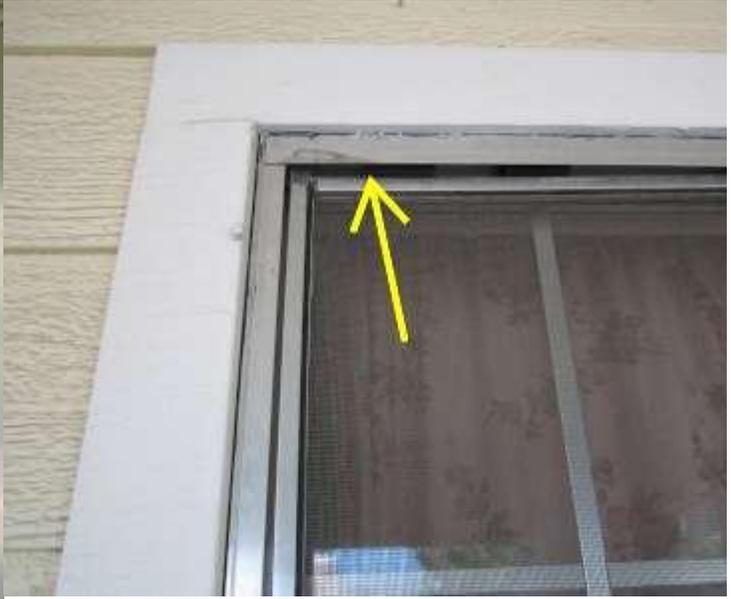
The window screens in the front of the house are in disrepair. The screen framing has been bent and screens should be replaced.

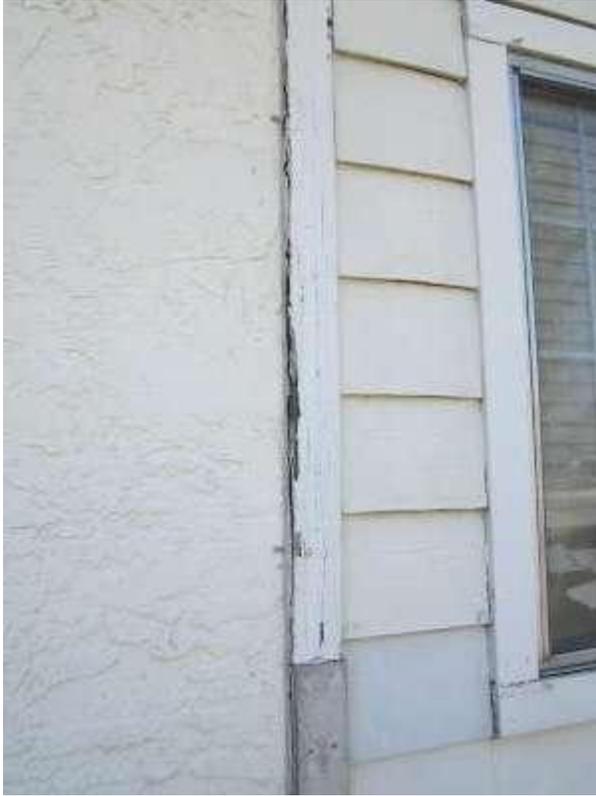
East exterior wood trim board rotten/deteriorated. This board needs to be replaced.

Photo 16
Board needs replacing.

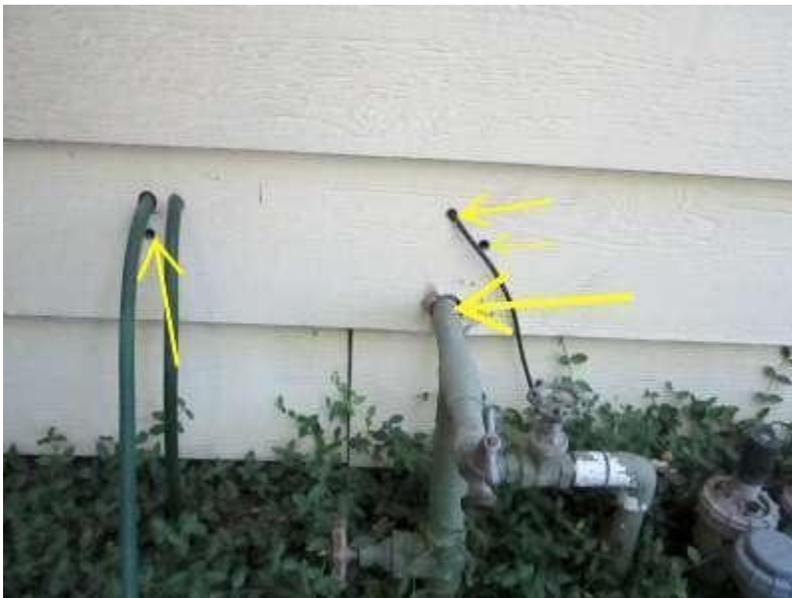
Photo 31

Sealing around openings and pipe outlets. On the east exterior wall of the house, there are several holes that need to be filled in and the gap around the main water service entrance pipe should be closed with caulking. These opening can allow wood destroying insects and wasps and hornets easy access into interior wood cavities.

Holes and gap need to be filled.

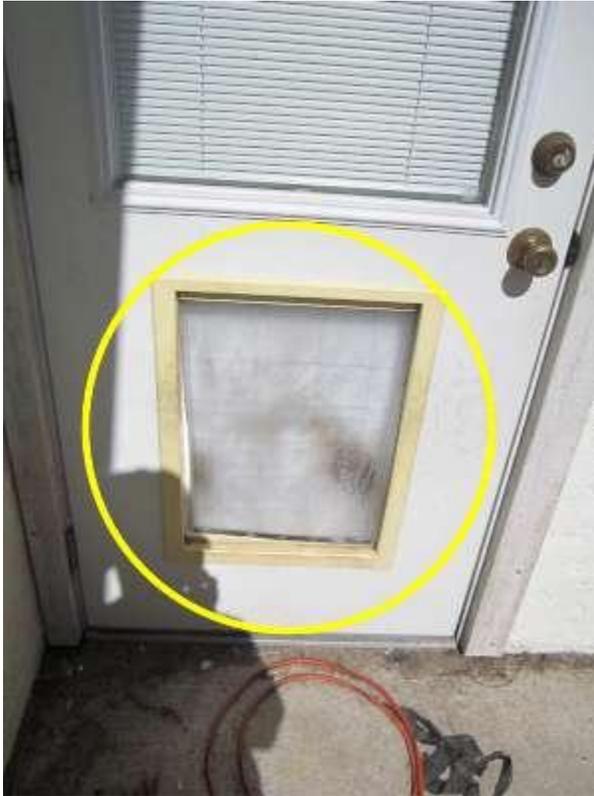
Photo 27

10) Dog door on kitchen/rear or house door is in disrepair. The dog door is needs to be replaced, and with one that can be securely looked from the inside of the home.

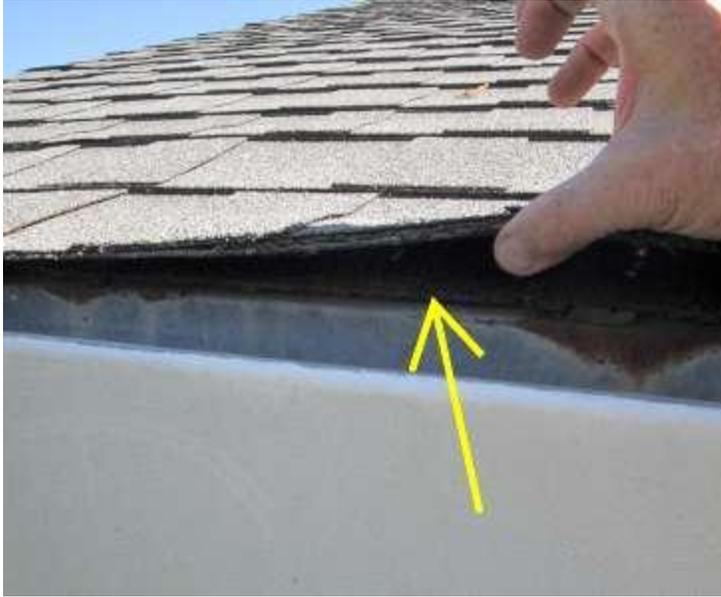
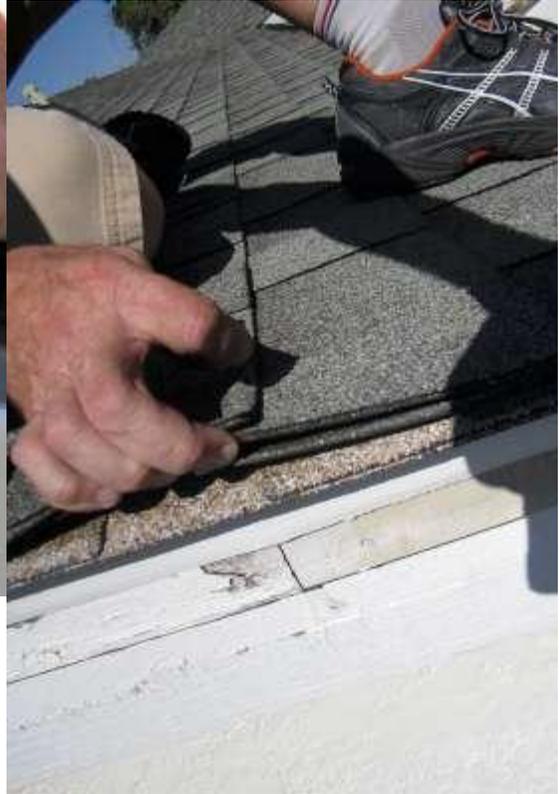
This asphalt or fiberglass composition roof surface has two or more layers of roofing materials. When this roof is replaced, recommend a complete "tear off", where all existing layers of roofing are removed before installing new roofing materials. For 30-year rated composition shingles, additional layers of material reduce the new roof material's lifespan as follows:

Photo 12
Two layers.

Removing existing roofing materials will significantly increase the cost of the next roof.

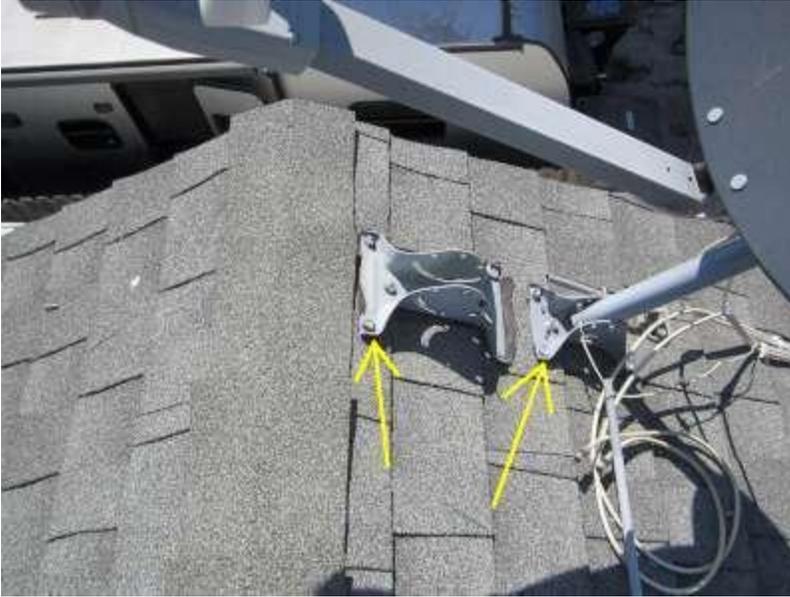
Photo 13

Satellite Dish(s) were installed and either too little sealant was used around many mounting screws and/or sealant has deteriorated.

Recommend that exterior sealant be applied to these areas and at intervals of every 3 years.

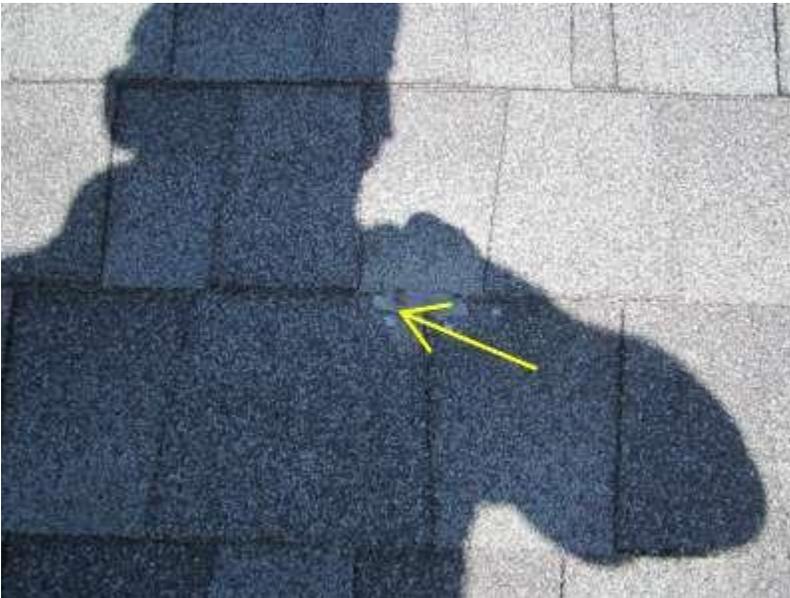
Photo 14

Improper shingle nailing. In one or more shingles, roofing nails were driven below the tab line on the external--exposed section of the shingle. These have been coated with a sealant, but sealant is going beyond its lifespan.

Recommend that all such improper nailing's be resealed or the shingles replaced.

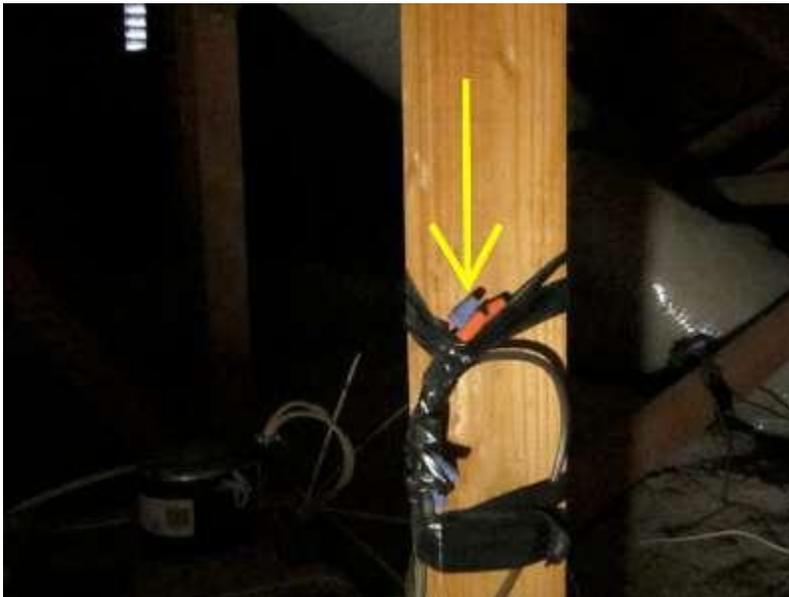
Photo 8

17) 🚫🔧🔍 Wire splices are exposed due to not being contained in a covered junction box. This is a safety hazard due to the risk of shock and fire. A qualified electrician should evaluate and make repairs as necessary. For example, install securely mounted junction boxes with cover plates where needed to contain wiring splices.

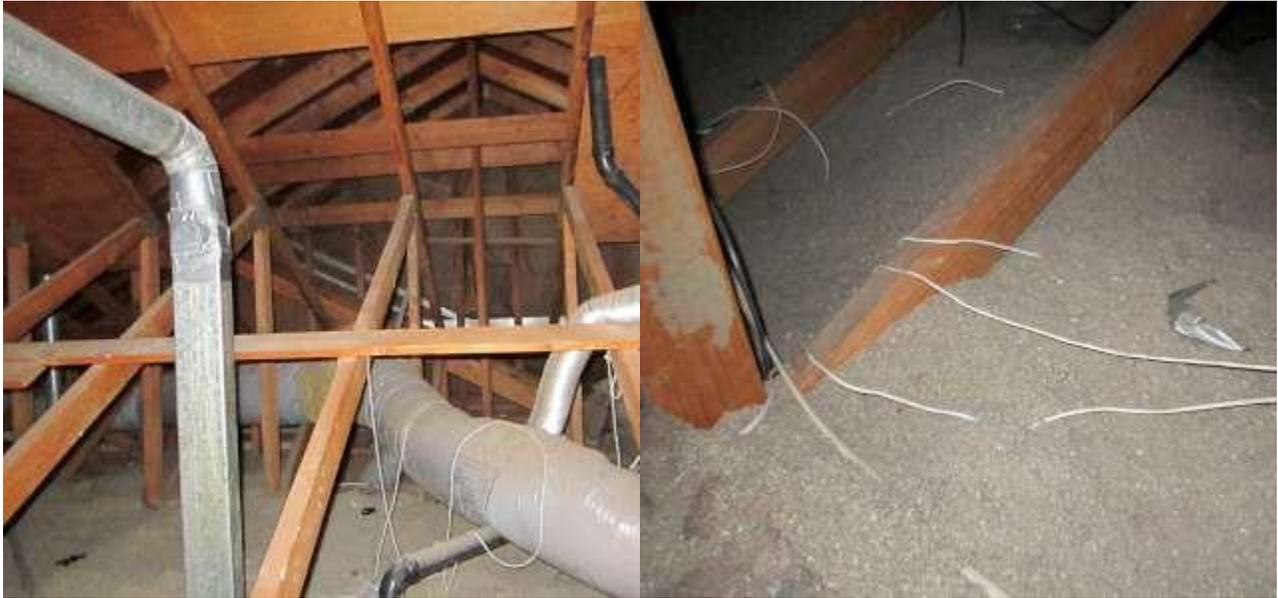
18) 🚫🔧🔍 1) Some wiring is loose, unsupported, or inadequately supported. Standard building practices require non-metallic sheathed wiring to be trimmed to length, attached to runners or to solid backing with fasteners at intervals of 4-1/2 ft. or less. Fasteners should be installed within 12 inches of all enclosures.

2) 1) Electrical cables within 4 feet from attic entrance without adequate protection from

abrasion. Additionally, electrical cables should not be running along a walkway unprotected. These can be damaged by movement in the attic and lead and become a fire and electrical shock hazard. Cables should be moved

A qualified, licensed electrician should evaluate and repair as necessary. For example, trim wire to length and/or install staples as needed.

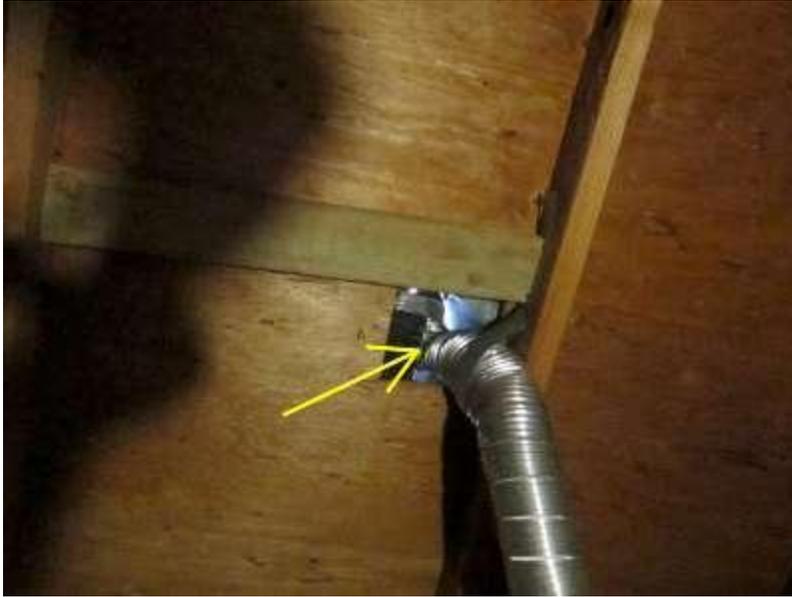
Photo 6

Master bathroom ventilation exhaust pipe is crushed/folded at roof exit. This can result in greatly reduced air flow and buildup of condensation in exhaust pipe, which is conducive to mold growth.

Recommend replacing the flexible exhaust pipe or if there is enough pipe, cut it off at the end and attach properly.

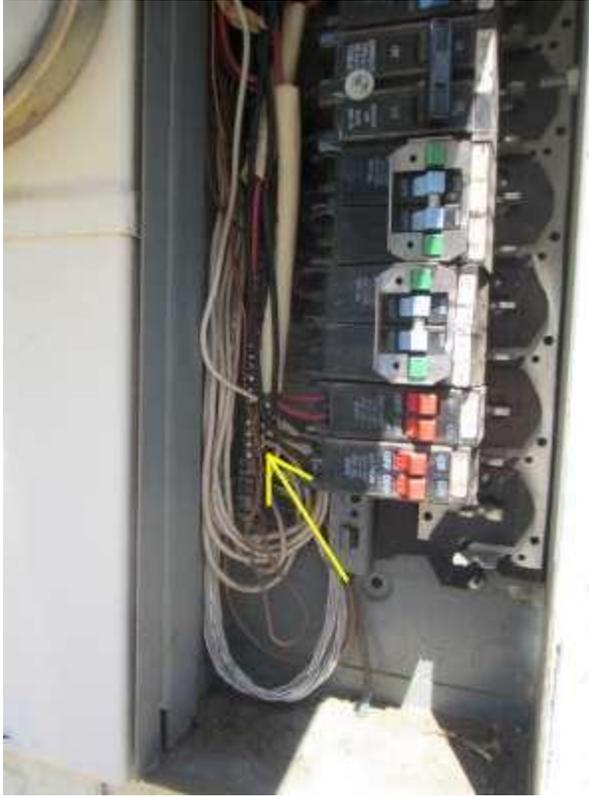
One neutral wire connection is doubled or bundled together on the neutral bus bar. This is unsafe due to the need to turn off multiple circuit breakers to work on any of the circuits using these wires. A qualified electrician should evaluate and repair as necessary.

Photo 34
Neutral bus bar double tapped in this location.

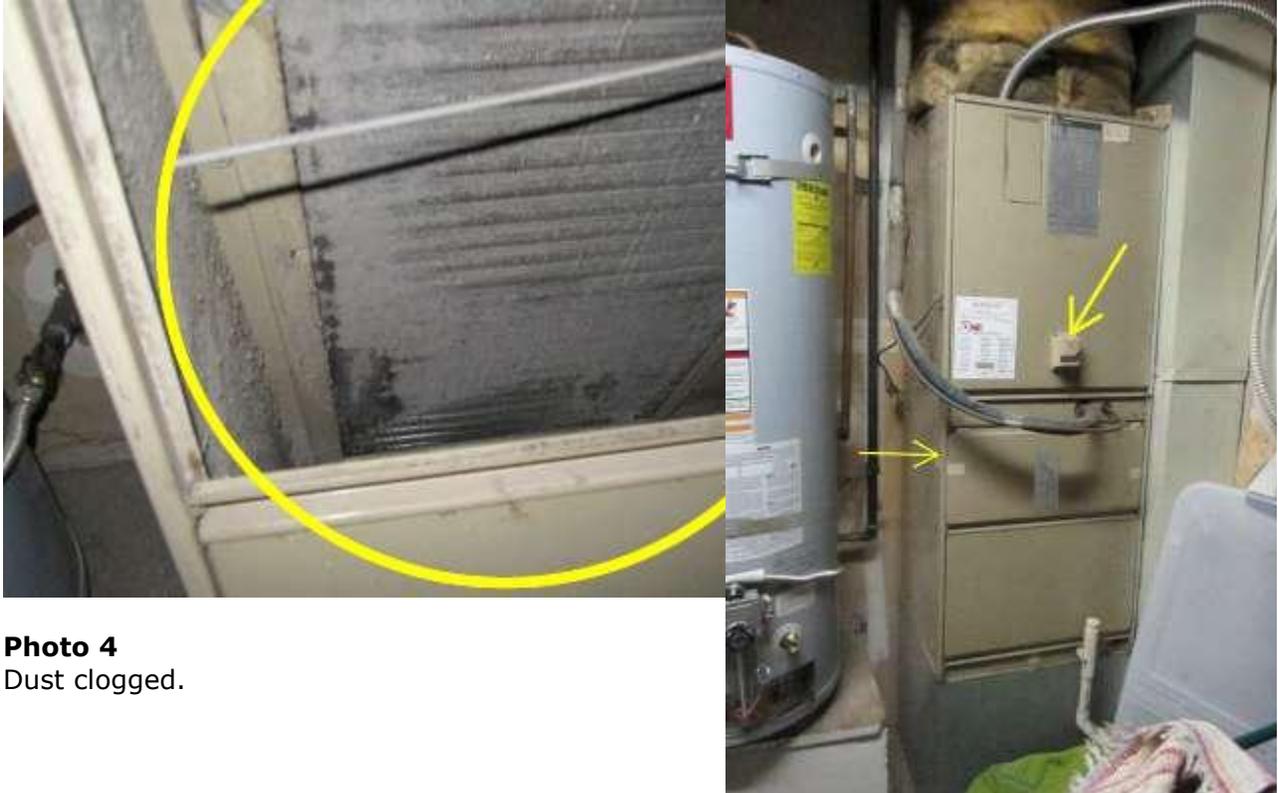
No filter is visible for the heating/cooling system. As a result, the unfiltered air has flowed through the system and clogged the A/C expansion radiator, built up on gas burners, and accumulated in the systems air ducts. The heating/cooling equipment life and the indoor air quality may be reduced. Correctly sized filter(s) should be installed. If necessary, guides or retaining devices should be installed or repaired so filter(s) are securely anchored and gaps around edges are minimized

When heat was activated, a burning odor was detected from vents. System was shut down to prevent a possible duct fire. Ducts should be cleaned and furnace cleaned as soon as possible.

Photo 4
Dust clogged.

Indicator reads that filter needs replacing. Without a filter present this indicates reduced flow due to dust build up.

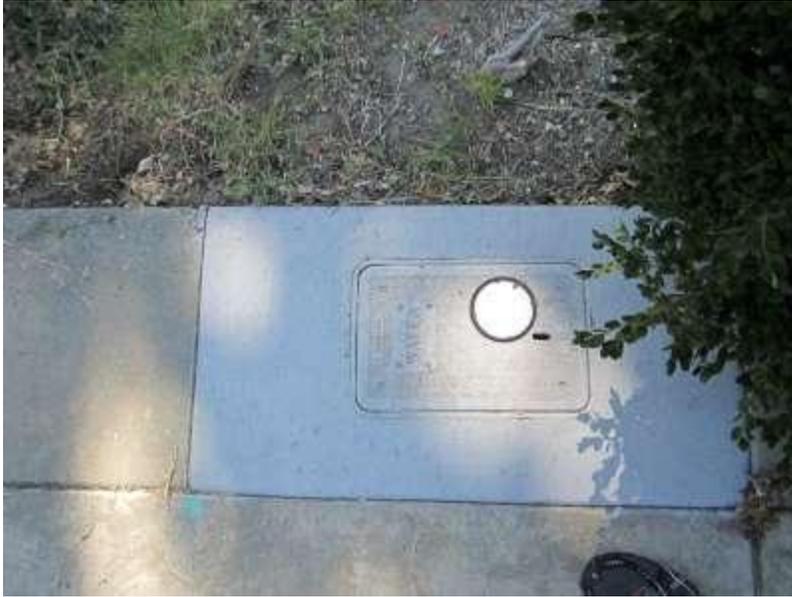
Photo 29

Note on the location of the main water shutoff. The original water shutoff valve was located near the street corner in the front lawn, but it has since been relocated to the west edge of the driveway. See photo below.

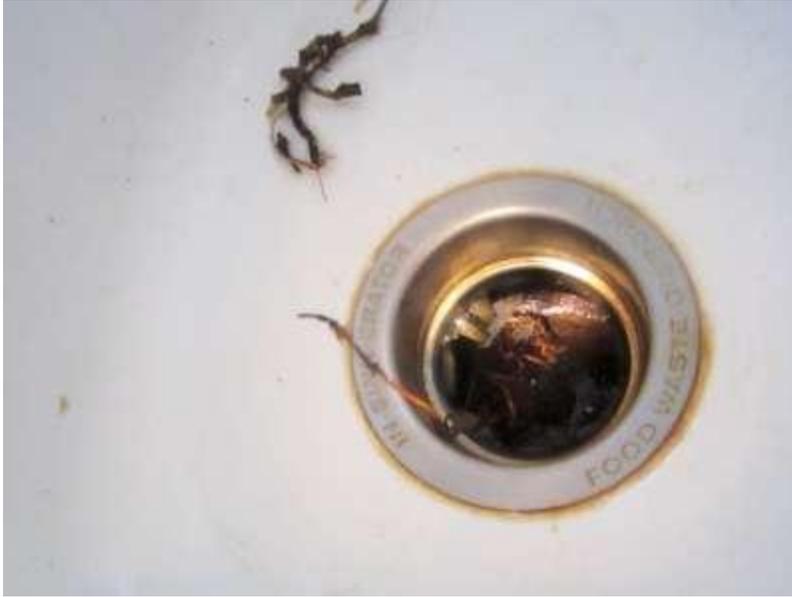
The under-sink food disposal is noisy. The disposal contains pieces of plastic that needs to be cleared out before operation.

Plastic pieces in disposal. Need to be cleaned out.

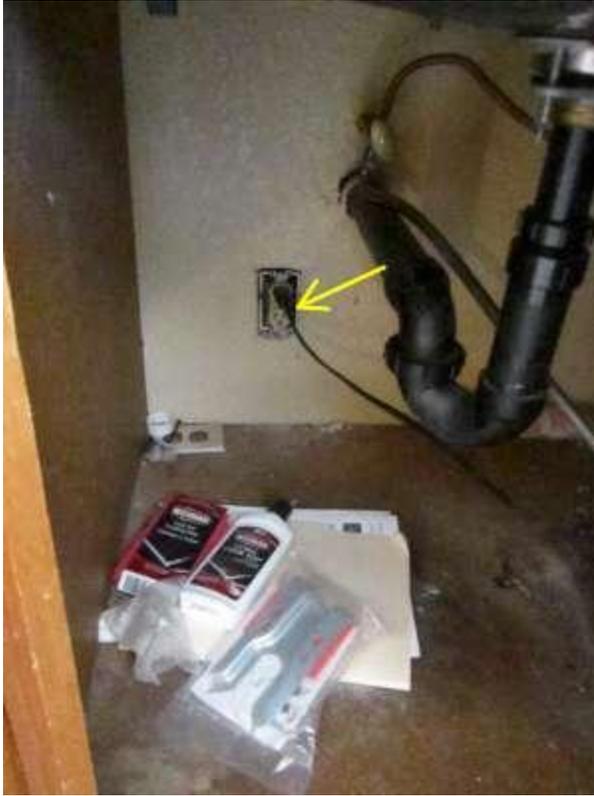
Photo 1

35) A cover plate is missing from an electrical receptacle under the sink. . They are intended to contain fire and prevent electric shock from exposed wires. This is a safety hazard due to the risk of fire and shock. Cover plates should be replaced where necessary.

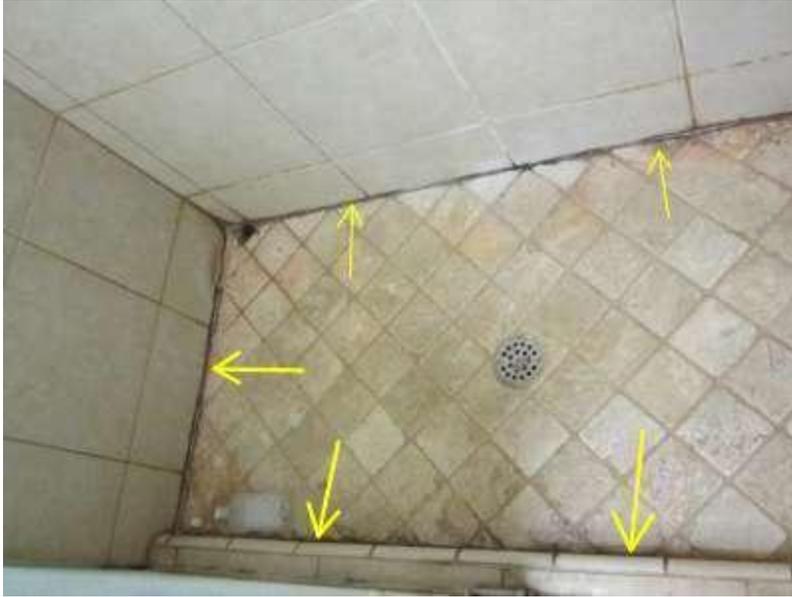
Photo 3

Minor damage deterioration was found on the grout at the base of the master bedroom shower. This was in conjunction of the extensive presence of black and pink mold. The client(s) should evaluate and consider having repairs made, and/or grout replaced where necessary.

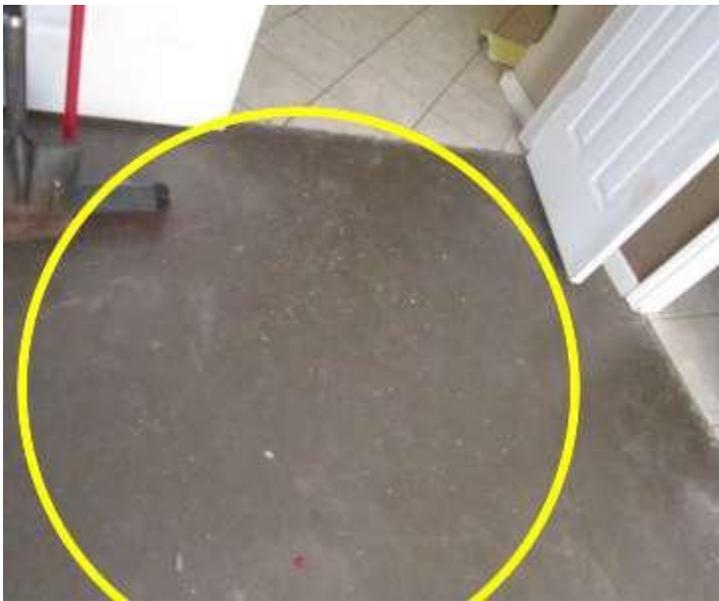
4) No carpeting in master bedroom--bare cement floor.

Photo 9
Missing carpeting.

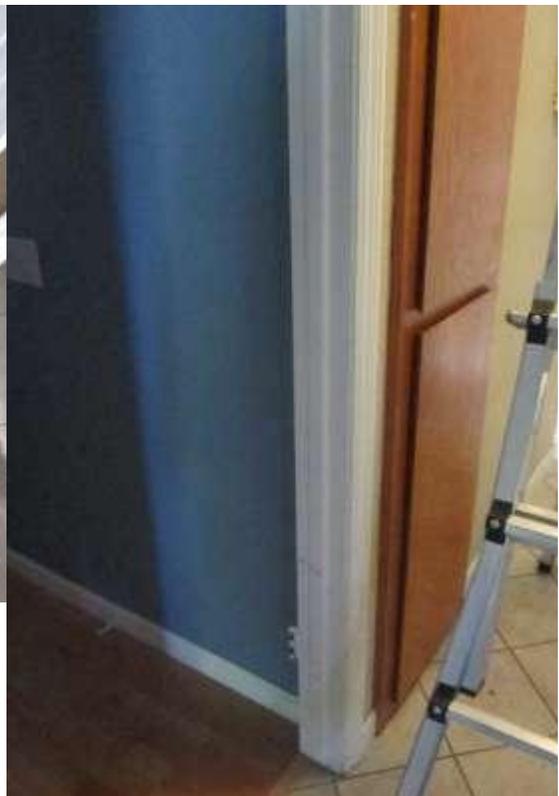
2) Door is off hinges in front bedroom.

Photo 10
Door off hinges.

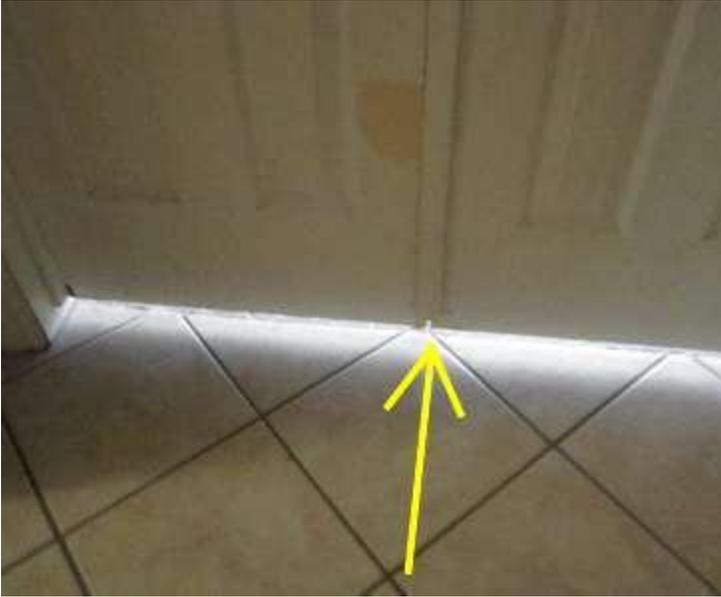
44) 🛠️ 1) Master bedroom entrance doors are cut to high off base.

Photo 11
Large gap.

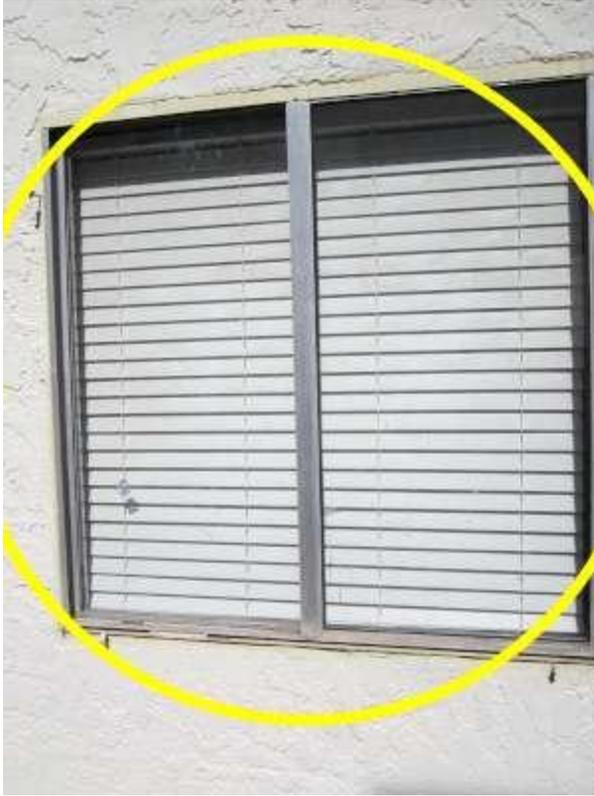
Screens are missing of one or more windows and the sliding screen is missing from the master bedroom. Screen doors should be replaced where necessary.

Photo 22
Missing screen.

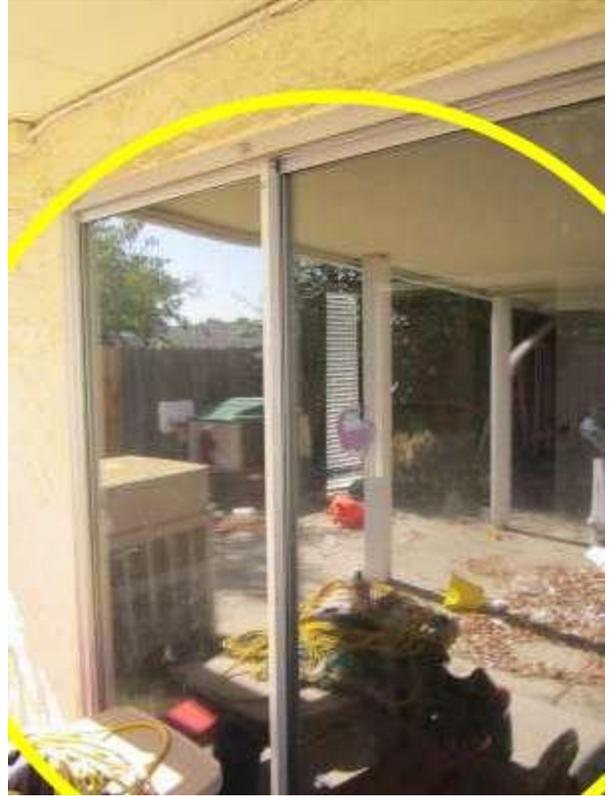
Photo 21
Missing screen door.
