Mercer Inspection Services

Property Inspection Report

**Property address: XXXXXXXX
XXXXXXXX**

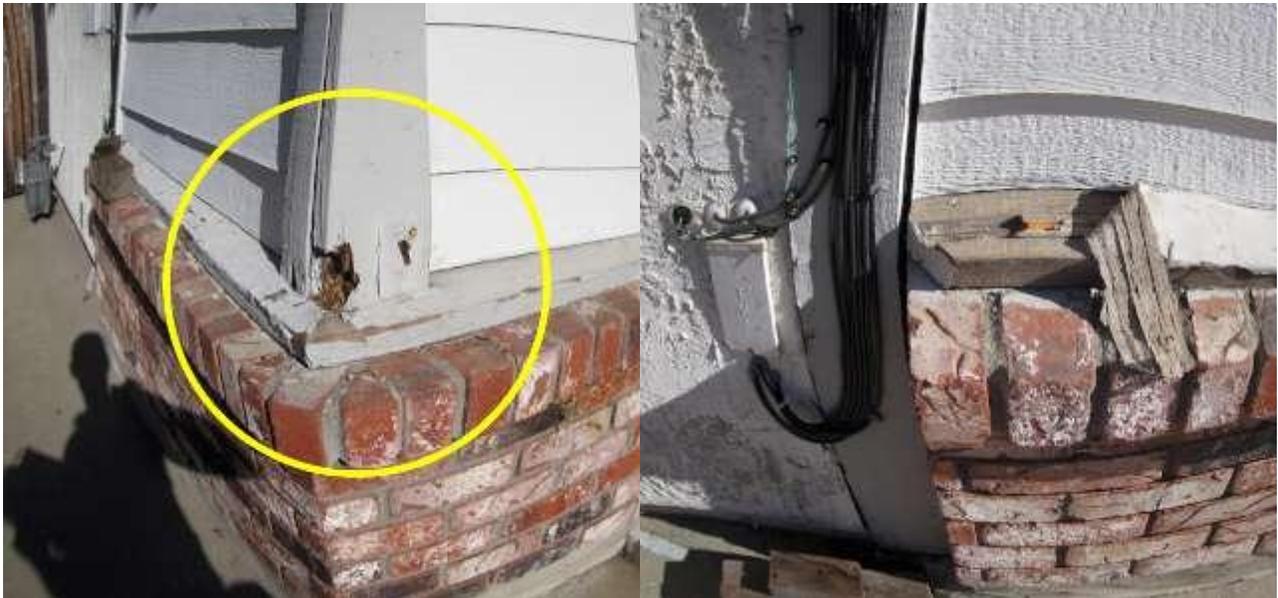
Photo 4

1) Siding at base of front southwest corner of the home is deteriorated and need replacement. A qualified contractor who should evaluate and make repairs and/or replace siding as necessary.

2) The wood base rail on top of brick adjacent to this corner is also deteriorated and need to be replaced.

3) A few areas of the masonry have holes, missing brick or mortar. These should be repaired by a qualified masonry contractor.

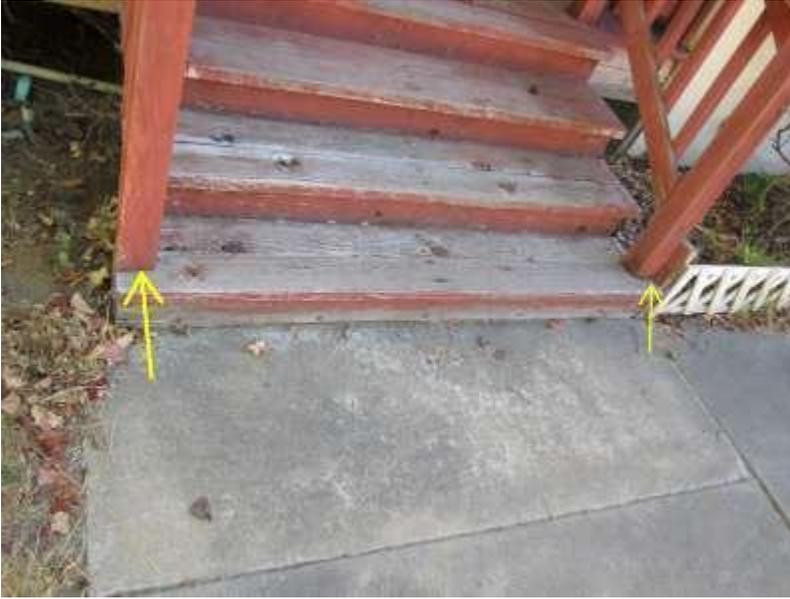
Photo 29

The deck stair rails on the northwest side of the house are unstable in one or more areas due to lack of diagonal bracing. This is a safety hazard since movement may lead to falling. A qualified contractor should evaluate and repair as necessary, such as installing additional supports and/or diagonal bracing.

This can be remedied by lag screwing each of the post to a 6" x 6" cross connector below the last step, or by replacing the post with longer posts that are anchored into the ground with concrete.

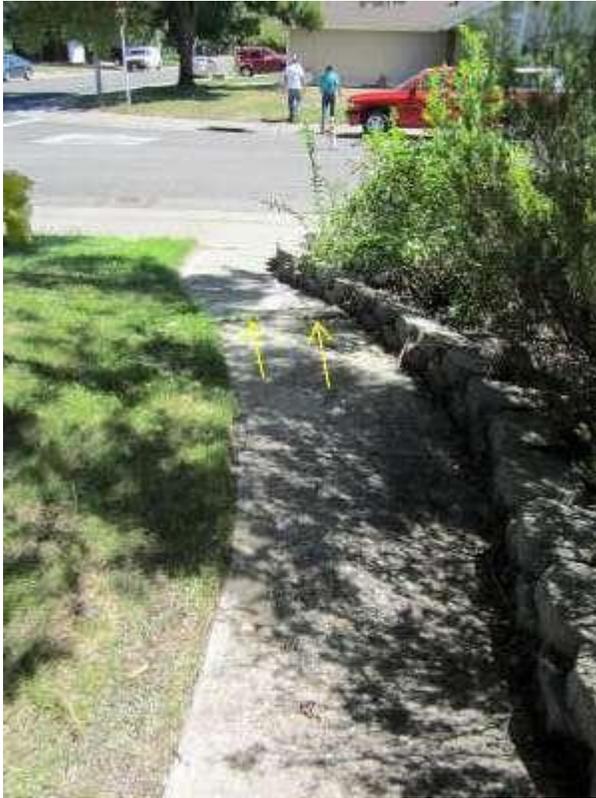
Photo 36

3) + Trip Hazard. A section of the front entrance way sidewalk has either lifted or depressed leaving a 1.5 inch raised edge. This is a trip hazard and needs to be repaired. This should be done by a licensed cement contractor.

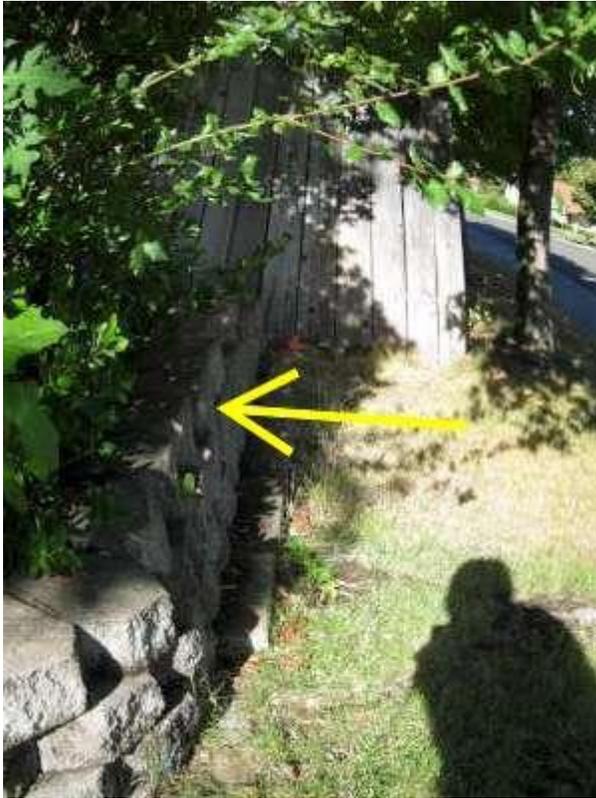
Photo 6

-
- 4) 🔍 Leaning was found in one of the retaining walls. This is the section in the front of the home on the north side; a qualified contractor should evaluate and repair or replace wall(s) as necessary.

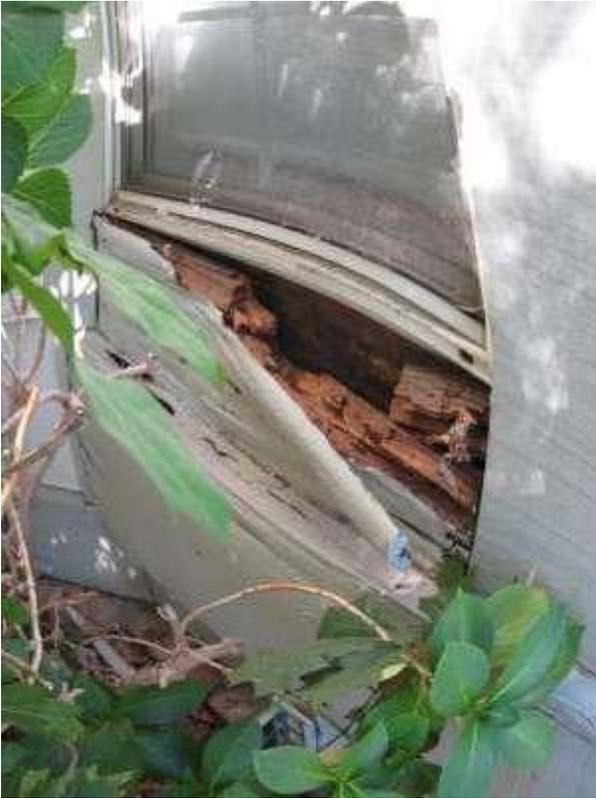
Photo 8

6) 🛠️🔍 Siding below the south side of the front bay window is damaged and/or deteriorated. A qualified contractor should evaluate and make repairs and/or replace siding as necessary to prevent water and vermin intrusion

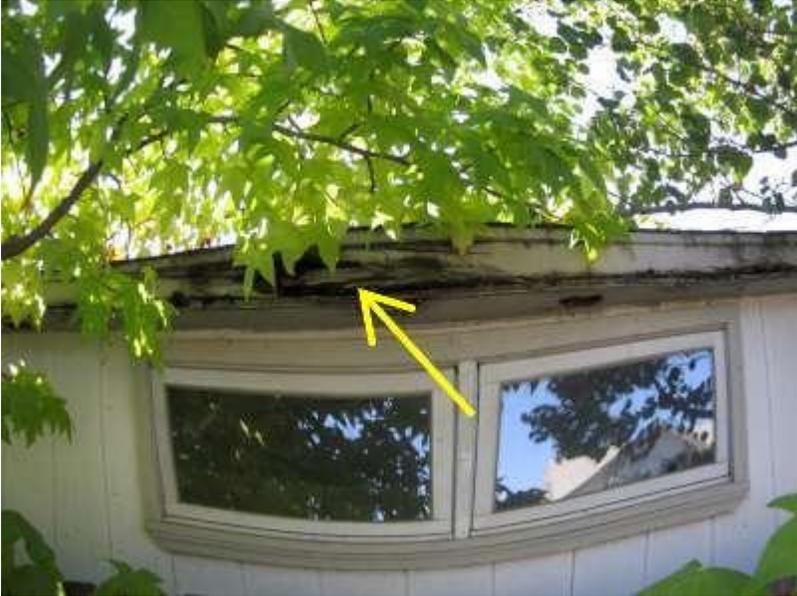
Photo 9

Fascia boards are damaged or deteriorated on the north side of the north storage building.

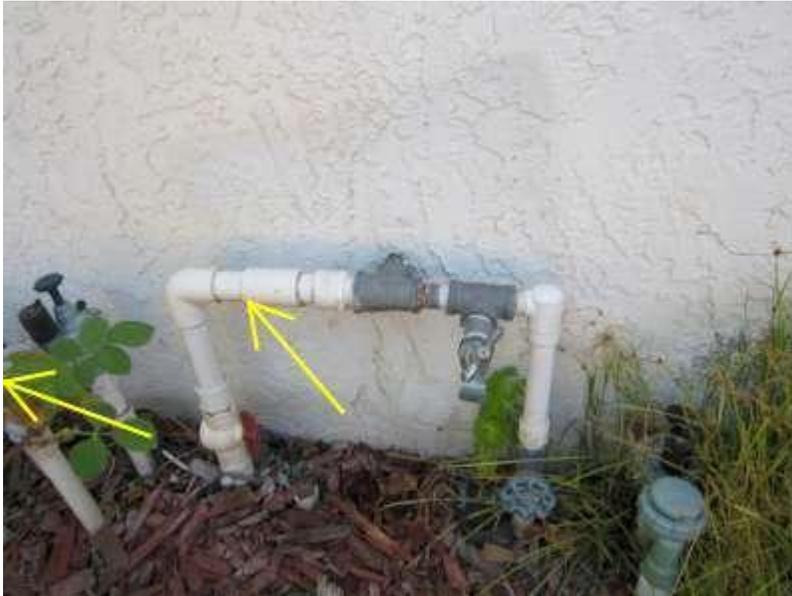
Photo 28

The outside water shutoff in the rear of the house leaks. The connector fitting to leading to a 90 degree elbow fitting is where the leak emanates. A qualified plumber should evaluate and repair as necessary.

One of the automatic sprinkler valve actuators at the rear of the house is leaking. A lawn and garden specialist should make this repair.

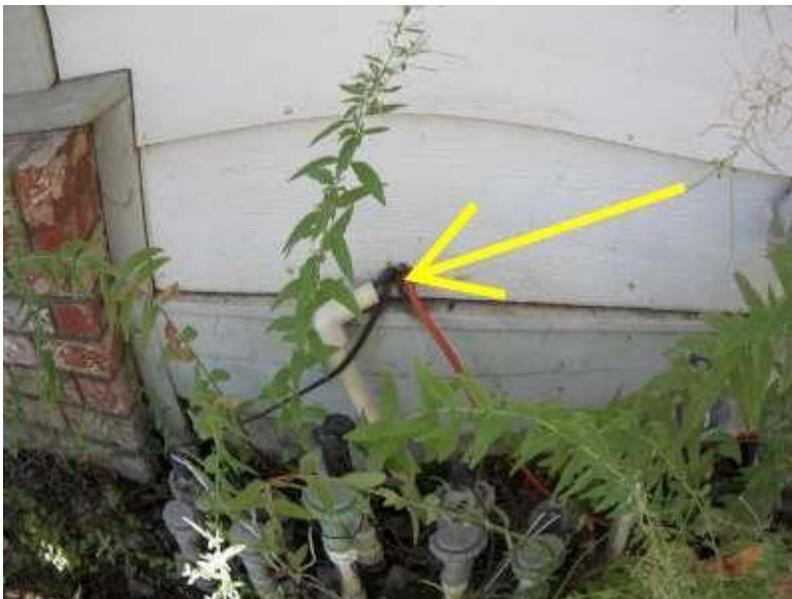
Photo 10

Gaps exist at one or more openings around the exterior, such as those where outside faucets, refrigerant lines, and/or gas supply pipes penetrate the exterior. Gaps should be sealed as necessary to prevent moisture intrusion and entry by vermin.

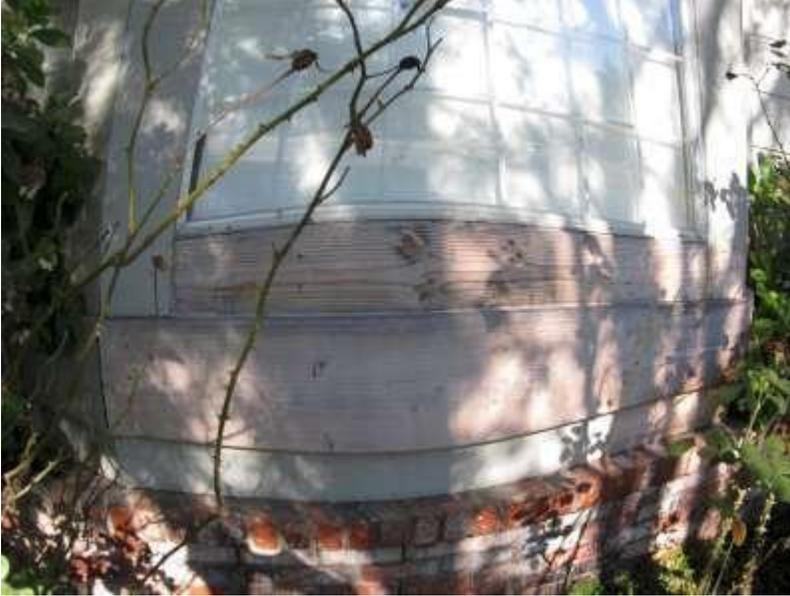
Photo 7

Some of the siding below the front bay window has been replaced, but has not been painted and caulked. A qualified contractor should evaluate and make repairs and/or replace siding as necessary to prevent water intrusion.

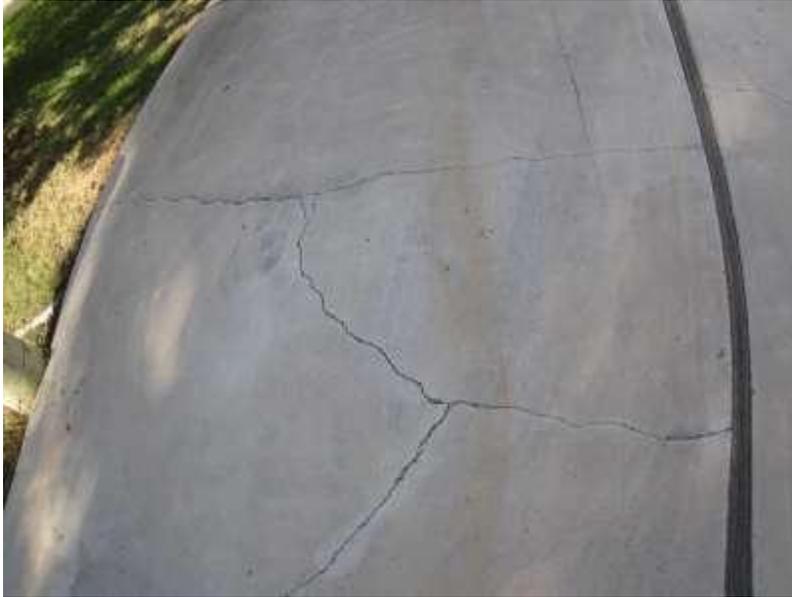
Photo 2

Minor cracks were found in the driveway. However they don't appear to be a structural concern and no trip hazards were found. No immediate action is recommended, but the client(s) may wish to have repairs made or have cracked sections replaced for aesthetic reasons.

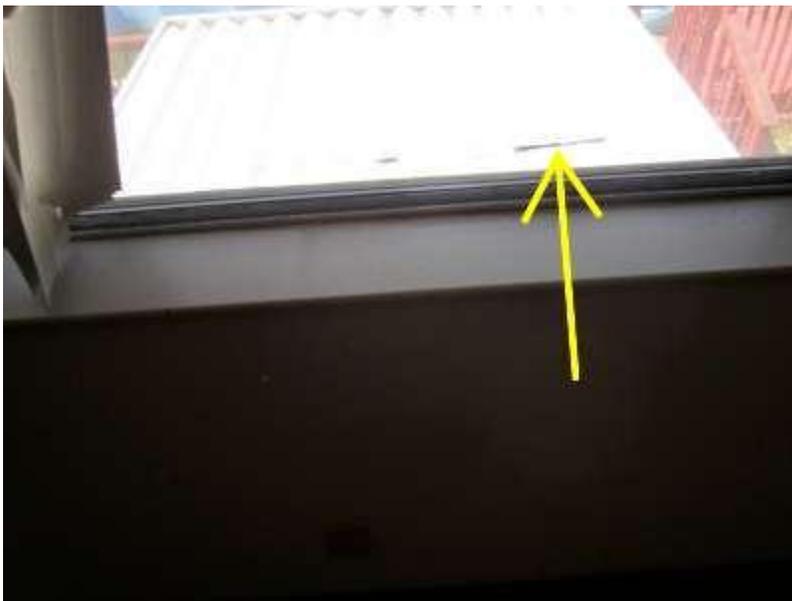
Photo 34

14) The screen in the front door and the master bedroom window has tears in them and should be repaired or replaced.

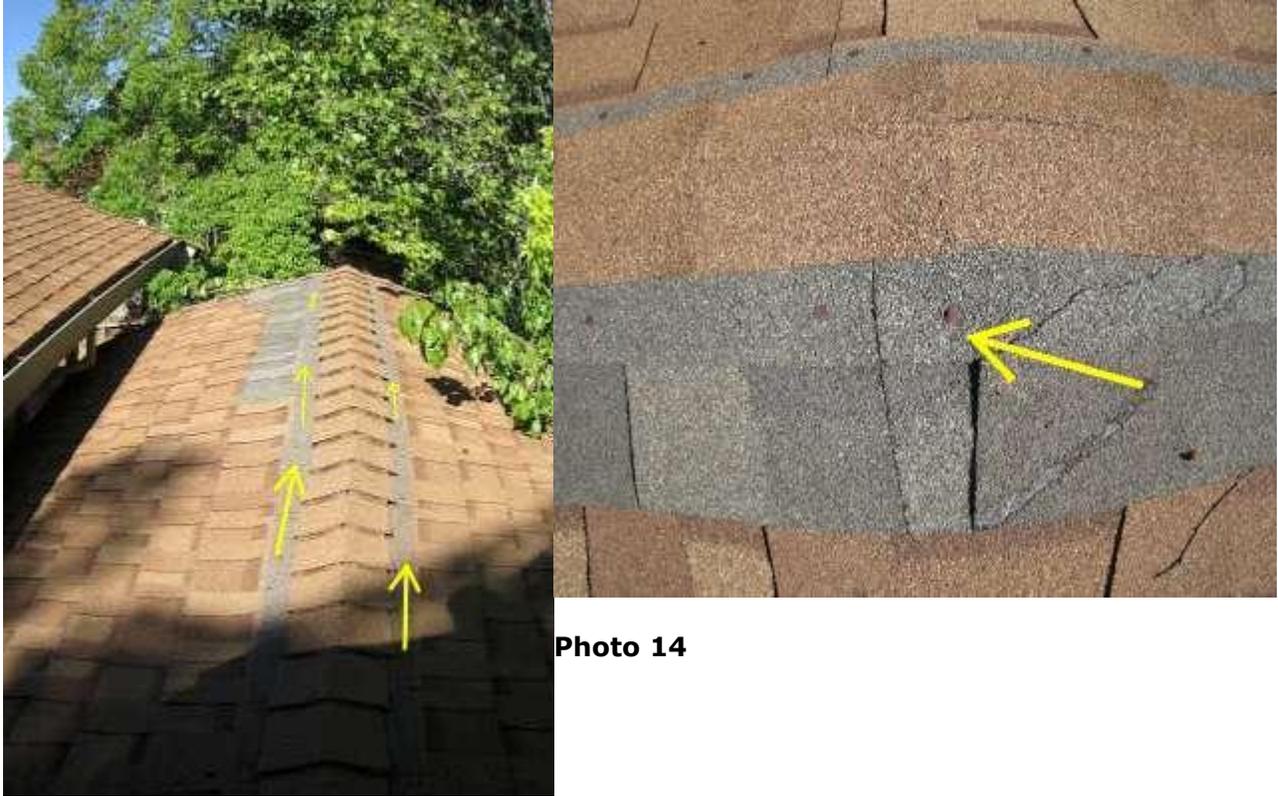
Photo 14

15) 🔍 The roof cap on the north side storage building was attached to shingles that were above minimum nailing line and exposing nails. This can lead to leaking. A qualified roofing contractor should add an additional section of shingle to the roof apex and a new roof cap.

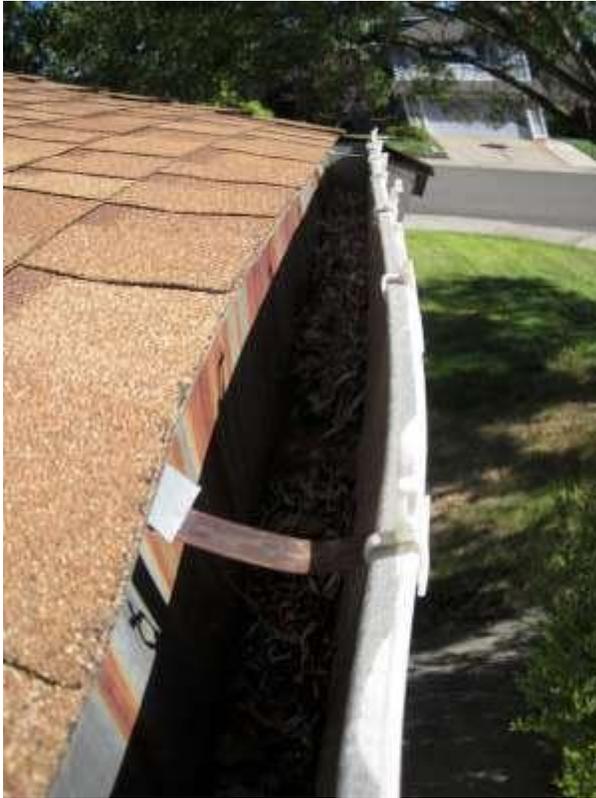
16) 🗑️ Debris has accumulated in one or more gutters. This is conducive for wood destroying insects since gutters may overflow and cause water to come in contact with the structure's exterior or make water accumulate around the foundation. Gutters should be cleaned now and as necessary in the future.

Photo 12
Debris in gutter.

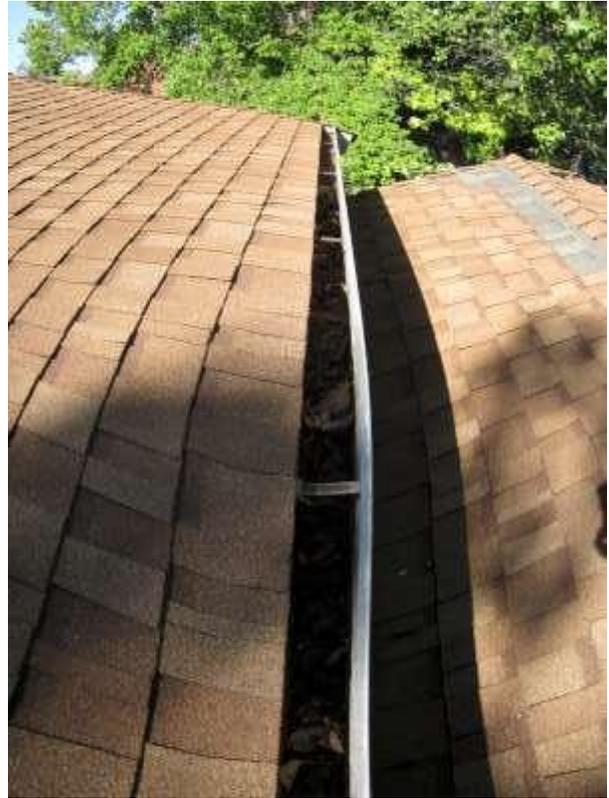
Photo 13
Debris in gutter.

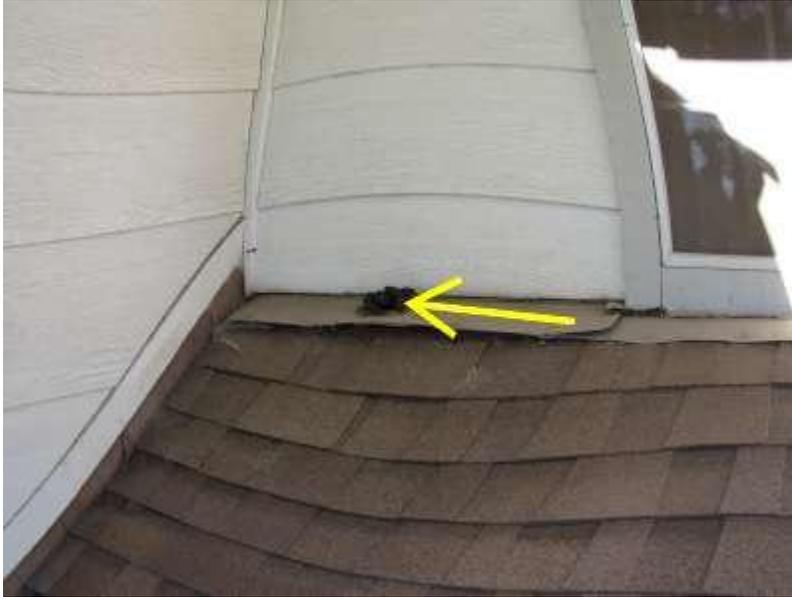
17) 🗝️ Trees are overhanging roof and are within 10 feet of roof vertically. This is conducive for wood destroying insects, animals, and organisms since organic debris such as leaves or needles are more likely to accumulate on the roof surface. Accumulated debris may cause water to enter gaps in the roof surface and leak into attic and/or interior spaces. Trees should be pruned so they are at least 10 feet above roof, or don't overhang the roof. The attached photo show raccoon scat on the roof due to animal being able to access roof via a tree limb.

Photo 16
Raccoon scat and perching spot outside of upstairs bedroom window.

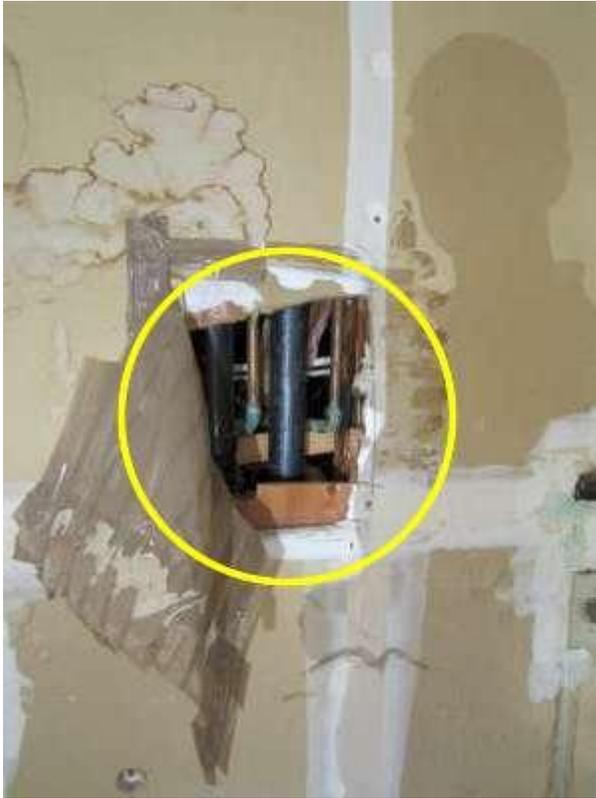
Photo 22

One wall surface between the attached garage and interior living spaces has a 12" x 12" cut away. These surfaces are intended to prevent vehicle fumes from entering living spaces, and to slow the spread of fire from the garage to living spaces. A qualified contractor should evaluate and make repairs as necessary so the attached garage wall and ceiling surfaces that adjoin living spaces are tightly sealed and fire rated as per standard building practices. Typically these surfaces require a one-hour fire rating.

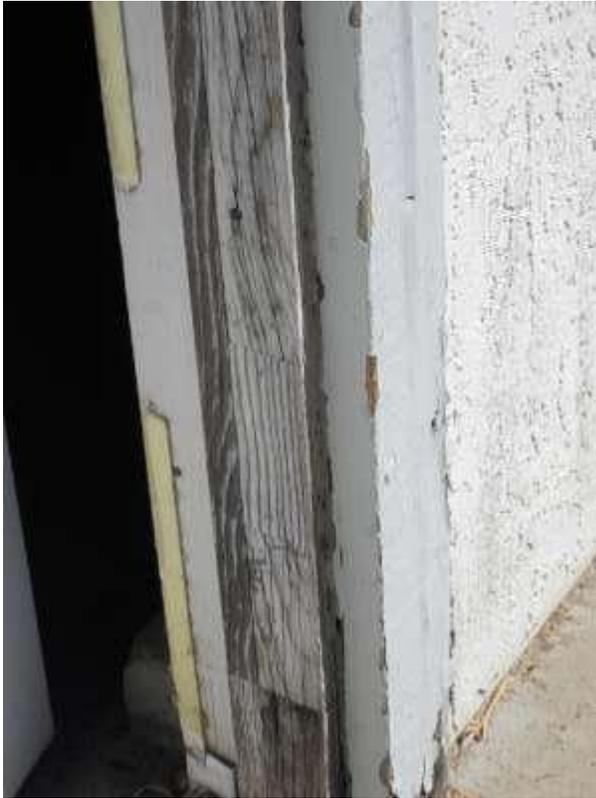
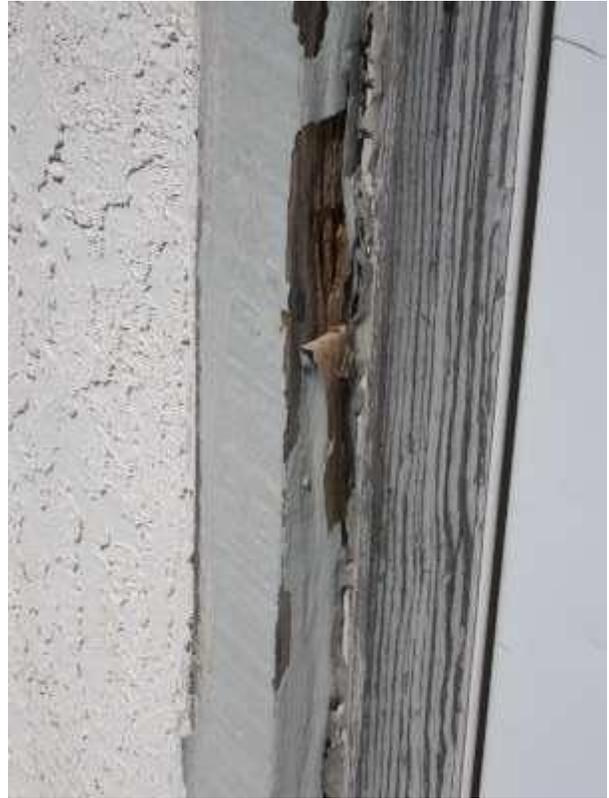
Frame of side garage entrance door is deteriorated to the point that it may require replacement. A licensed contractor should make this repair.

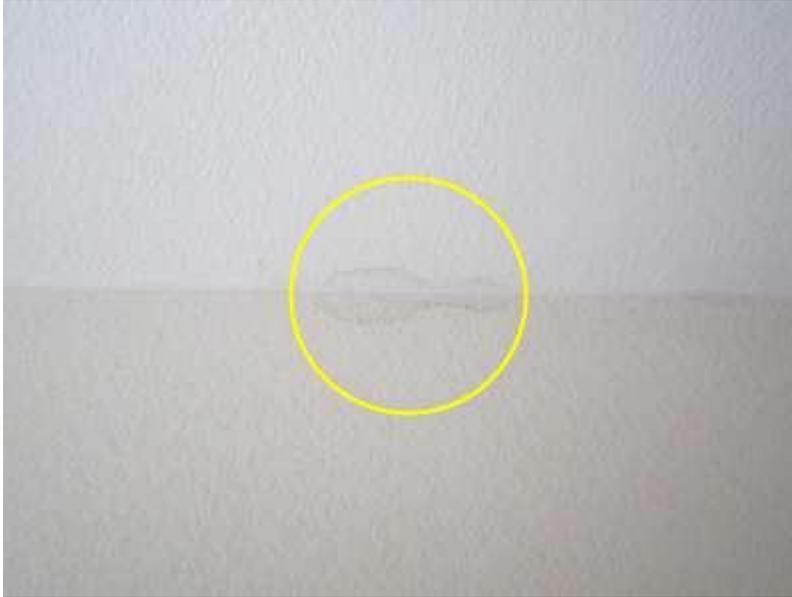
Photo 35

Stains were visible on the roof structure in one area. This area was dry at the time of the inspection. The stains may be caused by a past leak. There is evidence of this in the north/center wall/ceiling junction in the upstairs master bedroom. Recommend asking the property owner(s) about past leaks. The client(s) should monitor these areas in the future, especially after heavy rains, to determine if active leaks exist. If leaks are found, a qualified roofing contractor should evaluate and repair as necessary.

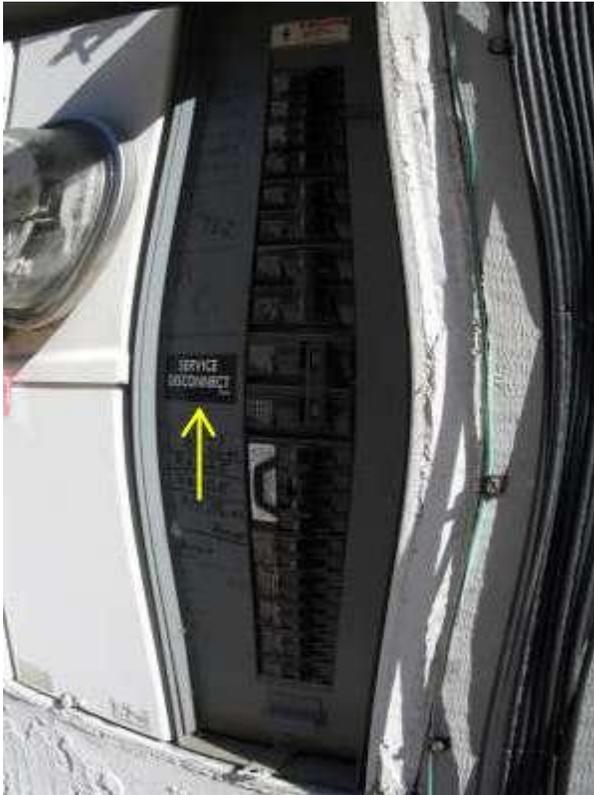
Photo 11

The electric service to this property appears to be rated at substantially less than 200 amps, and may be inadequate for the client(s) needs. Recommend consulting with a qualified electrician about upgrading to a 200 amp service.

This is a Siemens I-T-E, Type 3R service panel, which is rated for 125 amps. The meter is rated for 200amps.

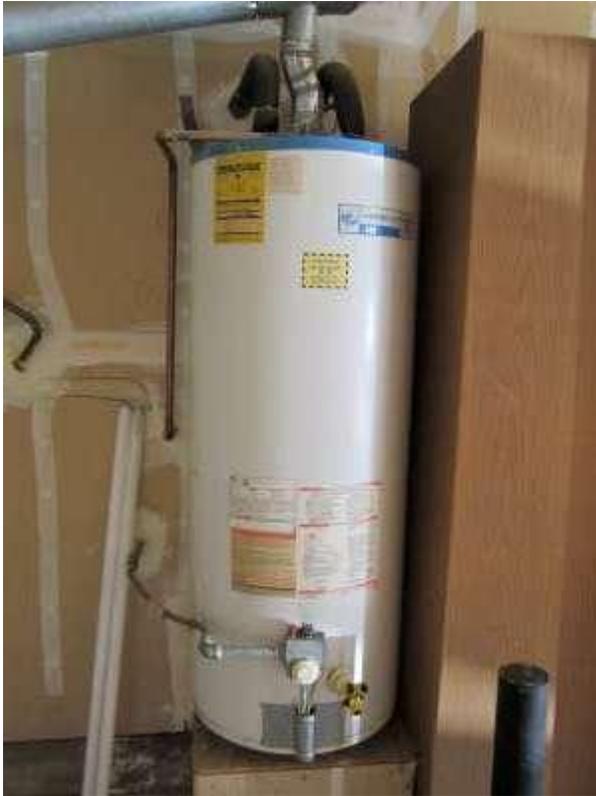
Photo 37

The water heater does not have seismic straps or struts installed. This is a potential safety hazard since movement can cause leaks in the gas supply lines or damage wiring. Leaks may also occur in water supply pipes. A qualified contractor should install seismic straps or struts as necessary and as per standard building practices.

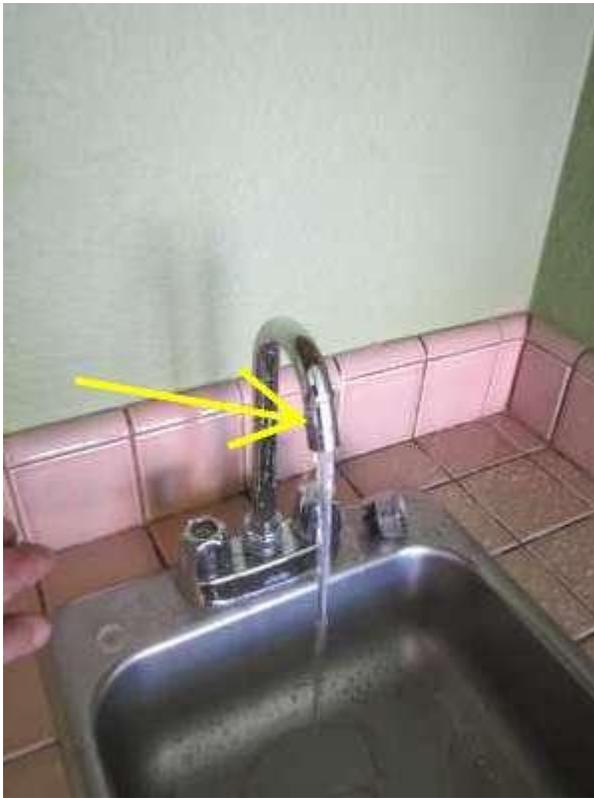
Photo 30

Faucet extension leaks at water outlet on the wet-bar sink in the living area. The end fitting should be replaced.

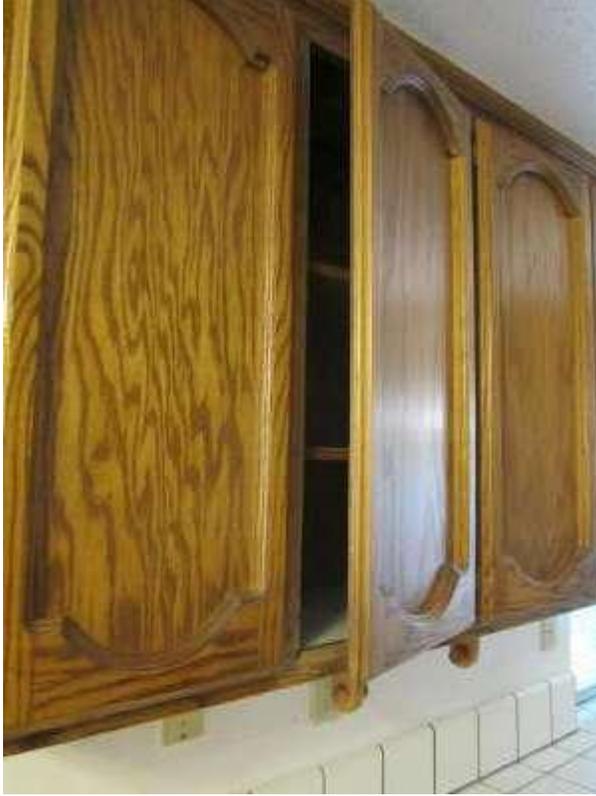
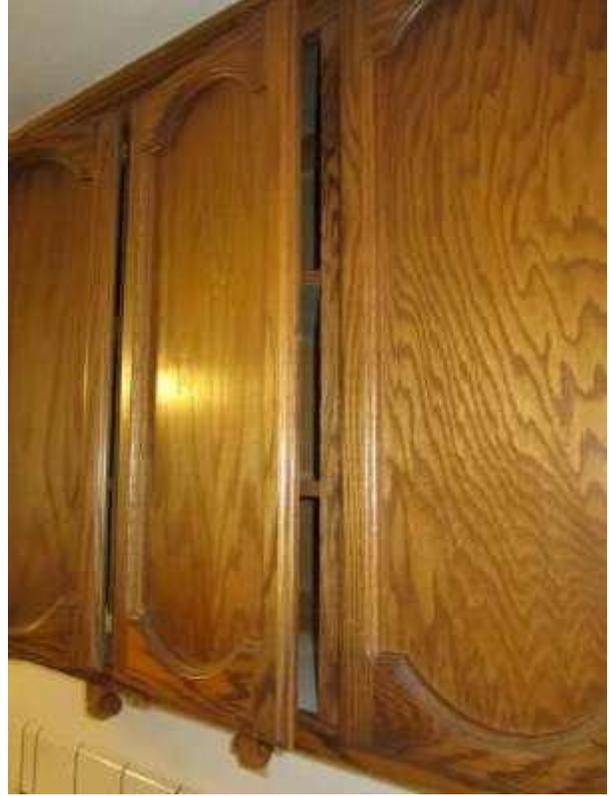
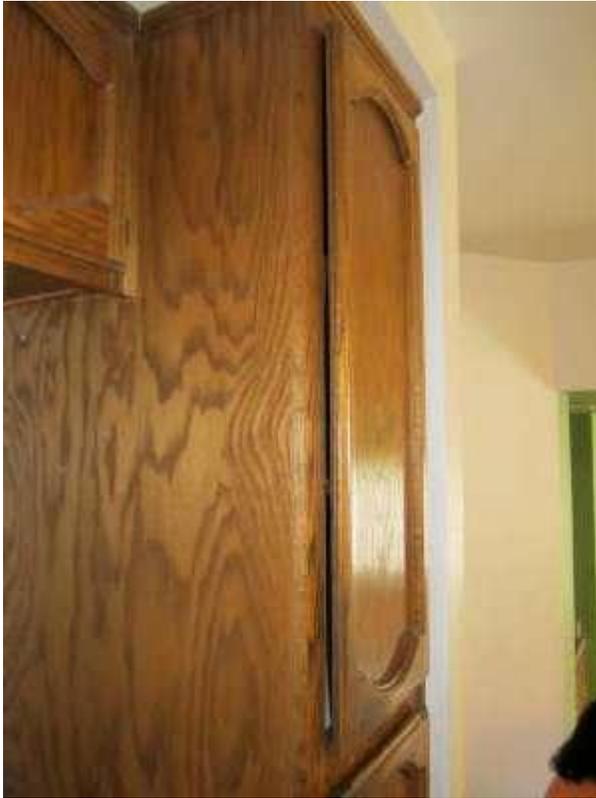
42) Three of the swinging kitchen cabinet doors do not close properly. The hardware on this door should be replaced.

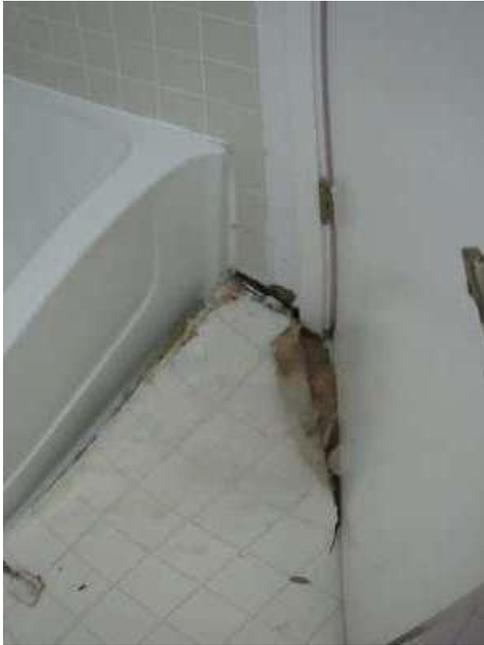
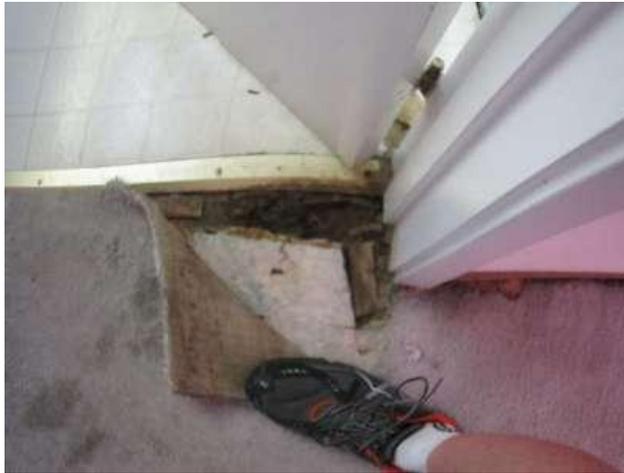
Sub flooring is damaged and/or deteriorated in the upstairs central bathroom. Damage extends from the south 1/3 of edge of tub to 18" along the north side of the hallway outside of the bathroom door. A qualified contractor should replace or repair the damaged flooring.

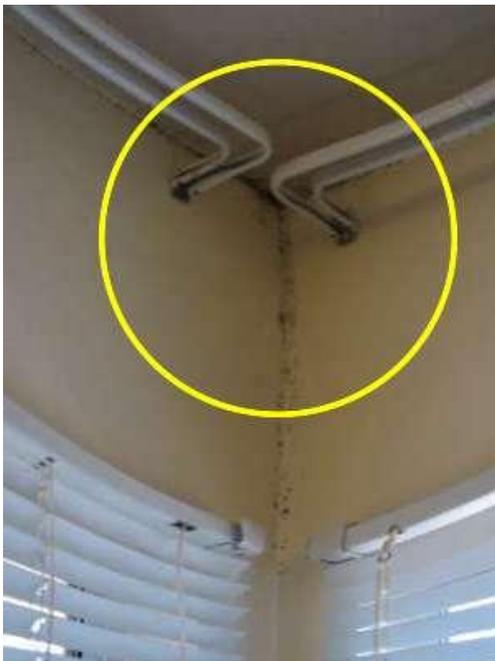
Photo 18

Molding in the southwest corner of the master bathroom ceiling (above tub). This should be cleaned with a suitable agent, such as X-15 and the paint should be touched up.

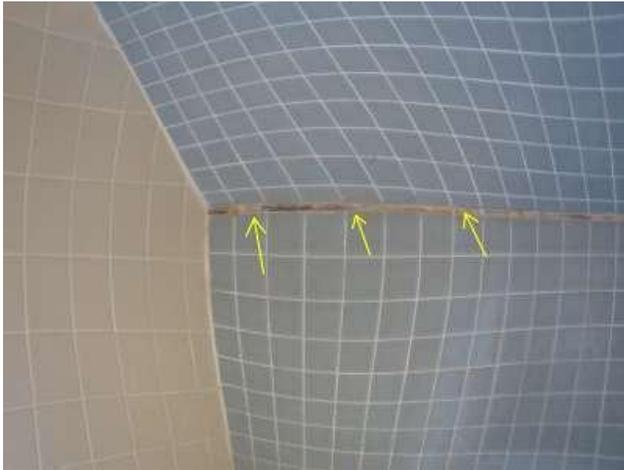
Photo 17

Recommend cleaning and sealing grout in rear of tub bottom joint line in the master bathroom.
