Mercer Inspection Services

Property Inspection Report

Property address: XXXXXXXXXXXXXXXX
XXXXXXXXXXXXXXXXXX

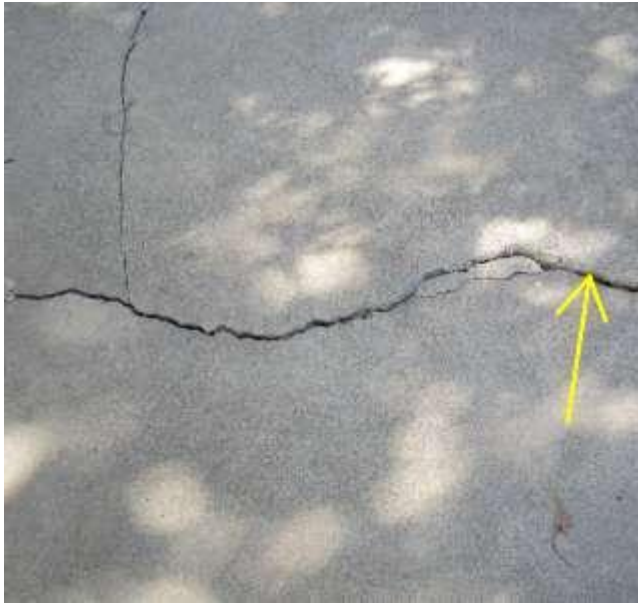
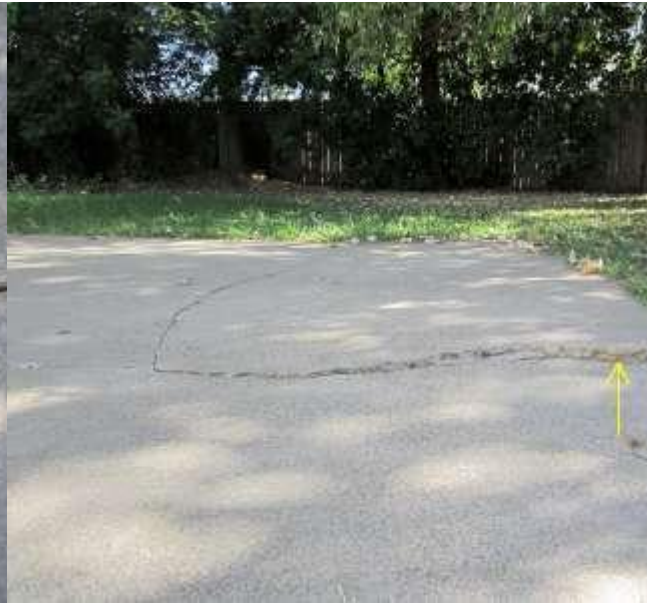
Photo 17

1) 🛠️🔍️ One trip hazard was found in the poured cement rear patio, and appears due to cracks, settlement and/or heaving. There is a strong likelihood that a Sugar Maple's root system is causal of this condition. A qualified contractor should be consulted. This may require the repairing or replacing sections of the patio to eliminate trip hazards. This may also involve removing sections of the root system and re-leveling and re-packing the soil.

Note: these two photos are of the same area and not two separate trip hazards.

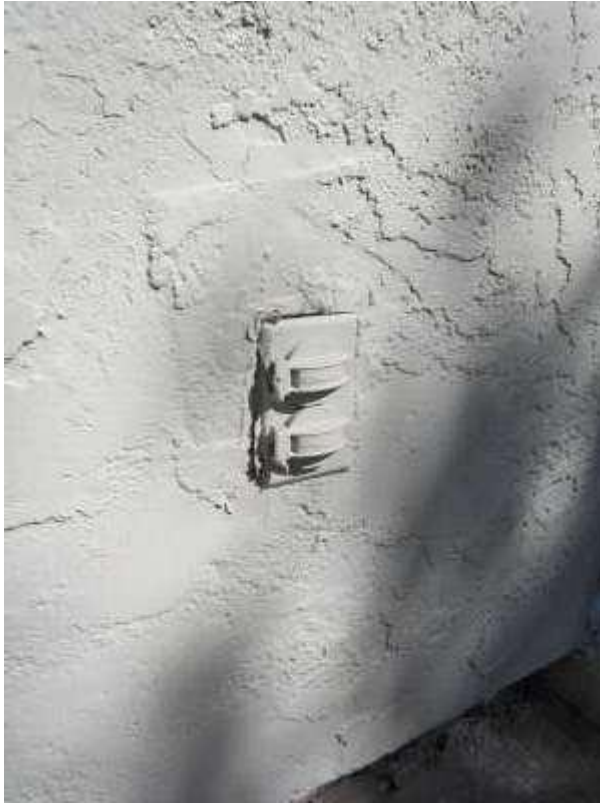
Photo 15

2) 🛠️🔍️ The electric receptacles adjacent to the patio door are loose. Wire conductors may be damaged due to repeated movement and/or tension on wires, or insulation may be damaged. This is a safety hazard due to the risk of shock and fire. A qualified electrician should evaluate and repair as necessary.

Receptacle is loose. When repaired, attention should be paid to making sure weather proof caulking is applied to prevent water intrusion.

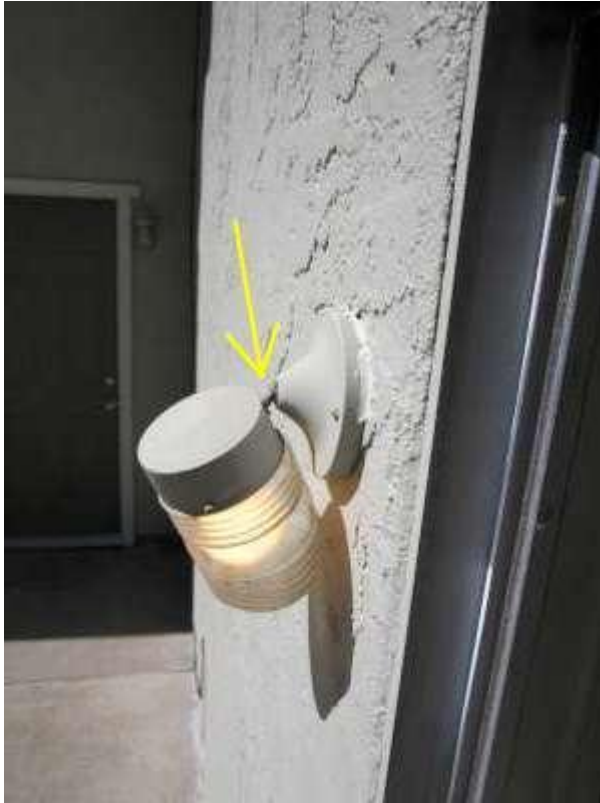
Photo 44

Wiring from a broken light fixture adjacent to the patio is exposed. The insulation can be damaged by objects coming in contact with it and/or it being repeatedly moved. This is a safety hazard due to the risk of shock and fire. A qualified electrician should replace the light fixture.

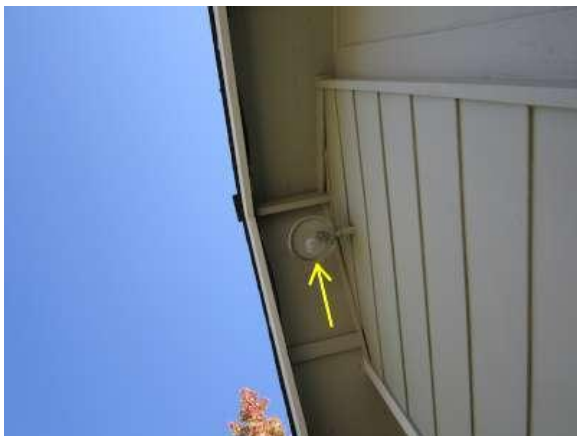
Photo 7

-
- 4) 🛠️🔪 Exterior flood light located at roof apex, under the eave on the front of the house is missing a protective cover. The fixture cover is designed to prevent the intrusion of water and debris that can lead to malfunctioning of the light and/or can be a fire hazard. Light cover should be replaced or the light should be completely removed. If removed, a qualified electrician should do this.

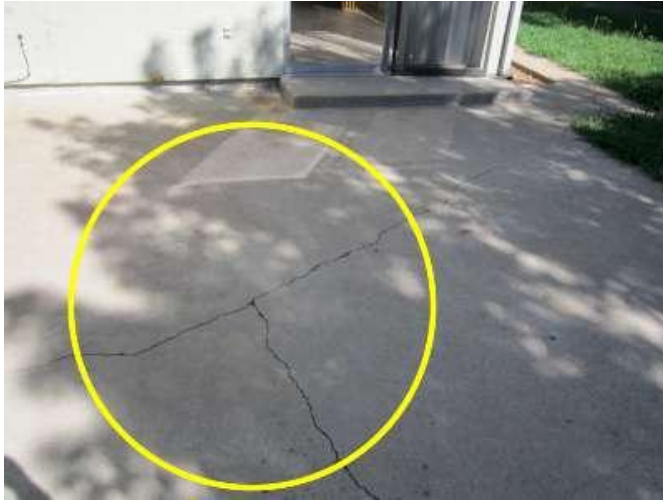
Photo 16

-
- 5) 🛠️🔪🔍 The patio has significant cracks and/or deterioration in one or more areas. A qualified contractor should evaluate and repair or replace sidewalk and/or patio sections as necessary.

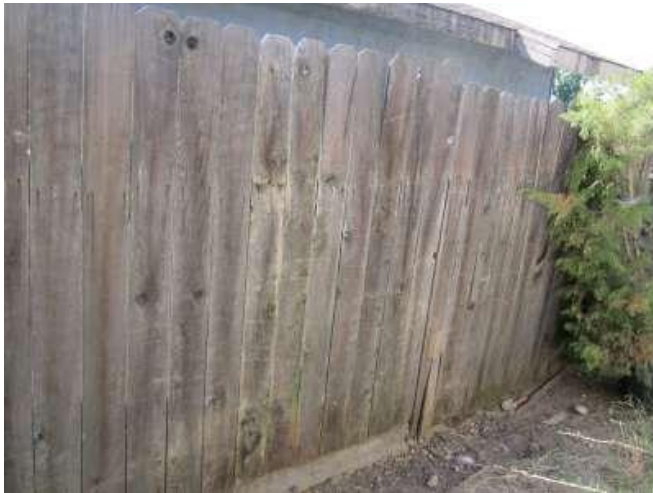
Photo 36

6) 🛠️🔍 The fences on the south border of the property is damaged and/or deteriorated in many areas. Deterioration is to the point that I recommend replacing this section of the fence. A qualified contractor should evaluate and replace sections as necessary.

Many of the fence boards are broken and poorly attached.
Fence posts are loose in their footings, so the fence is wobbly.

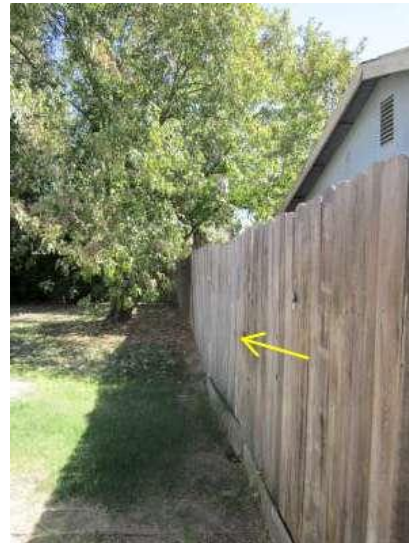
Photo 37

The point of the arrow show an area of the fence that is badly deteriorated and is leaning inward; it is being supported only by the surrounding areas of the fence.

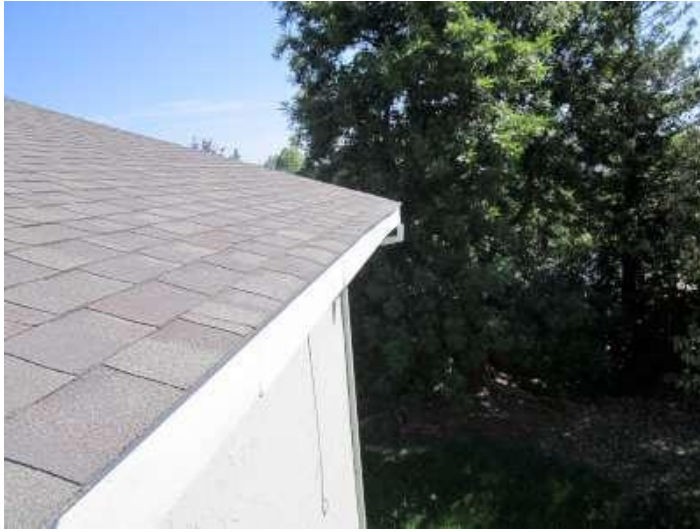
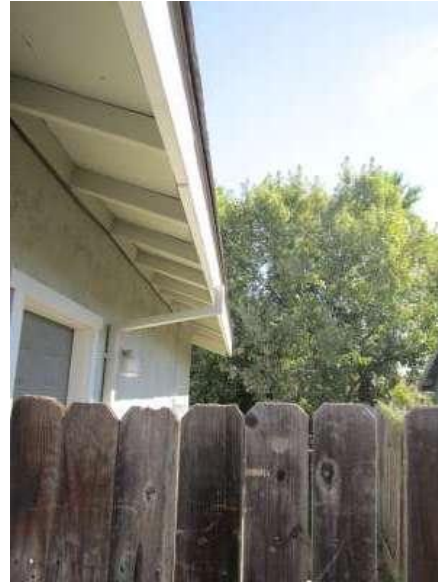
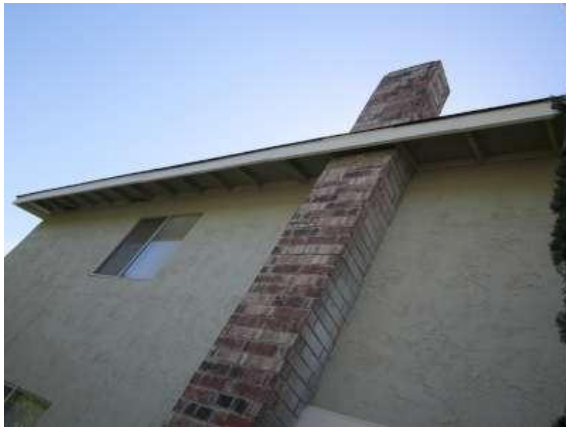
7) 🛠️🔍 Gutter for the entire house is missing. This can result in water accumulating around the structure's foundation and upon the air-conditioning compressor. Accumulated water is conducive to attracting wood destroying insects and organisms, and may also cause the foundation to settle and possibly fail over time. A qualified contractor should install gutters

where missing. Also recommend installing extensions such as splash blocks or tie-ins to underground drain lines as necessary to carry rainwater away from the house.

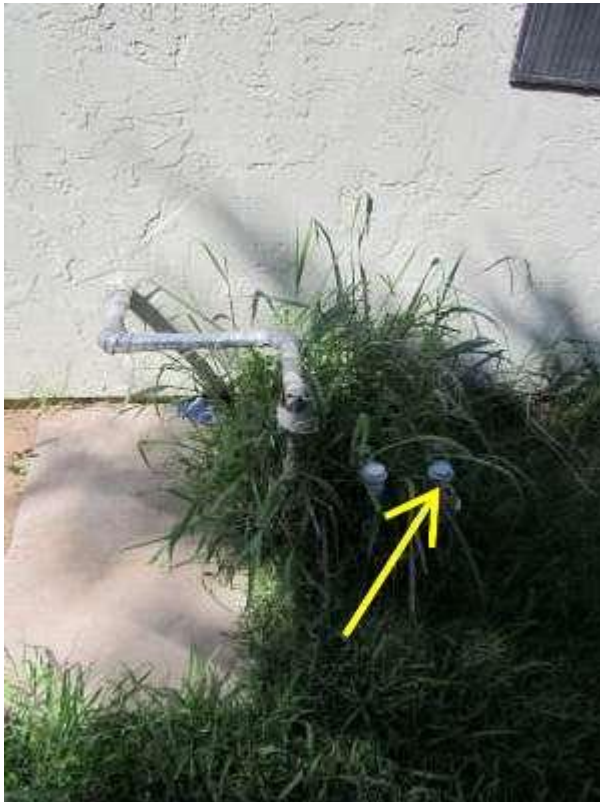
Photo 11

A 4' x 11' area, on the north side the grounds, adjacent to the structure, has significantly soggy soil and some standing water. A sprinkler head was found to be leaking, but it was able to be easily repaired by inspector. However, in my experience, I can never discount other complicating factors, possibly a leak in a below ground 90 degree connector joint. It would be rare coincidence for this to be the case, but I advise keeping an eye out on the area and making sure that it dries up over the next several weeks.

Richdei made $\frac{3}{4}$ " valve rubber diaphragm had some gravel lodged in it. The inspector removed the gravel and the valve now appears to shut off properly.

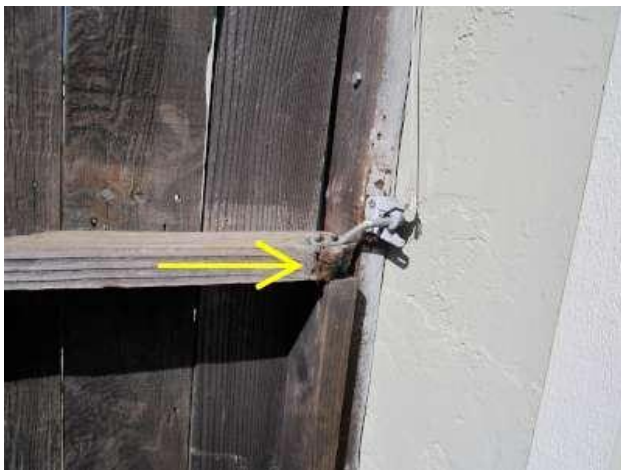
Photo 9

The south side gate's latch is damaged and/or deteriorated. Repairs should be made as necessary, and by a qualified contractor if necessary, so gates operate easily.

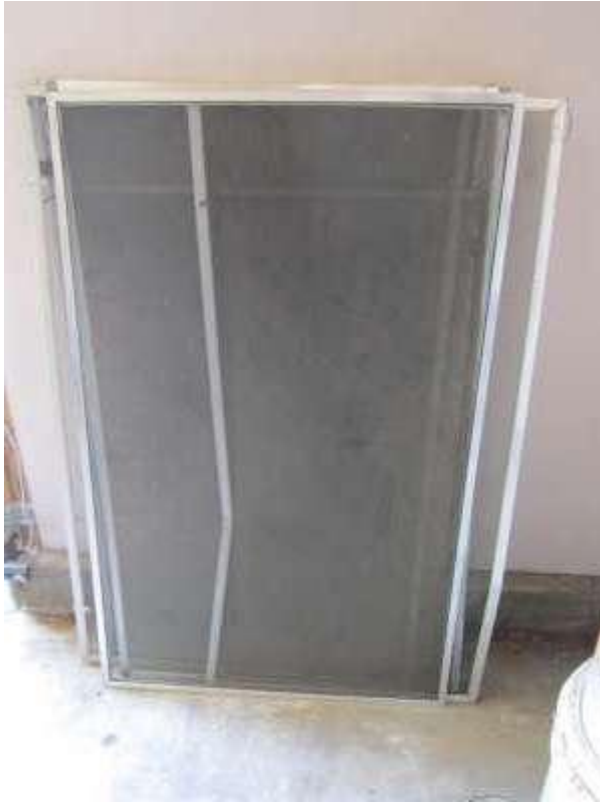
Photo 43

The patio sliding screen door track section of the framing is bent and/or dented and the screen door needs to be replaced.

Two of these appear usable. Note: these types of screens can also be repaired.

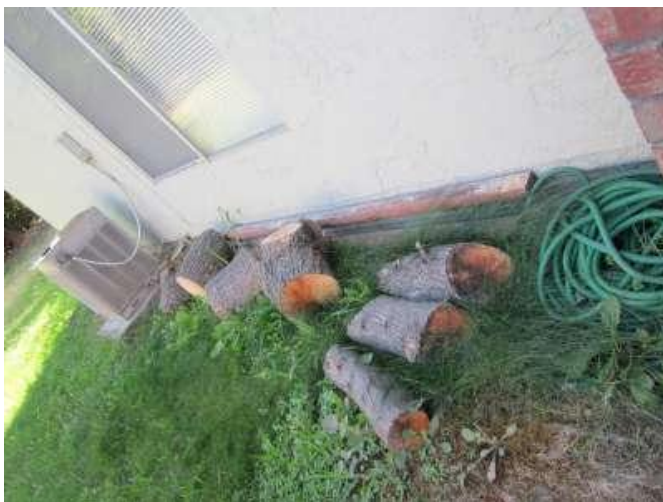
Logs and other debris next to side of house. Wood logs and other debris are either in contact or very near the external north wall of the house. This can attract and provide a conduit for wood destroying insects to enter the home. Recommend keeping all dead wood and other biomass at least two feet away from exterior walls.

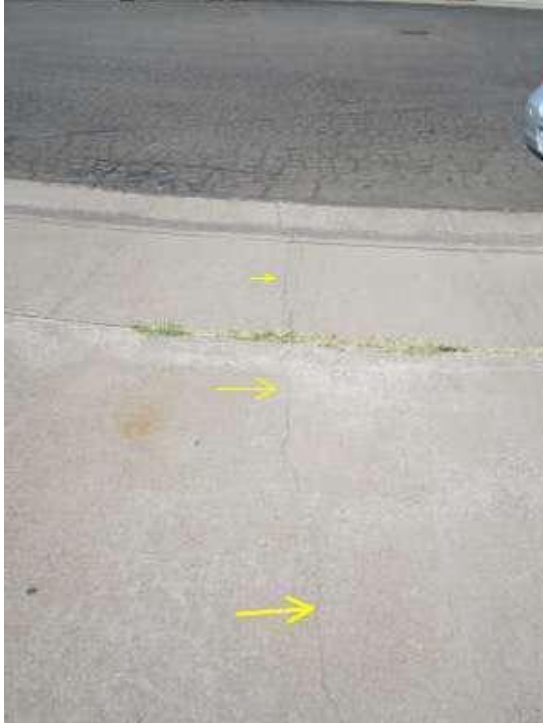
Photo 19

Minor cracks were found in the driveway. However they don't appear to be a structural concern and no trip hazards were found. No immediate action is recommended, but the client(s) may wish to have repairs made or have cracked sections replaced for aesthetic reasons.

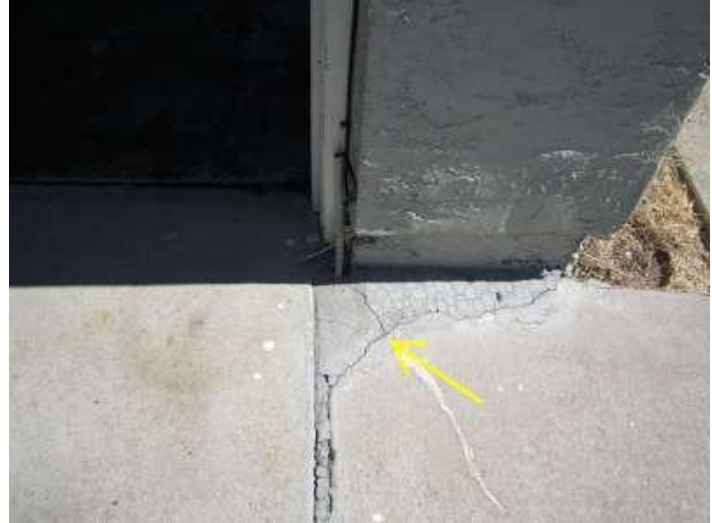
Photo 40
Former repair. Vinyl patching like this will need to be replaced every 7 to 10 years.

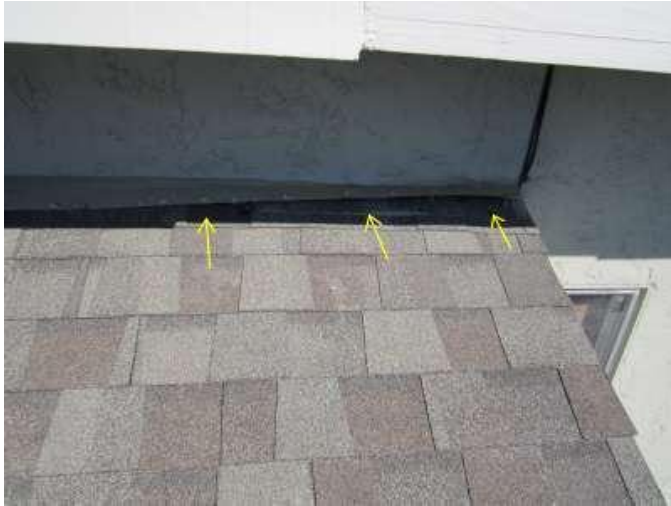
Photo 2

Roofing nails in the south side base of the upper story flashing have loosened or backed out. Leaks may occur as a result. A qualified roofing contractor should evaluate and make repairs as necessary, such as reseating nails and applying sealant.

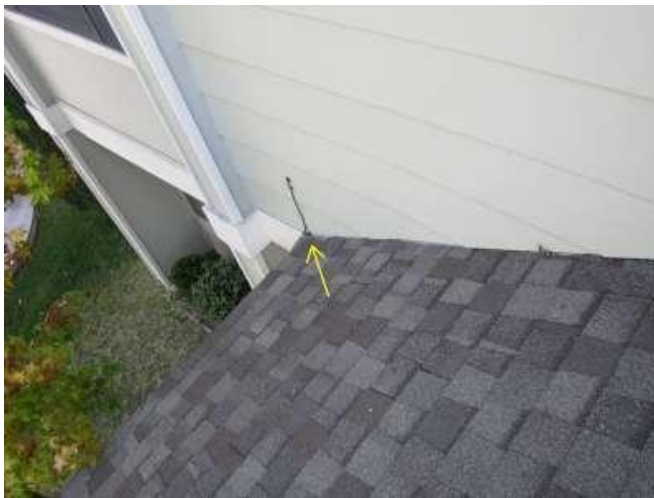
Photo 5

Kick out flashing should be installed at the base of the slope of the west side front wall. Kick out flashing is designed to divert water flow away from vulnerable corners and trim. Recommend that a qualified roofing contractor install flashing at the point shown in the picture below.

Kick out flashing needed where the arrow points to,

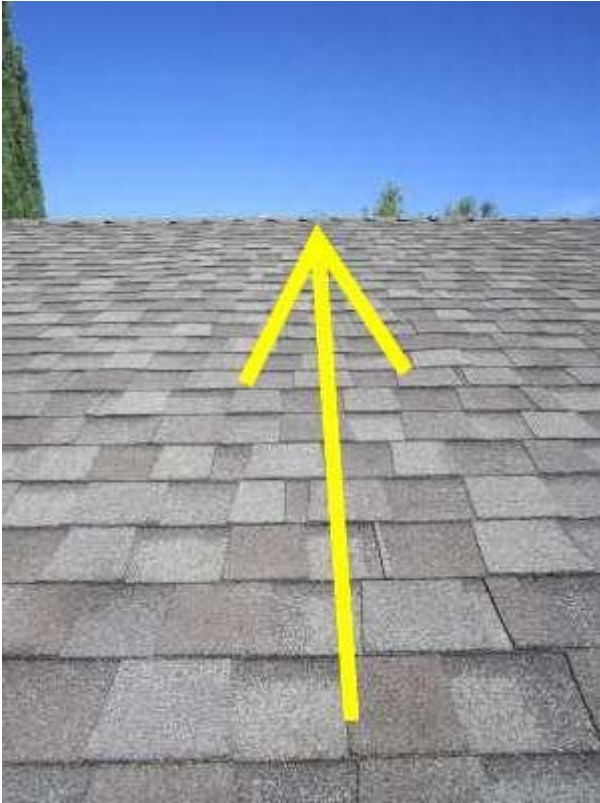
Photo 4

A section of the roof sheathing flexed considerably when walked upon by the inspector. This section is on the upper story south face, approximately at the horizontal and vertical center. There was no cracking or breakage upon walking on the roof surface, but the sheathing viewed from the attic shows some splitting and cracking. The sheathing appears strong enough to last until the next roof is installed. At that time in the future, this sheathing should be replaced by a qualified roofing contractor.

The arrow runs up the midline of the soft area of the roof. The soft area extends to four feet from the crest and four feet from the base and is about 2 feet wide. This indicates a cracked plywood sheet and was verified by an attic inspection. Note: the cracking is minor and the weight of the inspector did not further such problems.

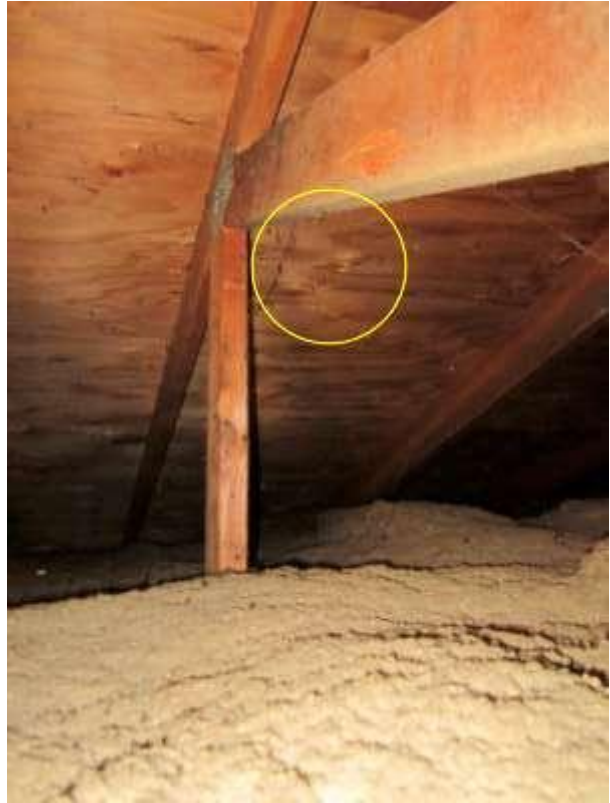
Photo 30

An area of cracked sheathing. Note that splitting and cracking is not continuous.

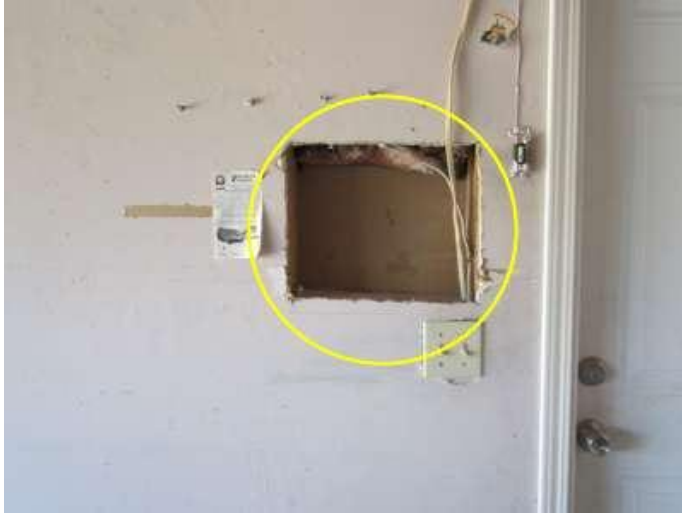
Photo 32

17) 🛠️ 🔍 One 14" x 14' wall surfaces section between the attached garage and interior living space is missing. This surface is intended to prevent vehicle fumes from entering living spaces, and to slow the spread of fire from the garage to living spaces. A qualified contractor should evaluate and make repairs as necessary so the attached garage wall and ceiling surfaces that adjoin living spaces are tightly sealed and fire rated as per standard building practices. Typically these surfaces require a one-hour fire rating.

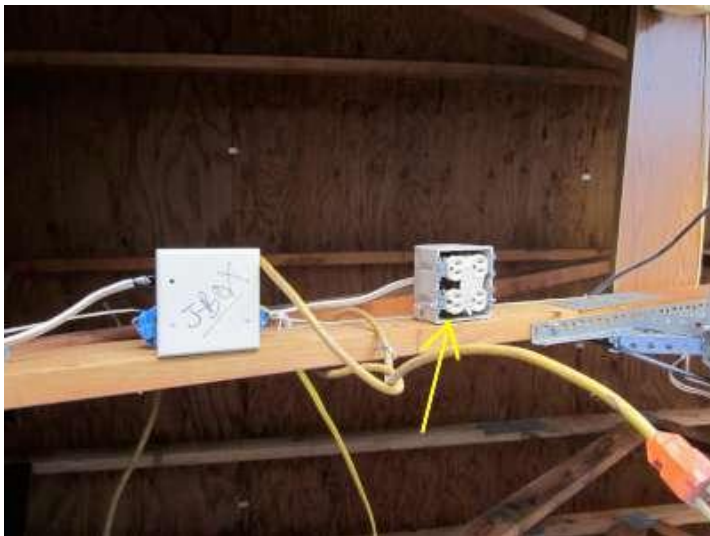
A cover plate is missing from the overhead electrical receptacle next to the garage door opener. They are intended to contain fire and prevent electric shock from exposed wires. This is a safety hazard due to the risk of fire and shock. Cover plates should be installed where missing.

Photo 38
Cover plate needed.

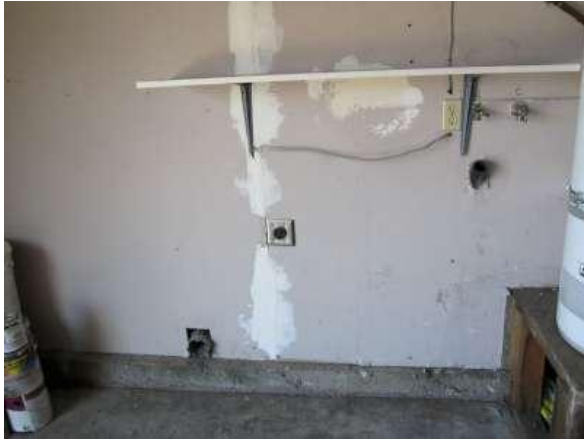
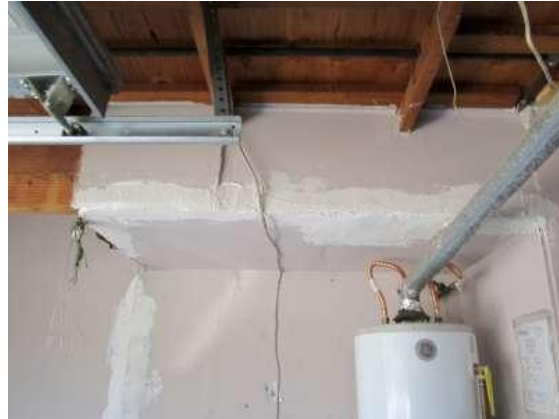
Section of the north east wall has had some insufficient repairs made to it. While the cracks in the unfinished repairs are not a fire (no lived in space behind this wall section)

or structural concern, the repair is not aesthetically pleasing and may reduce home value. I recommend that a qualified contractor upgrade this repair to good or better condition.

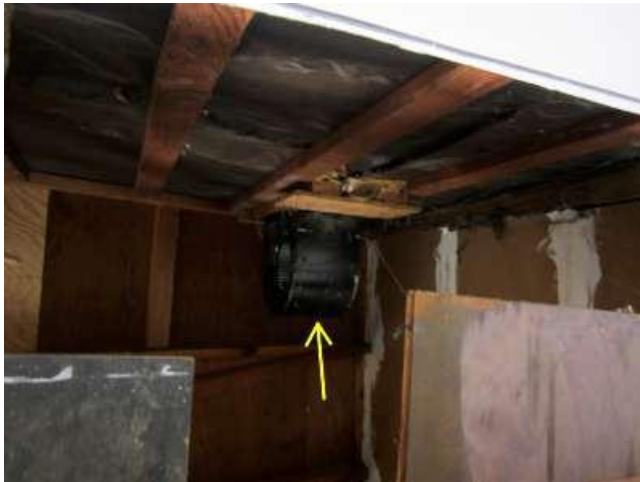
Photo 41

The blower installed in the upper northeast corner of the garage was not operable. Recommend a qualified HVAC contractor evaluate the blower.

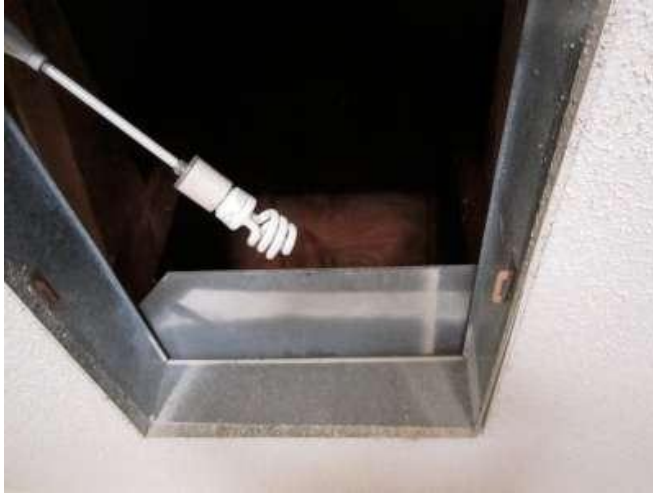
Photo 29

23) 🛠️ No insulation is installed over the attic access hatch. Recommend installing insulation above hatch for better energy efficiency.

Hatch cover should be covered with a piece of attached fiberglass batt insulation. Note: the location of the attic entrance is above the light fixture in the upstairs hallway.

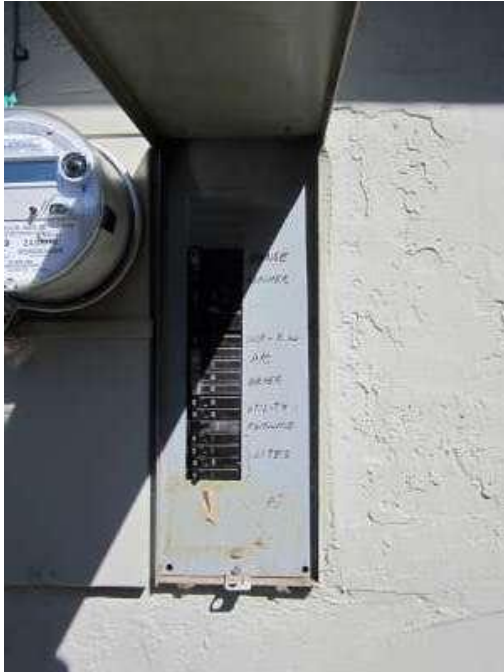
Photo 14

25) 🔍📄 The legend for overcurrent protection devices (breakers or fuses) in the main service panel is written on the cover panel, but it appears to be an old evaluation. I advise testing the circuit breakers for determine the accuracy of the legend.

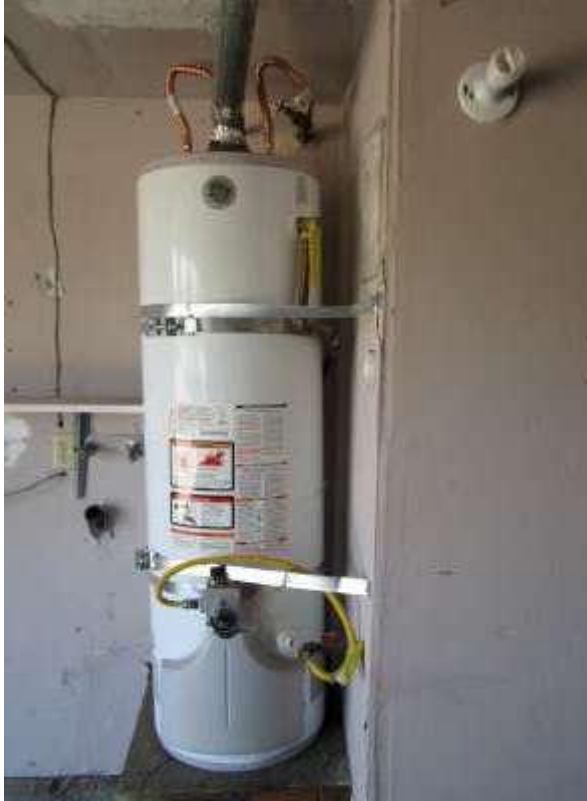
The water heater's mounting platform (wood box stand) is deteriorated and allowing the water heater to lean to the west. I recommend that a qualified plumber evaluate the platform for either repair or replacement.

Photo 34
Leaning west.

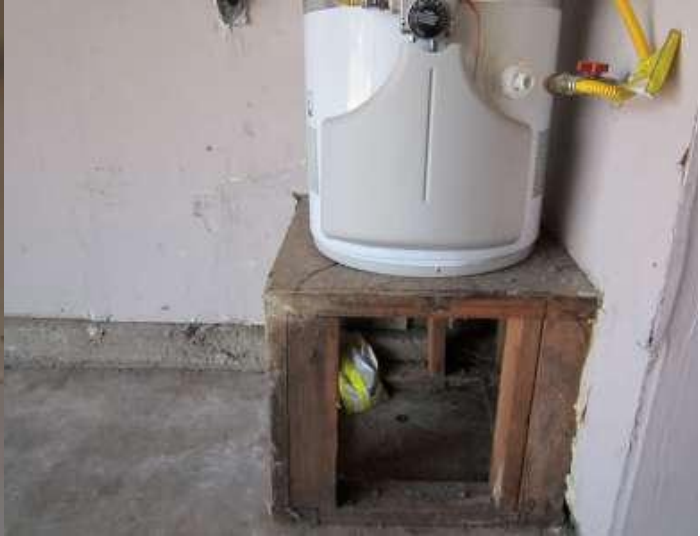
Photo 35
Support box needs to be better supported (i.e. repaired and leveled) or replaced.

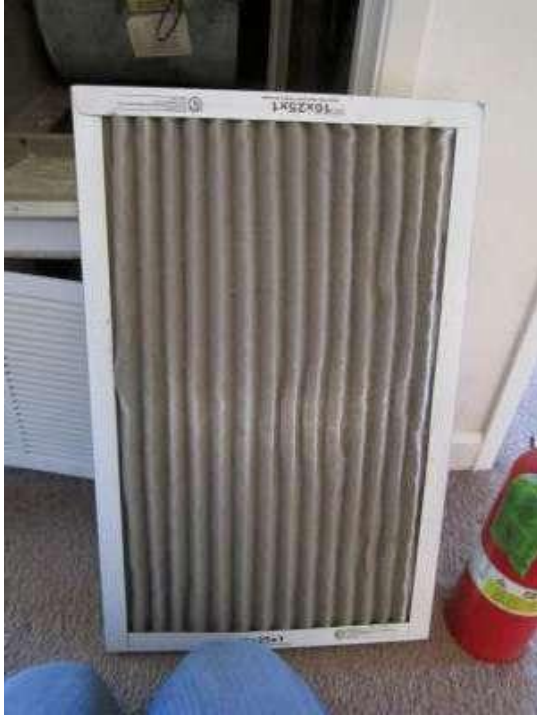
29) 🛠️ Air handler filter(s) are dirty and should be replaced now. They should be checked monthly in the future and replaced as necessary.

Photo 25
Dirty!

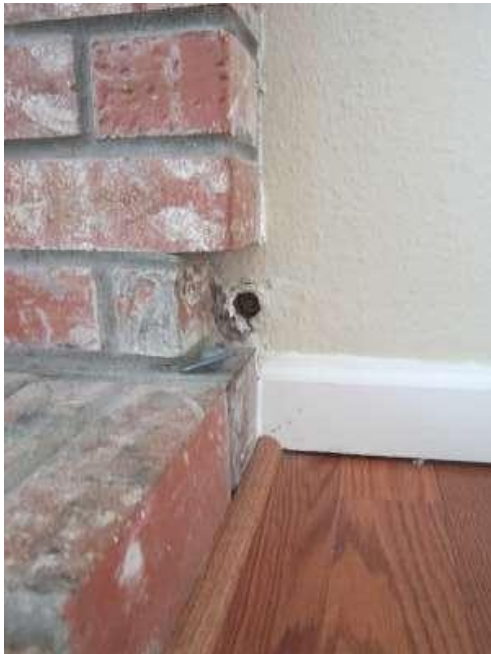
Photo 22

36) **i** The gas control key did not fit the control valve and so the fireplace could not be fully evaluated. Recommend consulting with the property owner(s) as to how they operated the fireplace or what has happened to the original key.

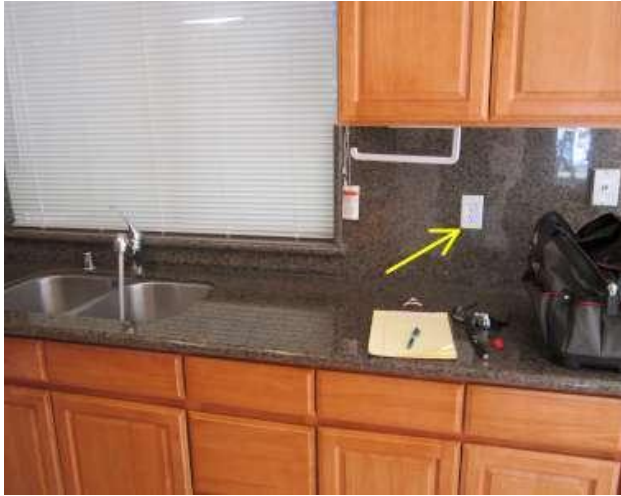
Two of the electric receptacles that serve countertop surfaces within six feet of a sink have no ground fault circuit interrupter (GFCI) protection. These are the outlets north and south of the sink. This is a safety hazard due to the risk of shock. A qualified electrician should repair so that all receptacles that serve countertop surfaces within six feet of sinks have GFCI protection. For example, install GFCI receptacles or circuit breaker(s) as needed.

Photo 20
Needs to be a GFCI.

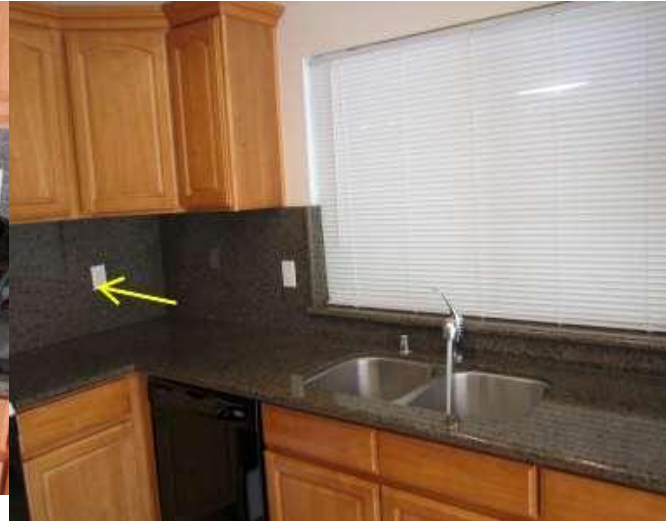
Photo 21
Needs to be a GFCI.

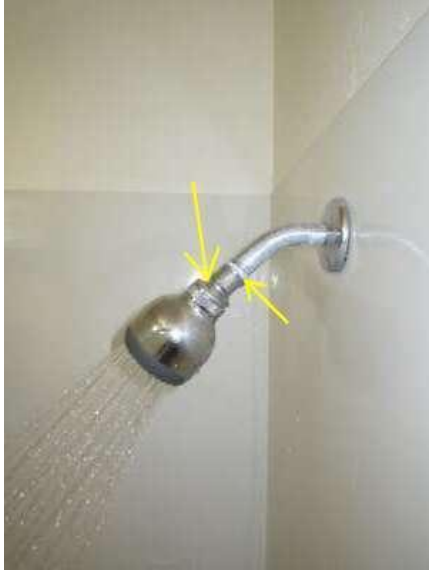
Photo 23

The shower head in the smaller upstairs bathroom leaks at the pivot and at the point of attachment. While the point of attachment can be made water tight with a re-application of plumbers tape, the pivot joint seal is worn, so I recommend replacing the shower head.

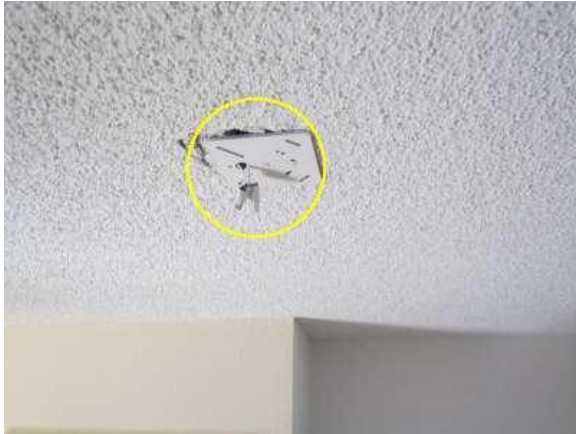
Photo 24

Wiring that are a part of what appears to be an old fixture attachment plate on the ceiling at the top of the upstairs staircase is not terminated properly. This is a potential safety hazard due to the risk of shock. A qualified electrician should evaluate and repair as necessary. For example, securely anchoring them in a covered, properly sized junction box or removing this wiring completely if it is no longer necessary.

Either remove wiring or place in a recessed junction box.

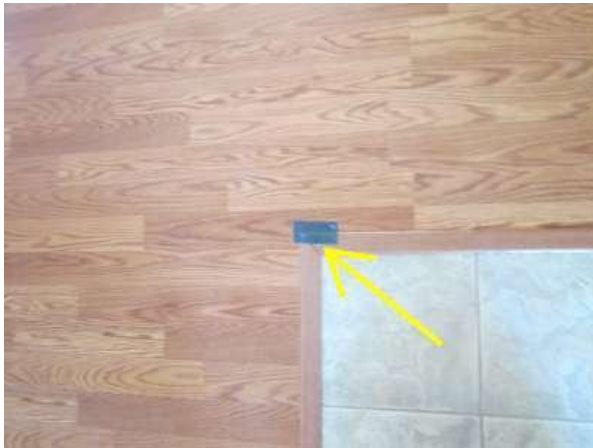
Photo 45

The corner section of the floor molding in the entrance hall needs to be fastened down securely. This should be done using an appropriate adhesive and finish nails. Note that this is a potential trip hazard because duct tape is not a reliable method of floor repair and the extent to which the molding may rise when the adhesive fails is unknown.

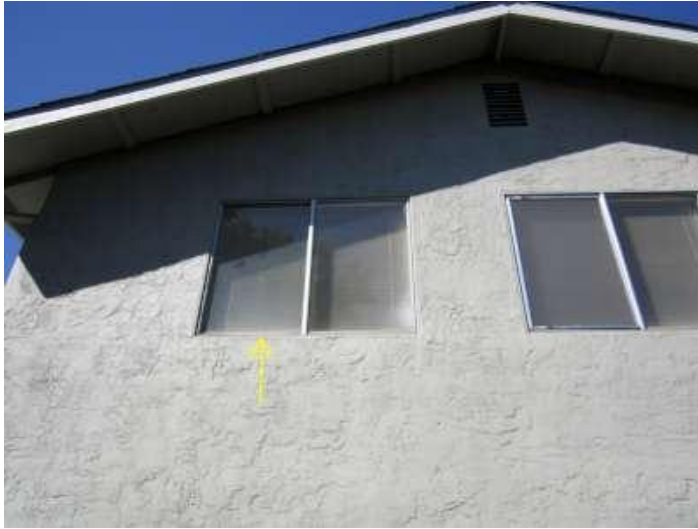
Screen(s) in a few of the windows are missing. The client(s) should ask the property owner(s) about this. I found several screens stored in the garage, a few of which appear usable and may be usable.

Photo 12
Missing screen.

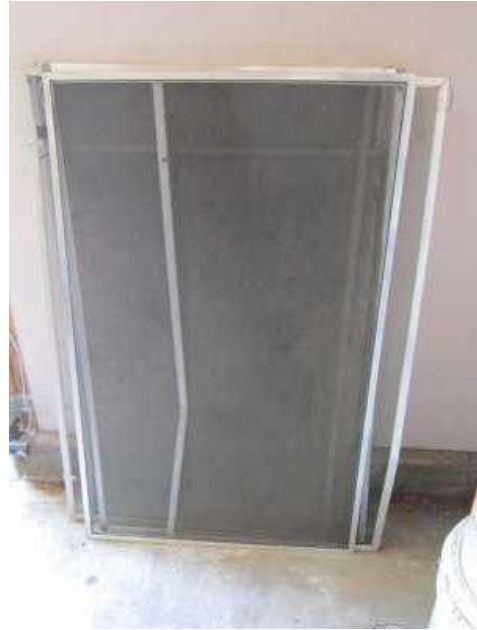
Photo 43
Two of these appear usable. Note: these types of screens can also be repaired.

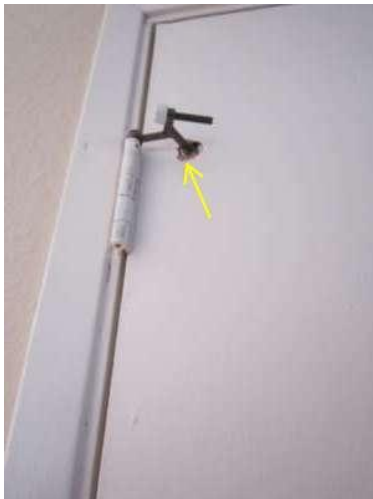
The downstairs closet door (10 feet east of entrance) has been damaged by the door hinge pinged stopper hardware: there is a 3/4" hole in the upper east corner of the door. This hole can be repaired without effecting the usability of the door, but because this is a hollow core interior door, the hinge pinged is going to exert too much pressure on the door surface and this will happen again. To remedy this, I recommend using a new or the same stopper with a brass or other ornamental metal base plate that is attached to the door where the rubber stopper presses upon.

Photo 27
After door is repaired or replaced, if this or a similar piece of hardware is installed, I recommend installing a metal base place at the location of the arrow.

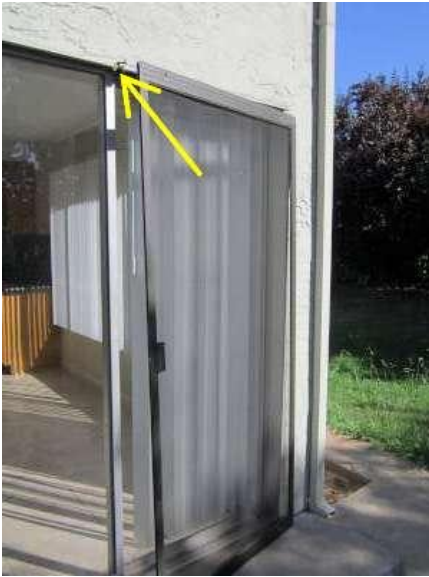
Photo 10

The sliding screen door to the patio is damaged and/or deteriorated. The mounting track also appears to be deteriorated. The screen door was held in place with a piece of duct tape. This assembly should be replaced.

Retaining assembly is broken and needs to be replaced.

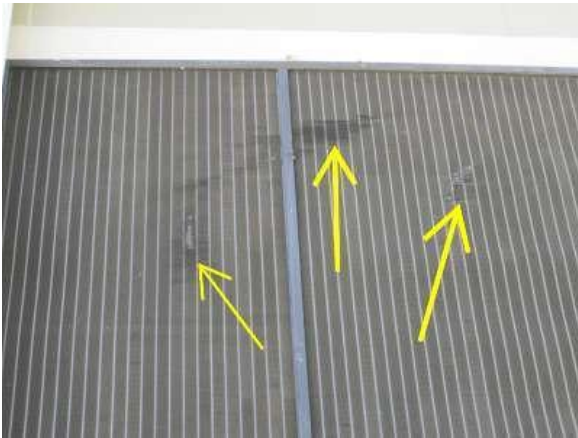
Photo 42

The heavy screen on the upstairs, front bedroom window is torn and worn in one or more areas. Recommend that this screen be replaced.

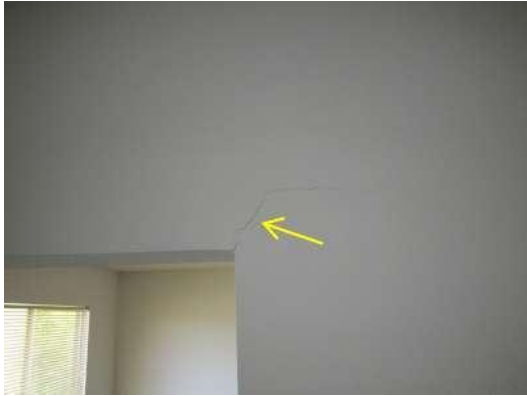
Photo 26

Cracking in interior drywall. There is one crack that radiates from the junction of the division between the upstairs master bedroom and the adjoining smaller room to the east. This crack does not appear to be active and may be due to former but now ceased settling. Since the crack does not extend vertically for any alarming distance and since there are no other such cracks in the lower or other upper story walls, there is no indication that there is a structural issue with the house that requires remediation at this point. This area should be repaired using spackling compounds and re-painted.

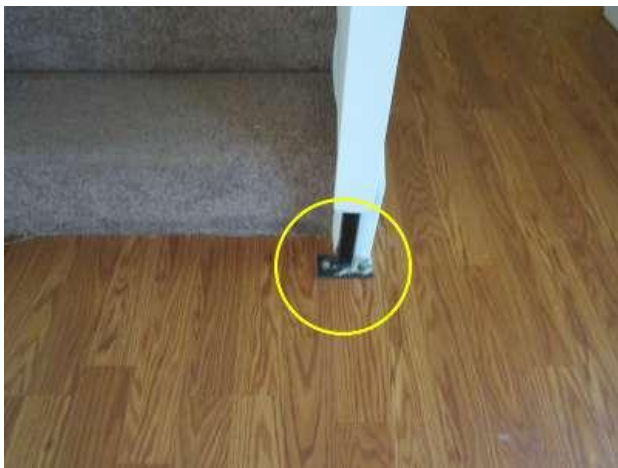
Photo 28

48) The railing post hardware at the base of the stairs is exposed. This is not a safety or a structural issue, but it is not aesthetically pleasing and may reduce the value of the home. There are many options to better this, but I suggest that a crafted wood block that matches the floor color and grain pattern be installed over, and attached to the metal hardware. A qualified finish carpenter should do this work.
