Mercer Inspection Services

Property Inspection Report

This report published on Wednesday, September 12, 2012 2:45:13 PM PDT

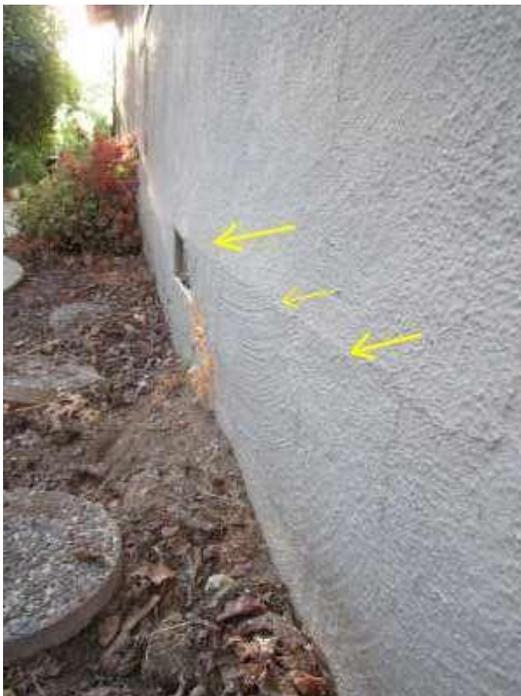
Photo 27

Leaning and/or bowing were found in approximately 8 feet of the south wall/mid exterior wall due to a detached rim joist. Additionally, there are cracks in the adjacent stucco that are most likely due to the pressure exerted from the detached, decayed rim joist. The condition of the rim joist appears to be attributable to long term decay caused by the discharge of a formerly installed window air conditioner directly above, and potentially, wood destroying insects. Viewed from the crawl space, it also appears that the sill (what the rim joist rests on) is deteriorated in that area and has collapsed, which will cause the rim joist to descend and detach from the floor joists. There is no evidence that the rim joist is continuing to advance and it appears that some old repairs to cracks in the stucco in this area have been previously made, and the condition has not worsened. However, to prevent any further complications, I recommend that this be repaired by a qualified contractor.

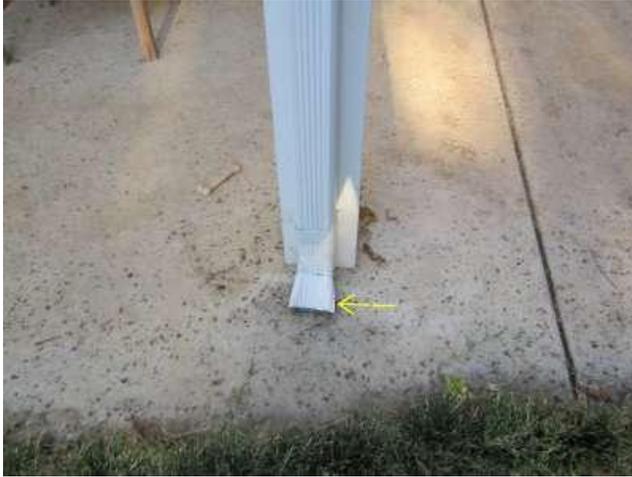
Photo 26

The base of the downspout on the southwest corner of the patio is crushed at the bottom. In this particular case, it will NOT restrict the water flow and result in clogging and overflowing gutters. The issue with this damage is aesthetic. However, the termination of the downspout allows water to discharge directly on the patio and may result in water pooling on the cement surface. Recommend either having a drain installed to alleviate this issue or an extension installed to take the water out onto the lawn. Damaged downspouts should be repaired or replaced as necessary, and drainage systems should be installed by a qualified contractor.

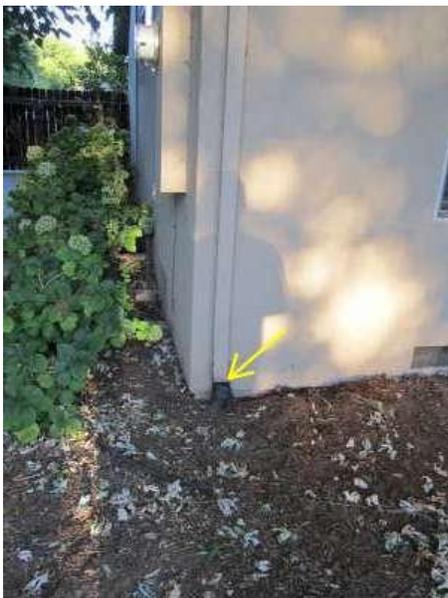
Photo 36

The plastic drainage that connects the downspout on the northwest corner of the house is detached. This can result in water accumulating around the structure's foundation, or in basements and crawl spaces if they exist. Accumulated water is conducive for wood destroying insects and organisms, and may also cause the foundation to settle and possibly fail over time. Repairs should be made as necessary so downspouts are securely anchored and functional.

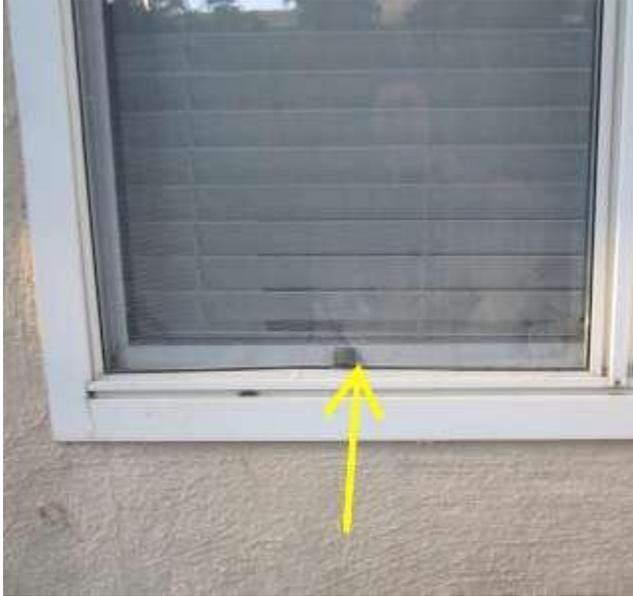
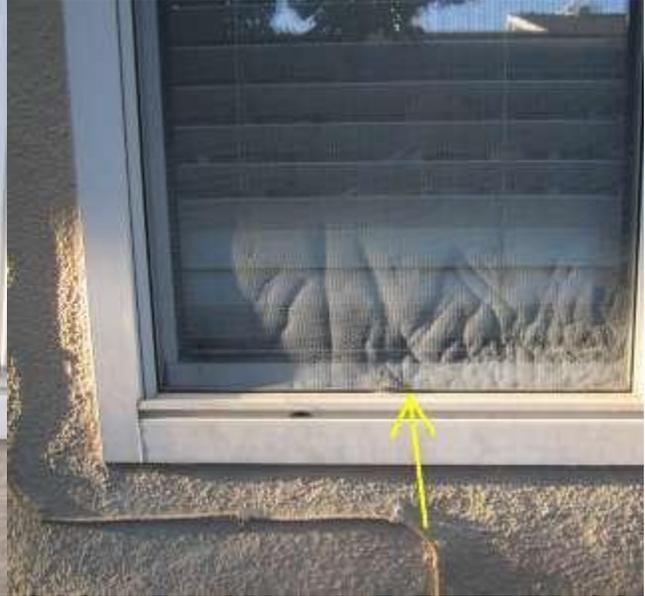
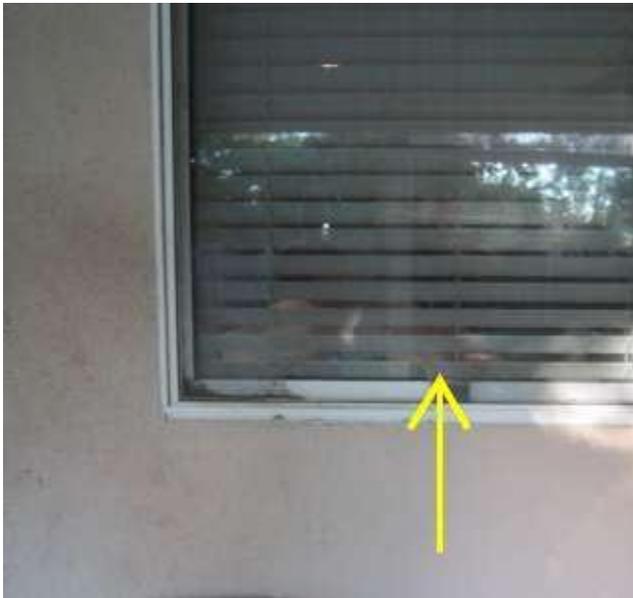
4) 🪛 Three of the window screens are deteriorated along the south and west sides of the house. Screens should be replaced or repaired where necessary.

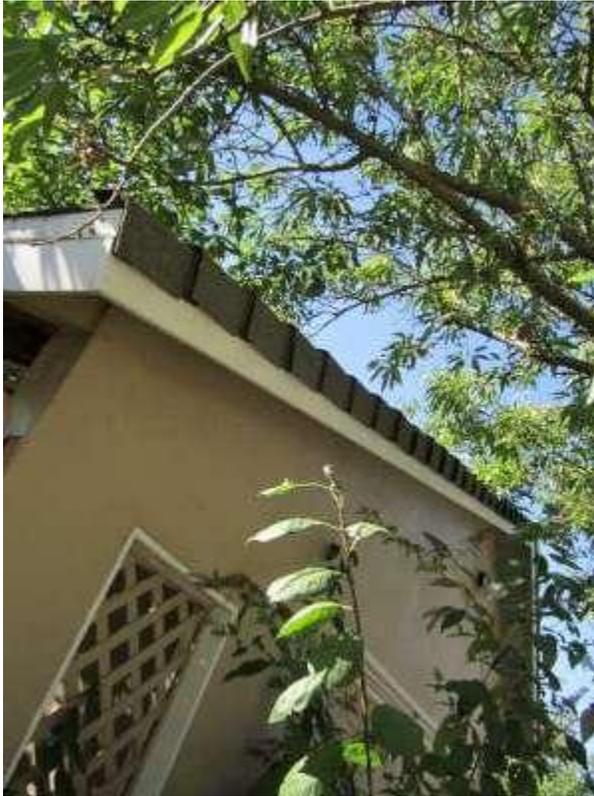
Photo 1

5) 🪛 Vegetation such as trees, shrubs and/or vines are in contact with or less than one foot from the structure's exterior. Vegetation can serve as a conduit for wood destroying insects and may retain moisture against the exterior after it rains. Vegetation should be pruned

and/or removed as necessary to maintain a one foot clearance between it and the structure's exterior.

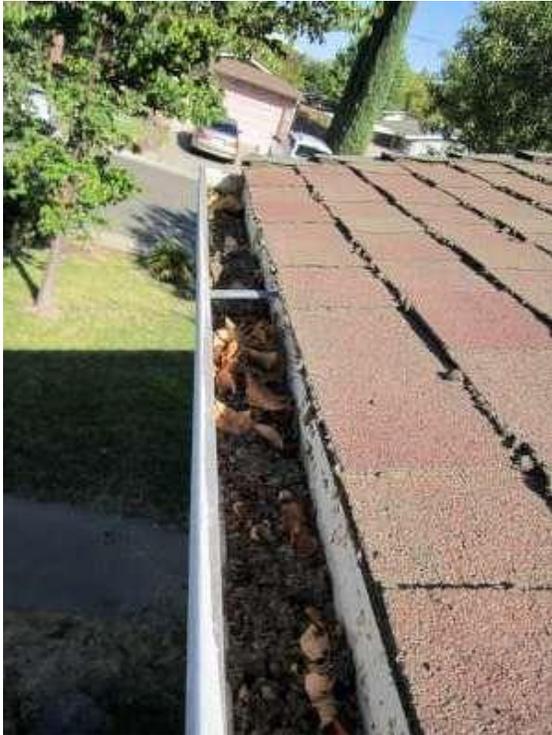
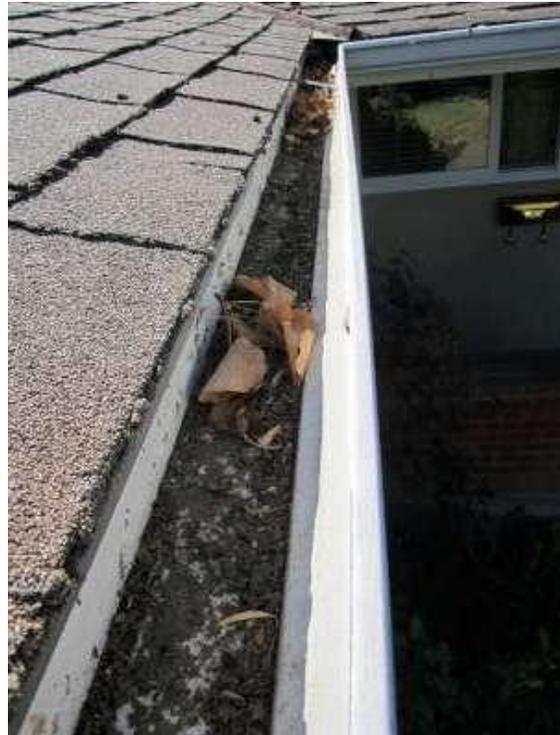
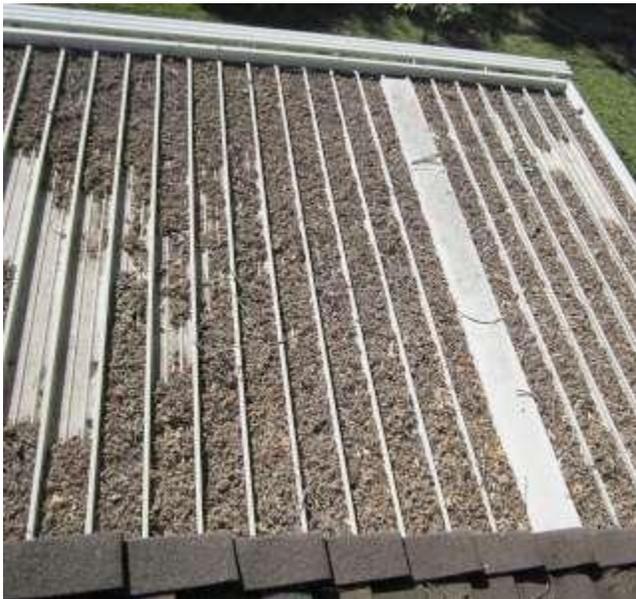
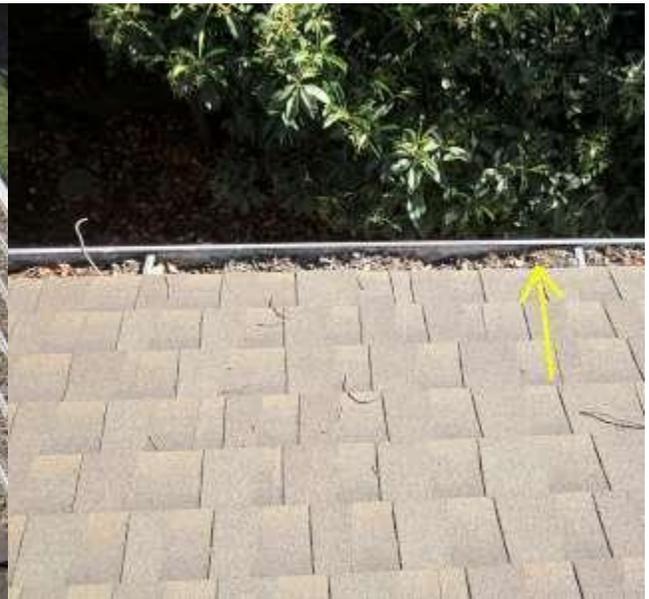
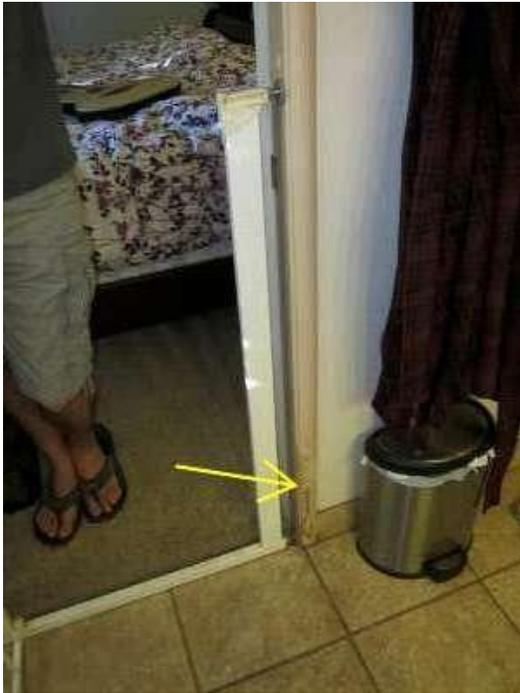
7) 🧹 Debris has accumulated in one or more gutters. This is condition for wood destroying insects since gutters may overflow and cause water to come in contact with the structure's exterior or make water accumulate around the foundation. Gutters should be cleaned now and as necessary in the future.

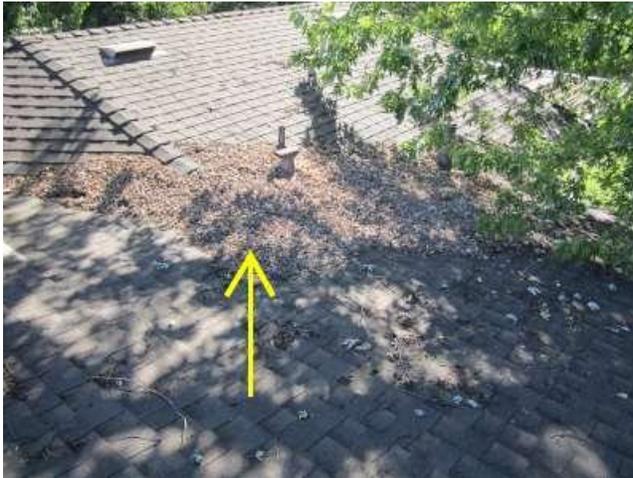
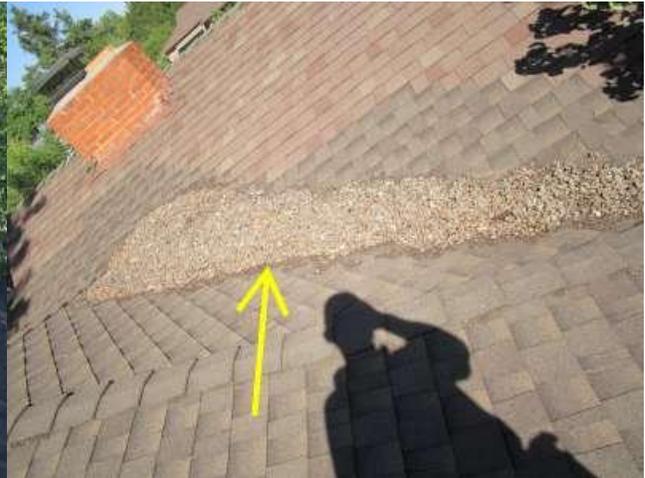
8) 🧰 Debris such as leaves, needles, seeds, etc. have accumulated on the roof. This is conducive for wood destroying insects and organisms since water may not flow easily off the roof, and may enter gaps in the roof surface. Leaks may occur as a result. Debris should be cleaned from the roof now and as necessary in the future.

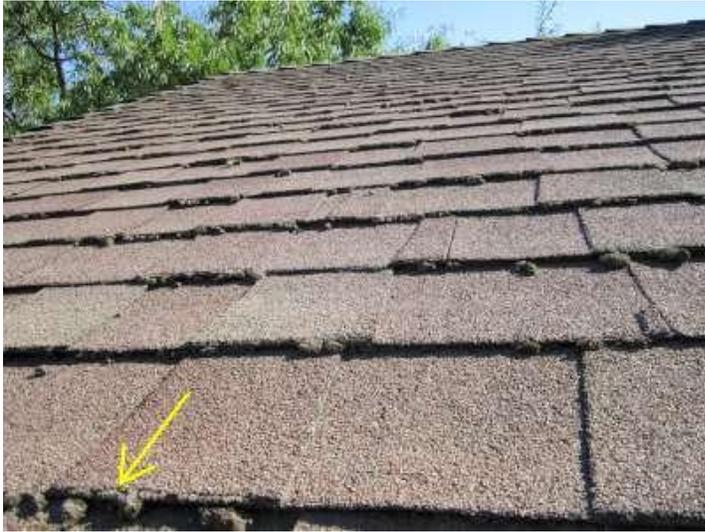
Photo 4

9) 🧰 Moss is growing on the roof, notable on the north faces. As a result, shingles may lift or be damaged. Leaks may result and/or the roof surface may fail prematurely. This is conducive for wood destroying insects and organisms. Efforts should be taken to kill the moss during its growing season (wet months). Typically zinc-based chemicals are used for this, and must be applied periodically. For information on various moss treatment products

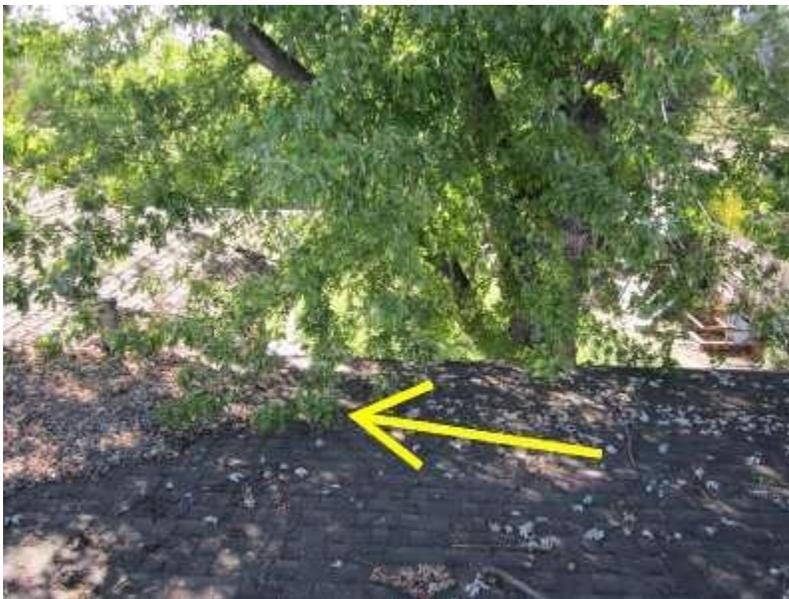
Photo 7

10) 🛠️ Trees are overhanging roof and are within 10 feet of roof vertically. This is conducive for wood destroying insects and organisms since organic debris such as leaves or needles are more likely to accumulate on the roof surface. Accumulated debris may cause water to enter gaps in the roof surface and leak into attic and/or interior spaces. Trees should be pruned so they are at least 10 feet above roof, or don't overhang the roof.

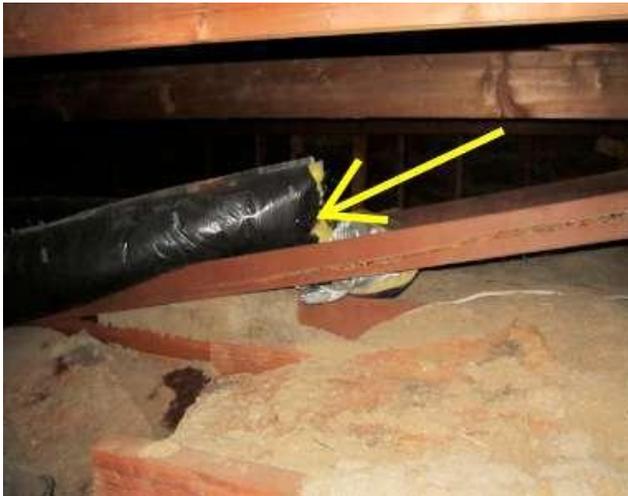
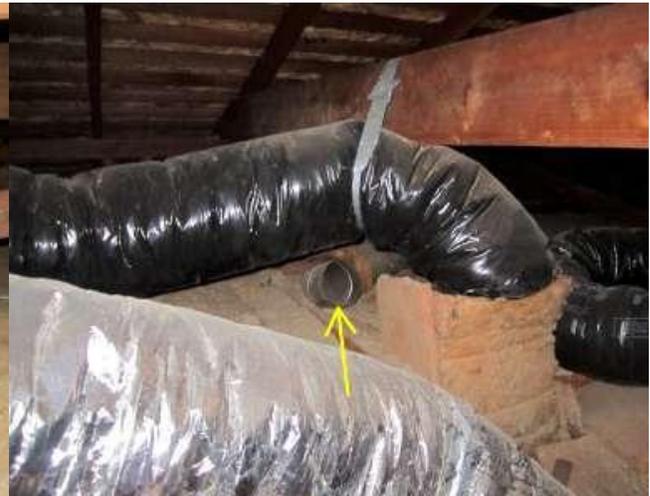
15) 🛠️📌 Unused duct work left in attic. It appears that when flexible ducts were installed in the older section of the home, some were damaged, unused and left there. These waste pieces should be removed.

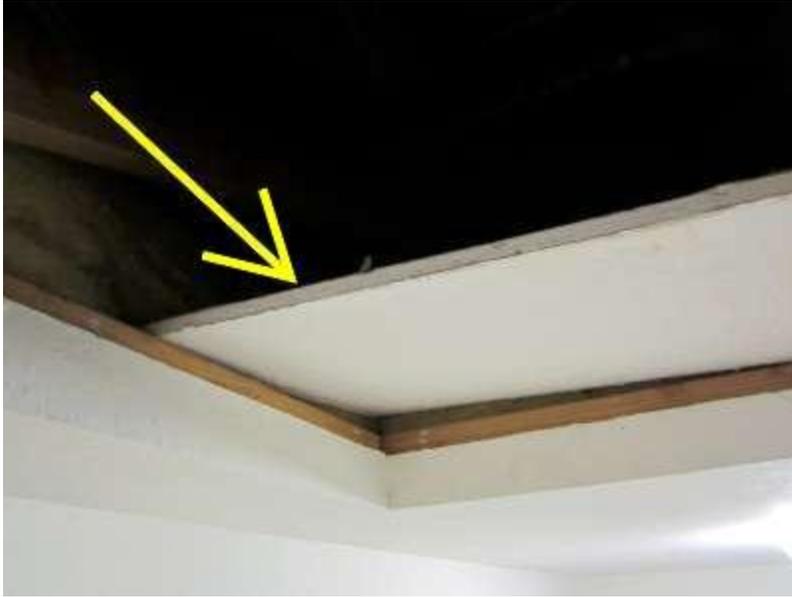
Photo 19

16) 🛠️ No insulation is installed over the attic access hatch. Recommend installing insulation above hatch for better energy efficiency.

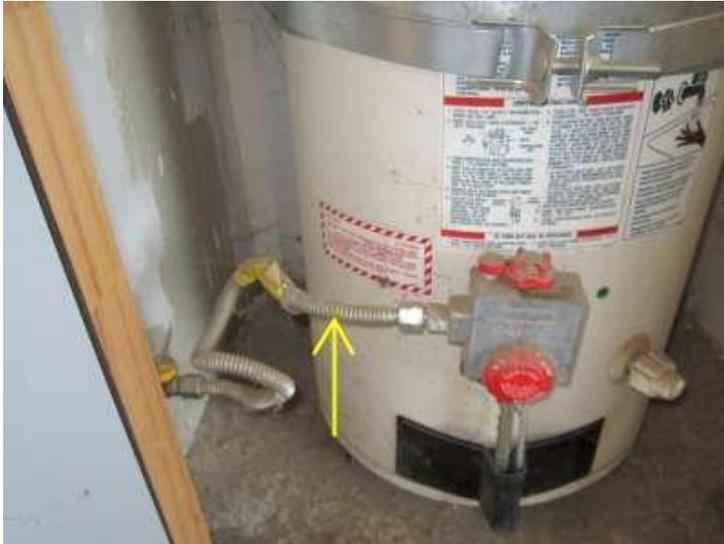
No drip leg is installed on the water heater gas supply line. Drip legs are intended to trap oil, scale, water condensation and/or debris from the gas supply lines before they reach and damage the water heater components. A qualified contractor should install a drip leg as per standard building practices.

Photo 34
Drip leg should go here.

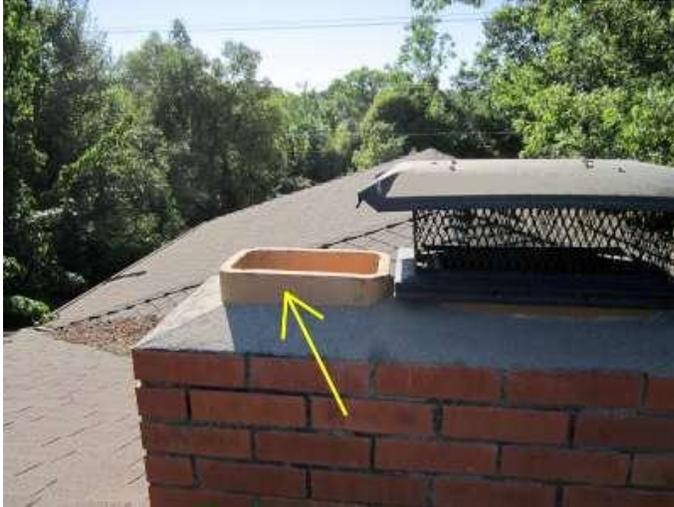
Photo 5

- 27) 🛠️ The south (smaller) chimney flue does not have a rainproof cover installed. They prevent the following:
- Rainwater entering flues and mixing with combustion deposits, creating caustic chemicals which can corrode flues
 - Rainwater entering flues and causing damage to terracotta flue tiles from freeze-thaw cycles

A qualified chimney service contractor should install rainproof cover(s) where missing.

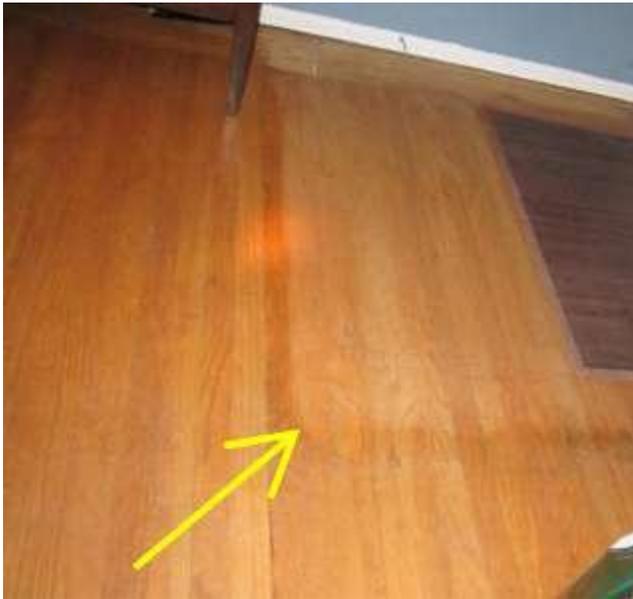
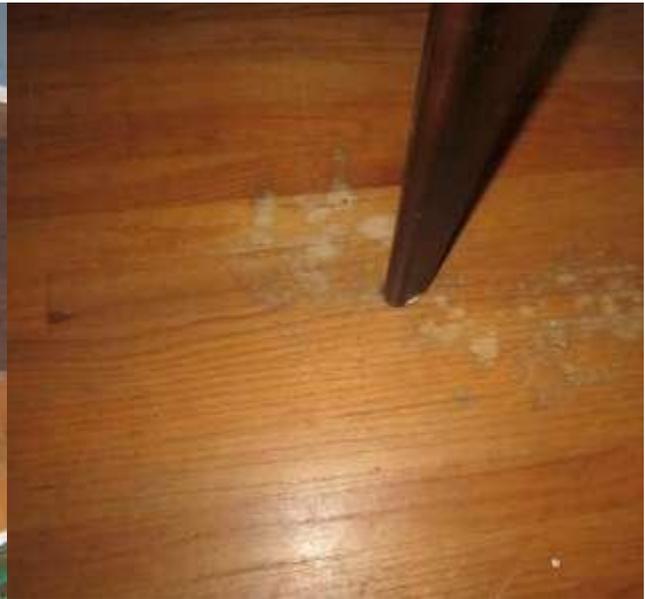
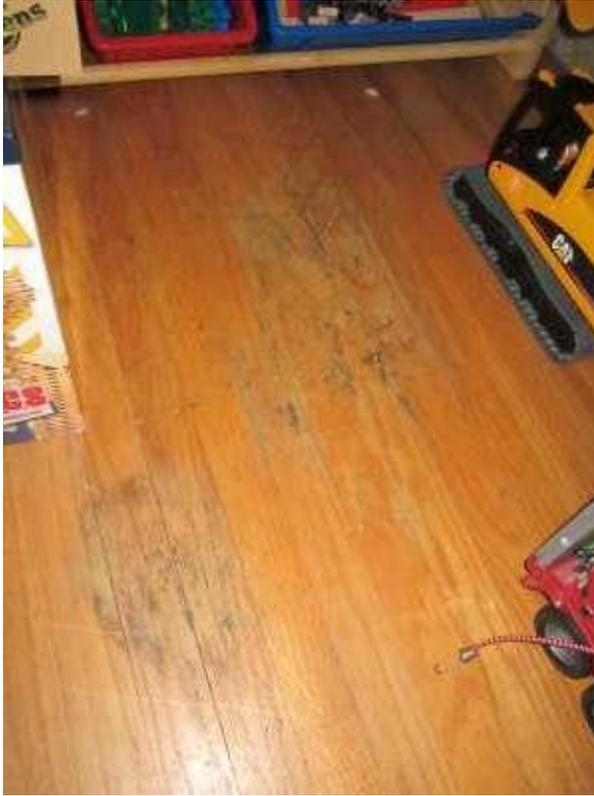
Wood flooring in one or more areas is worn, damaged and/or cupping. Recommend having a qualified contractor evaluate and refinish wood flooring as necessary.

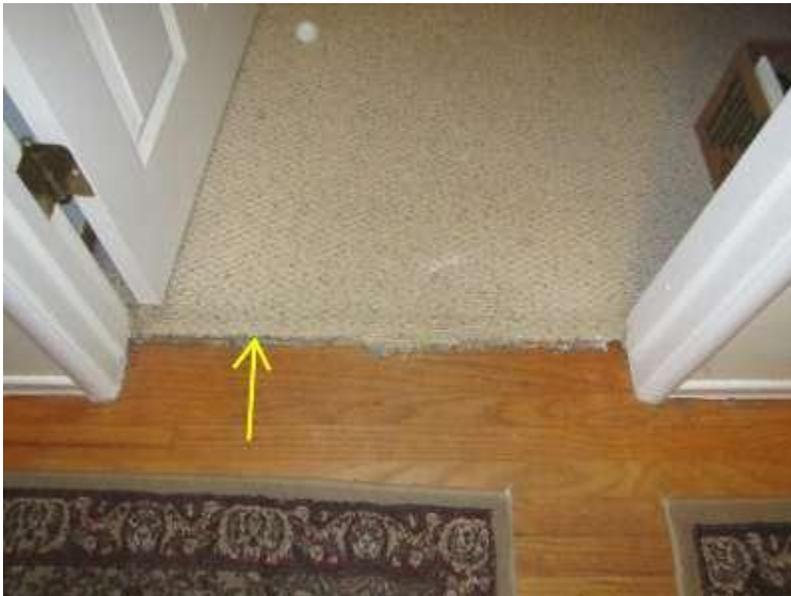
Photo 25

Carpeting interface to external hallway in one or more rooms is beginning to deteriorate. To prevent further damage, I recommend installing door plates where needed or extending carpeting throughout the hallway.

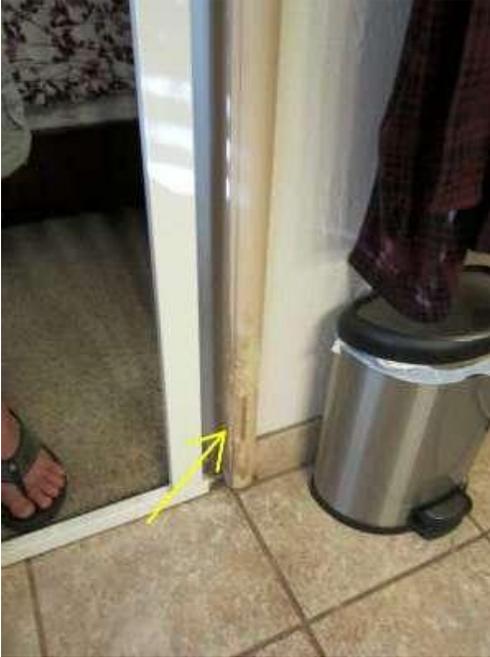
Photo 18

Trim is damaged and/or deteriorated in the master bathroom door frame. Recommend having a qualified contractor replace or repair trim as necessary.

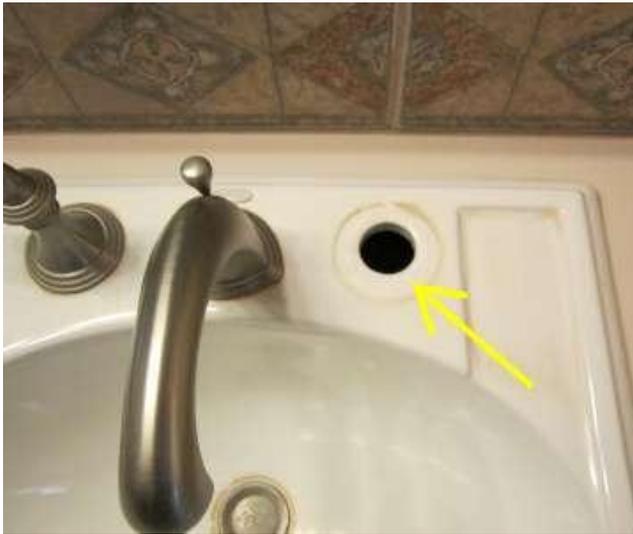
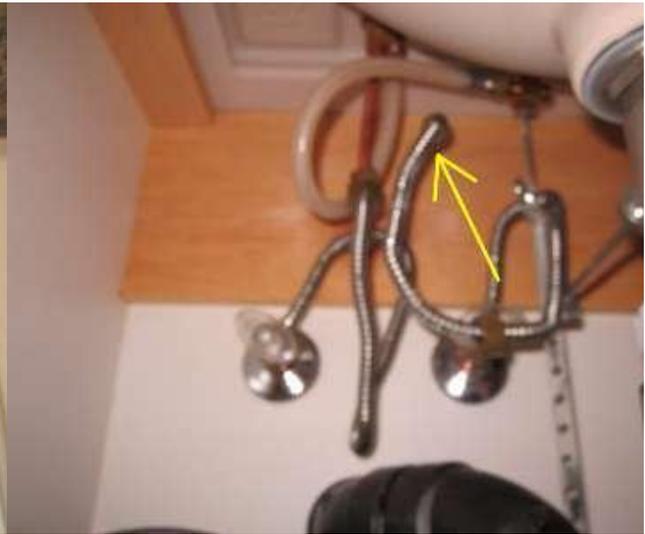
The cold water hardware on the right sink of the master bedroom is missing and the supply line from the under sink shutoff has been cut. The hardware and supply line need to be replaced.

Cut supply line, need to be replaced.

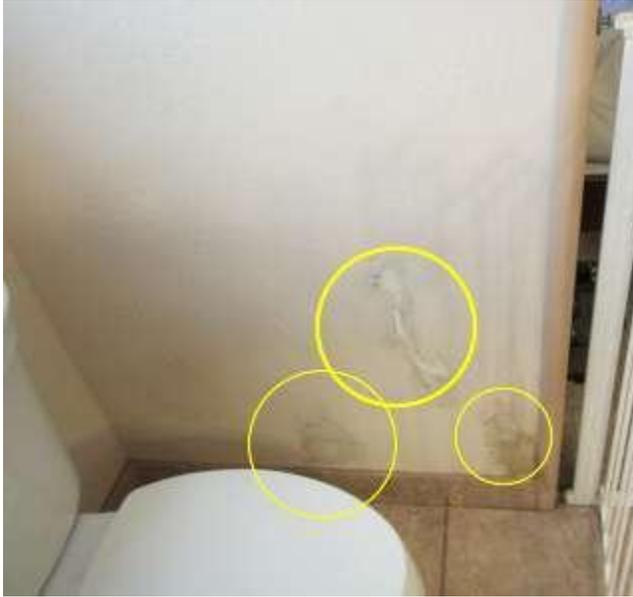
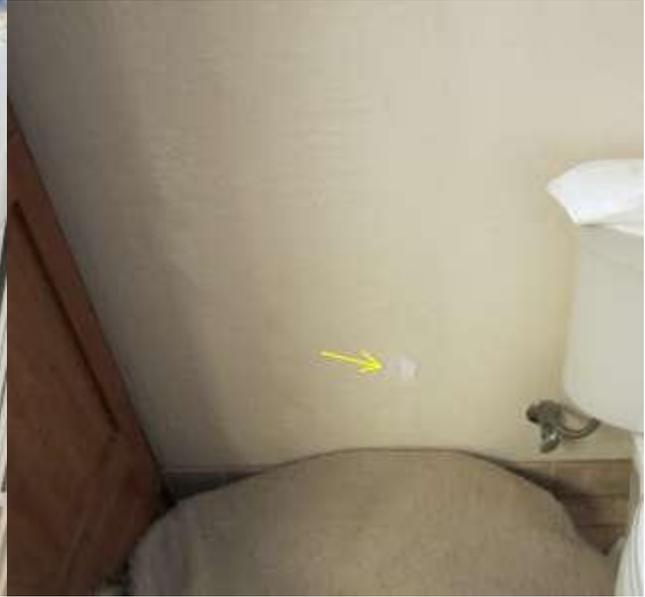
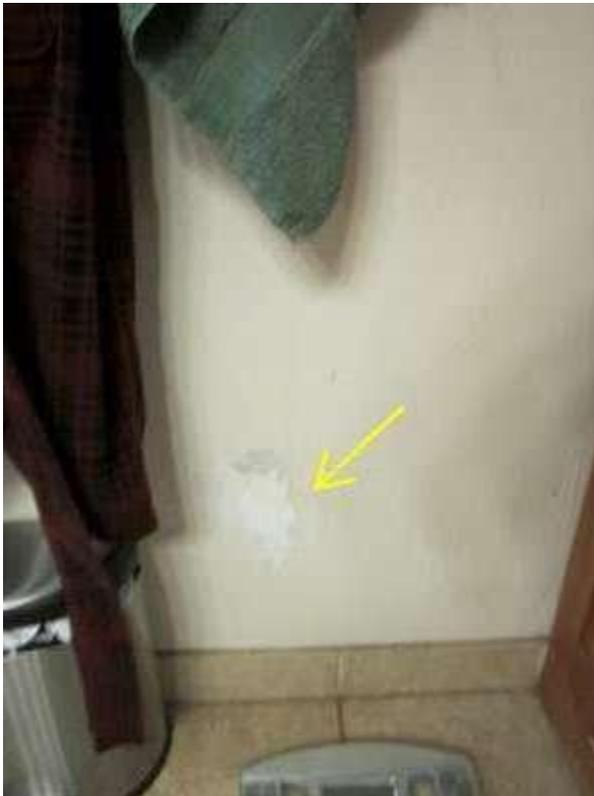
North wall in the master bedroom, adjacent to the toilet and one other adjacent wall has been damaged and improperly repaired. The damage to the drywall in this area should be repaired by a qualified contractor.

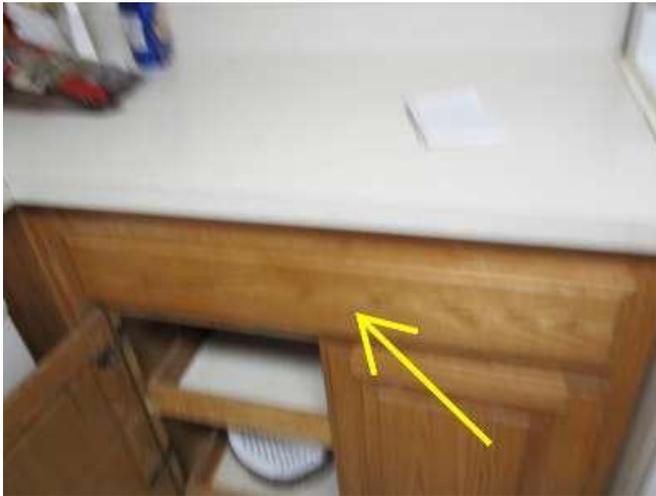
Photo 11

One of the slide out drawers is difficult to open and close and comes off it hardware. The slide rails need to be repaired or replaced. This drawer is located on the inside northwest corner of the counter. A qualified contractor should evaluate and repair as necessary.
