# Mercer Inspection Services

## Property Inspection Report

**Report number:** 1011

**Structures inspected:** House and attached garage.

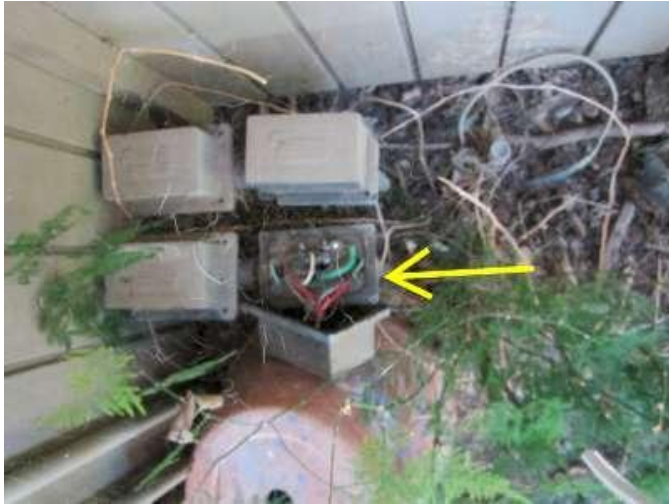
**Photo 23**

Cover plate(s) are missing from one the electric boxes in the east/rear of the house. They are intended to contain fire and prevent electric shock from exposed wires. This is a safety hazard due to the risk of fire and shock. Cover plates should be installed where missing.

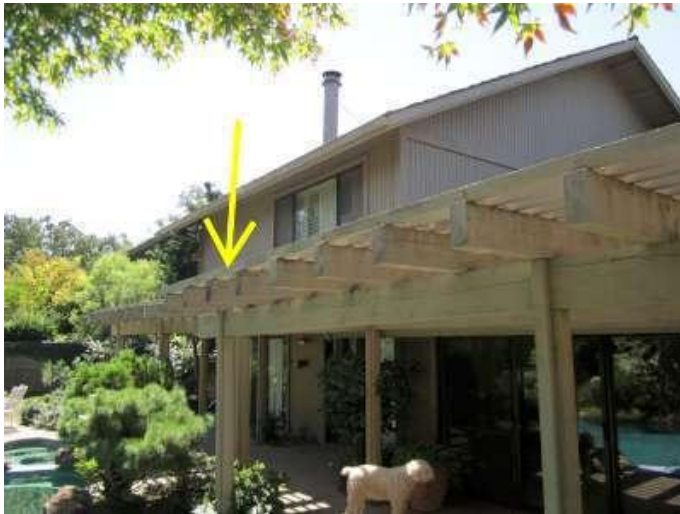
**Photo 22**

The center wooden support post for the patio cover has sunk. This has caused slopping of the patio and movement of the attached patio beams. This appears to be due to a sinking footer. Because of the weight of the patio and the number of connecting beams involved, I recommend that a qualified structural engineer should evaluate to determine what repairs are necessary. Repairs should be made by a qualified contractor.

Point and direction of depression.

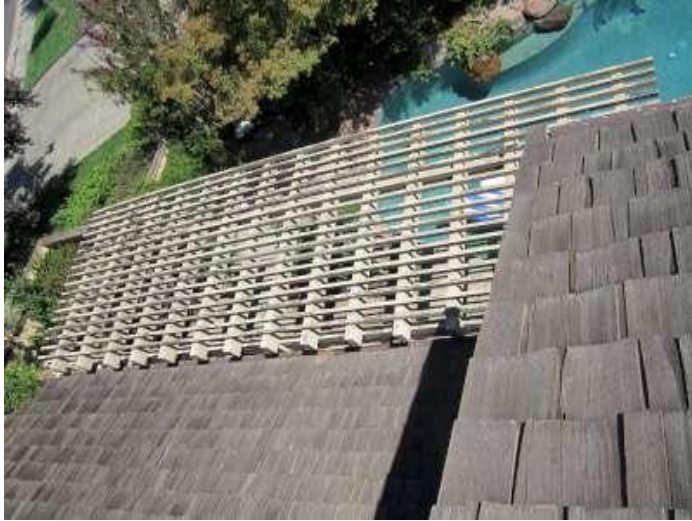
**Photo 14**

The paint on the wooden patio cover is peeling and the wood is exposed on the top of the wood lattice. Deterioration of the wood has begun in many areas but it appears that if stripped and repainted in the near future will prevent having to replace much of the wood covering. The photo below show only the north section, and this applies to all of the patio covering.

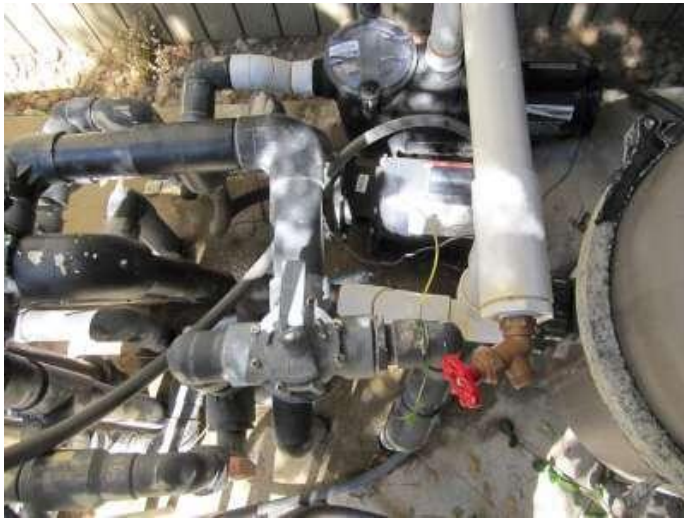
**Photo 24**

5) 🔧🔍 The pool filter plumbing leaks. Although the pool is excluded from this report, I note this as a general alert that is time for the pool to receive maintenance by a qualified pool professional.

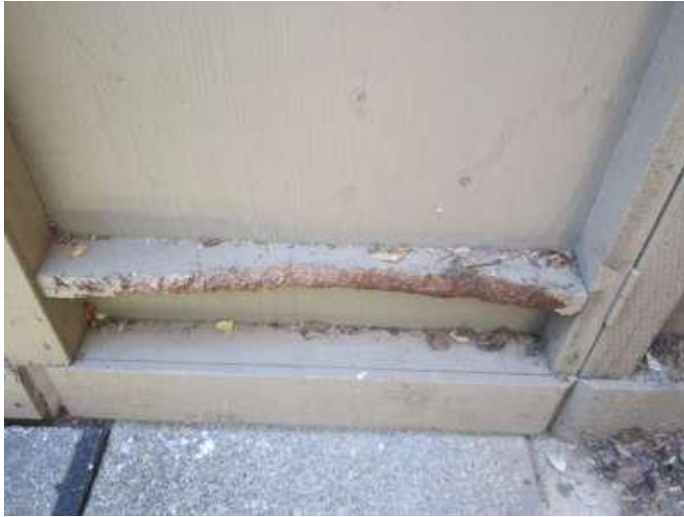
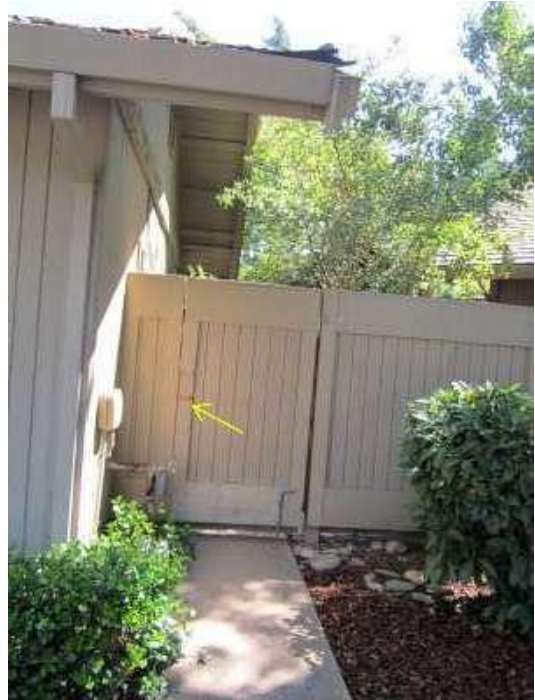
6) 🔧 1) The lower portion of the inside frame of the south entrance gate has been damaged by a dog.  
2) The outside of the south gate has some small damage.

Repairs should be made as necessary, and by a qualified contractor if necessary, so that this section of the gate does not deteriorate.

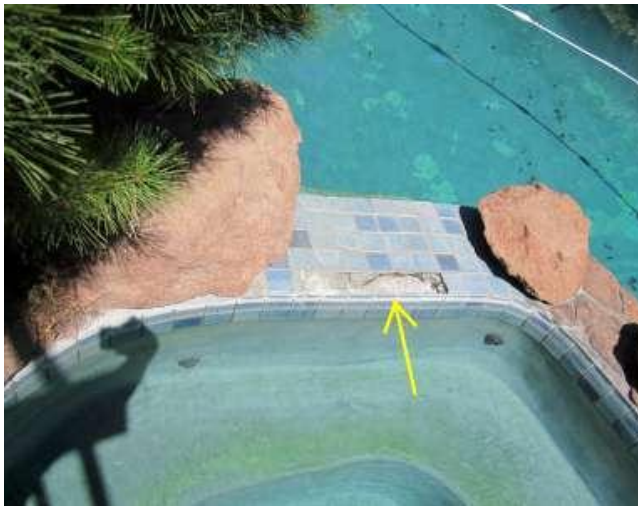
**Photo 26**

Although the pool is excluded from this report, I note that the surface tile and edge concrete are cracked in one location each. Recommend that a qualified pool masonry specialist make these repairs.

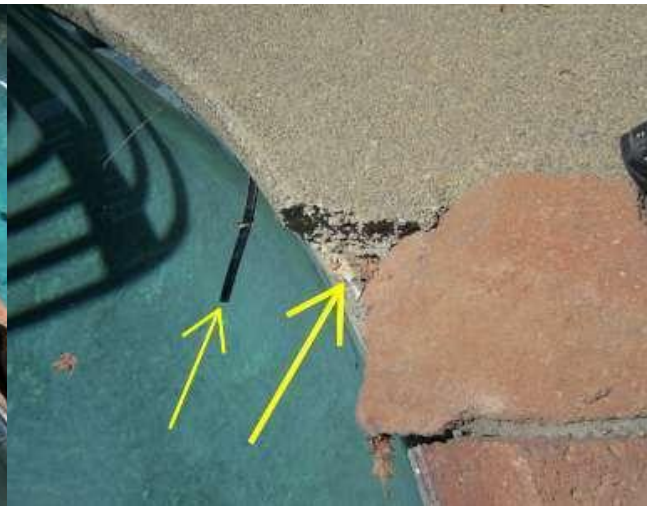
**Photo 36**

Fractured aggregate and torn edge seal.

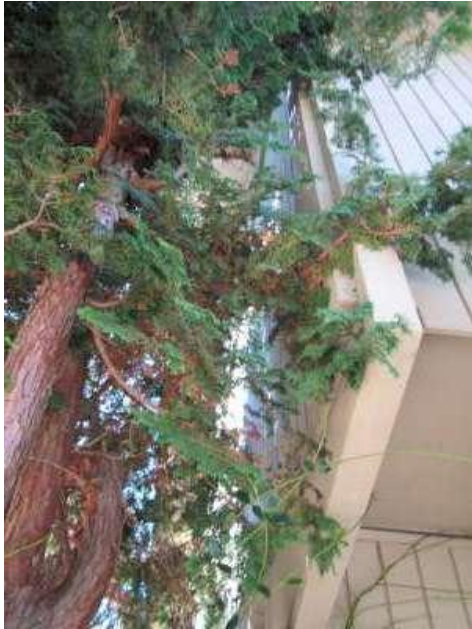
**Photo 25**

Vegetation such as trees, shrubs and/or vines are in contact with or less than one foot from the structure's exterior. Vegetation can serve as a conduit for wood destroying insects and may retain moisture against the exterior after it rains. Vegetation should be pruned

and/or removed as necessary to maintain a one foot clearance between it and the structure's exterior.

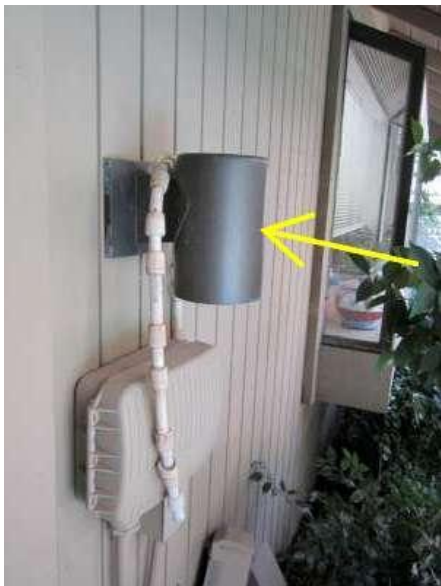
**Photo 35**

One or more of the black external light fixtures appear to be inoperable. Recommend further evaluation by replacing bulb(s) and/or consulting with the property owner(s). Repairs or replacement of the light fixture(s) by a qualified electrician may be necessary.

These light fixtures were not operable.

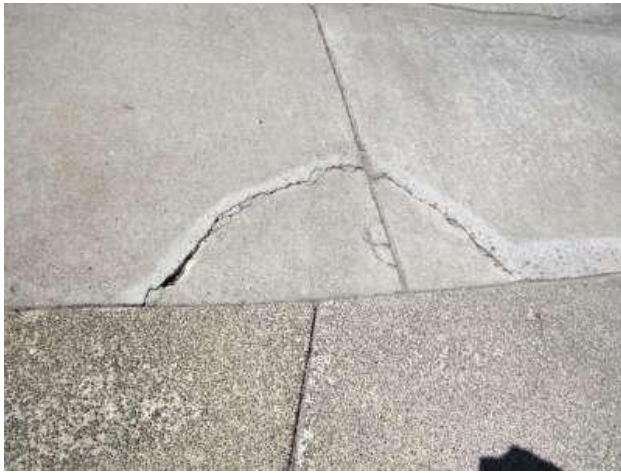
**Photo 2**

Minor cracks were found in one sidewalk section. However they don't appear to be a structural concern and no trip hazards were found. No immediate action is recommended,

but the client(s) may wish to have repairs made or have cracked sections replaced for aesthetic reasons.

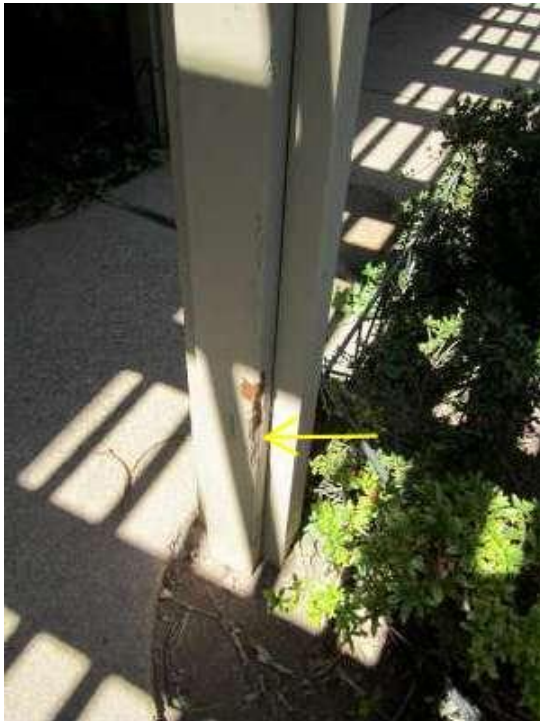
**Photo 27**

**11)** Minor damage to one of the patio support posts. This can be repaired with a common wood filler and repainted.

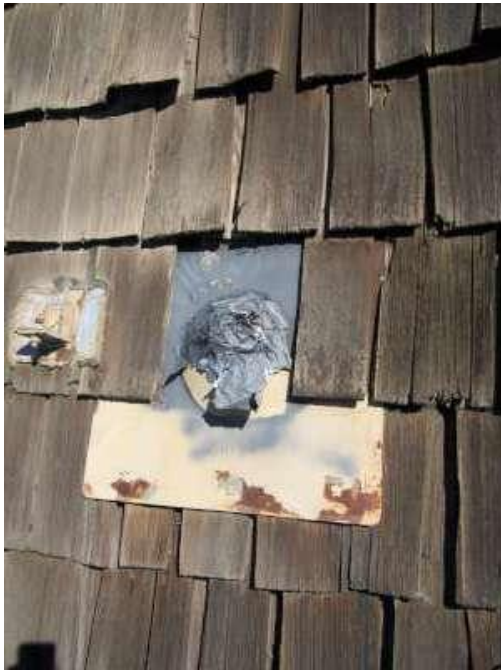
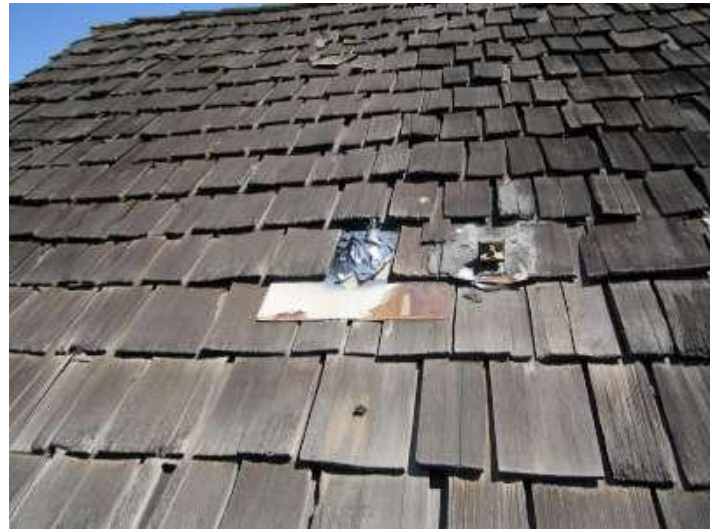
A solar water heater was removed from the west face of the roof and the plumbing pipes were only capped with aluminum foil and a thin coat of sealant. This is inadequate. These pipes and the hardware mounts for the unit should be removed and the holes patched and roofed over. A qualified roofing contractor should make this repair.

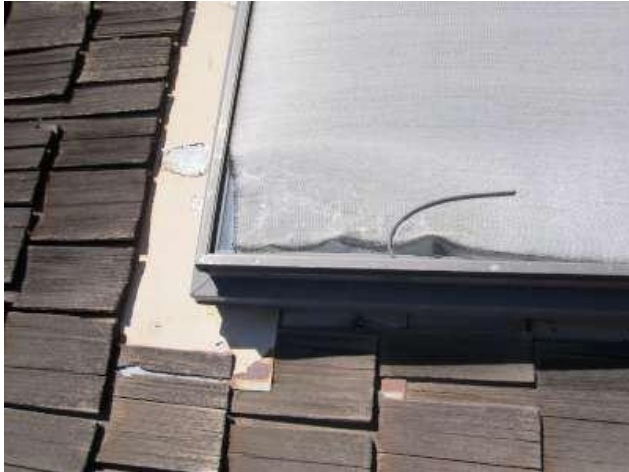
**Photo 13**

Screen is torn on skylight of master bedroom. Recommend that you consult with a window specialist about either repairing or replacing this screen.

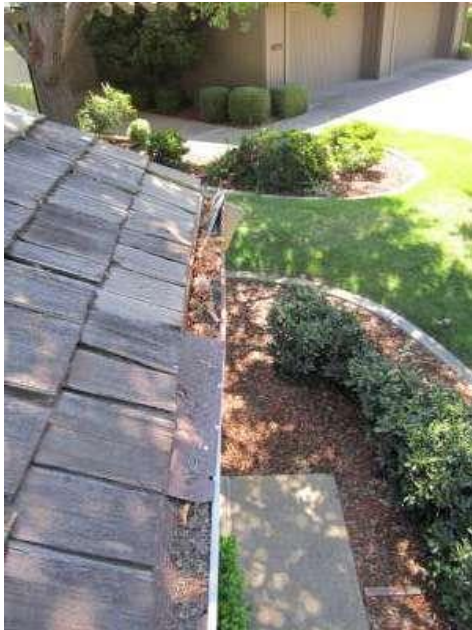
**Photo 11**

**15)** 🧰 Debris has accumulated in one or more gutters. This is conducive for wood destroying insects since gutters may overflow and cause water to come in contact with the structure's exterior or make water accumulate around the foundation. Gutters should be cleaned now and as necessary in the future.

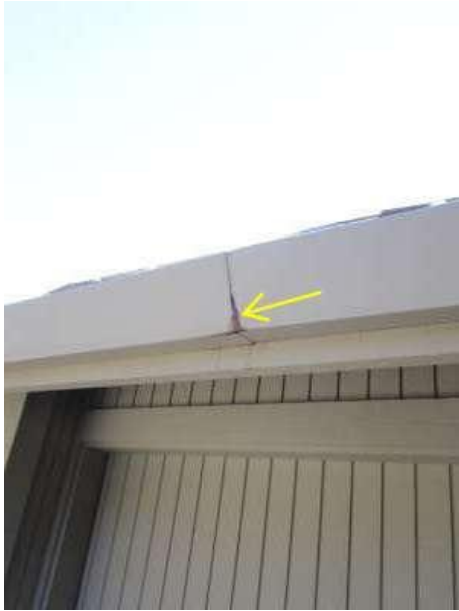
**Photo 4**

**17)** Seam leak in front gutter over the garage. Stains at the joint indicate that the joint is leaking. Sealant should be cleaned and re-applied.

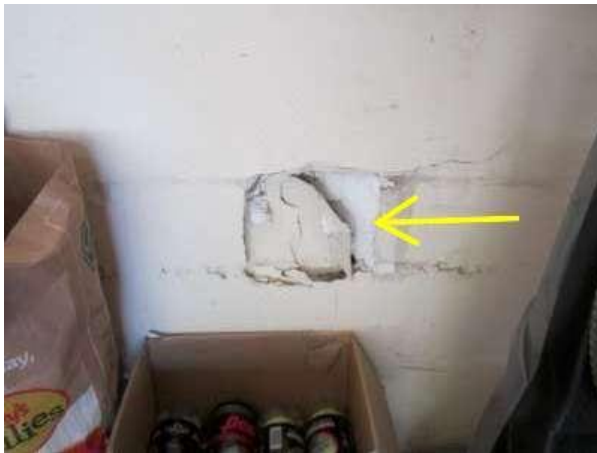
**Photo 18**

**18)** 🔧🔍 One of the wall surfaces between the attached garage and interior living spaces has a significant hole. These surfaces are intended to prevent vehicle fumes from entering living spaces, and to slow the spread of fire from the garage to living spaces. A qualified contractor should evaluate and make repairs as necessary so the attached garage wall and ceiling surfaces that adjoin living spaces are tightly sealed and fire rated as per standard building practices. Typically these surfaces require a one-hour fire rating.

Break in the firewall. Approx. 6 feet south of house/garage door.

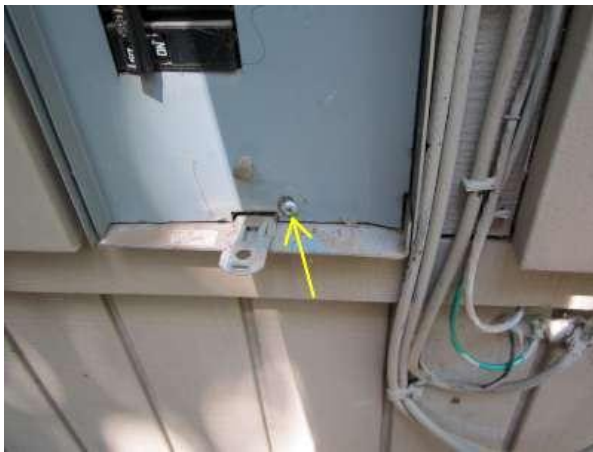
**Photo 20**

Incorrect service panel retaining screw. The retaining screw at the base of the service panel interior panel is a 1.5" sheet metal screw. This can penetrate wire insulation inside the service panel and so is considered unsafe. This screw should be replaced with a blunt ended 0.5 inch metal screw.

Incorrect fastener.

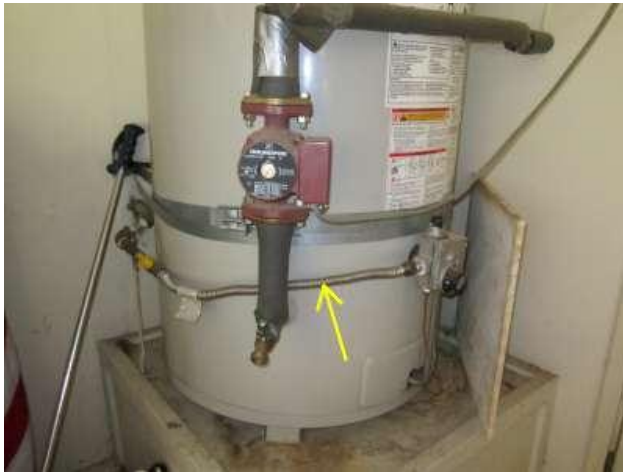
**Photo 19**

No drip leg is installed on the water heater gas supply line. Drip legs are intended to trap oil, scale, water condensation and/or debris from the gas supply lines before they reach and damage the water heater components. A qualified contractor should install a drip leg as per standard building practices.

Drip leg should be on this gas line.

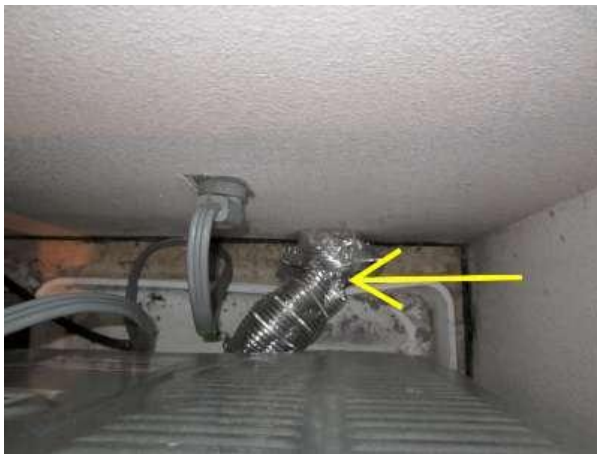
**Photo 10**

The clothes dryer exhaust duct is kinked, crushed and/or damaged just behind the dryer. Air flow is restricted as a result. This is a safety hazard due to the risk of fire. The exhaust duct should be replaced or repaired, and by a qualified contractor if necessary. For more information, visit:

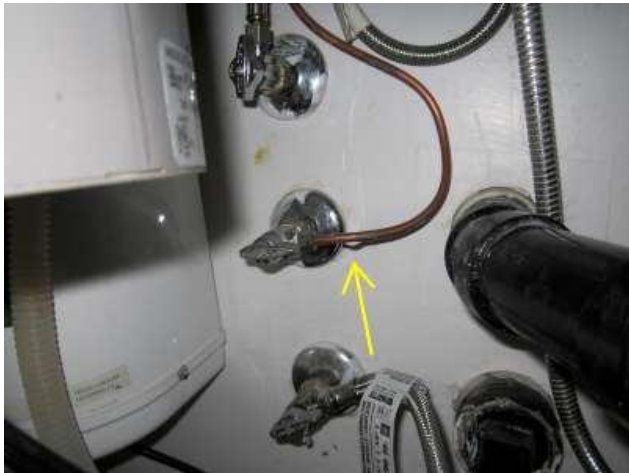
**30)** 🔧🔍 The supply line to the Instant 190 Hot Water dispenser located in the left side sink leaks or drips. A qualified plumber should evaluate and repair as necessary.

**Photo 37**  
Drip point.

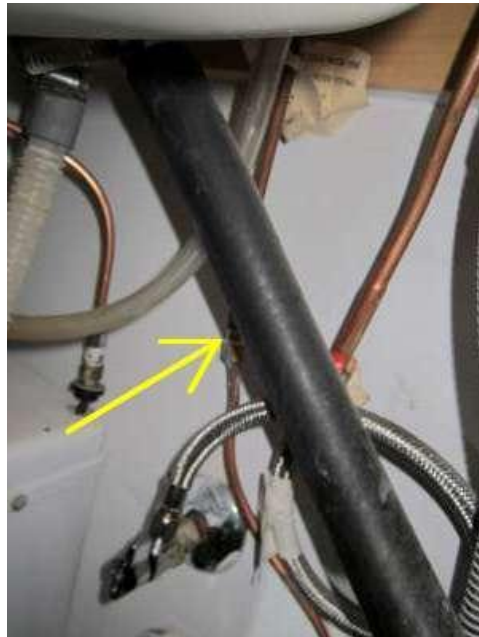
**Photo 38**  
Leak source.

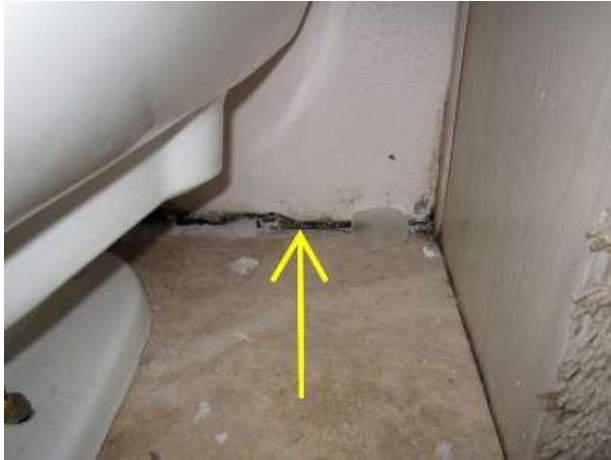
The base of the wall behind of the toilet in the downstairs front bathroom has been deteriorated by water damage and contains black mold. A presumed leak that caused this appears to have been repaired, but the full extent of the damage needs to be fully evaluated by a drywall specialist.

**Photo 40**  
Right side.

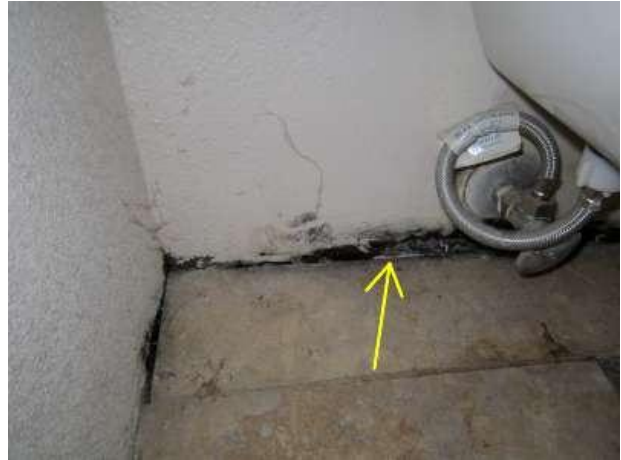
**Photo 41**  
Left side.

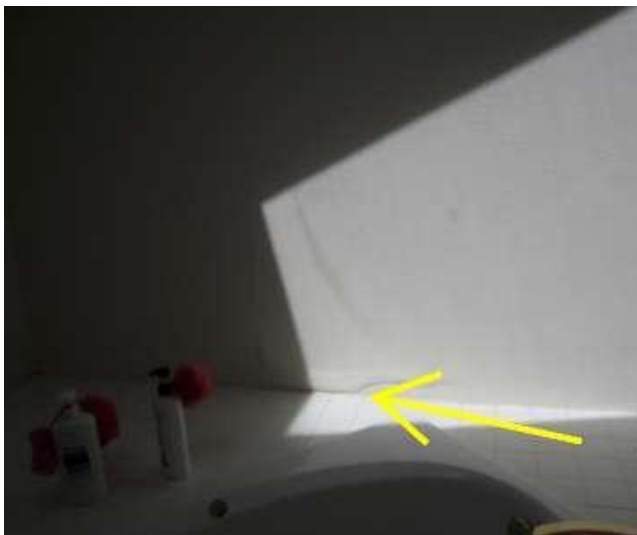
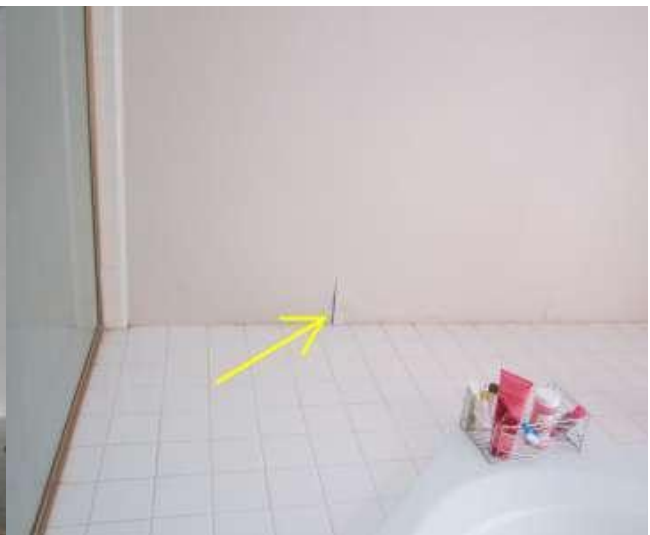
Two sections of the wall that surround the upstairs master bedroom tub have split or delaminated. This should be repaired by a qualified contractor.

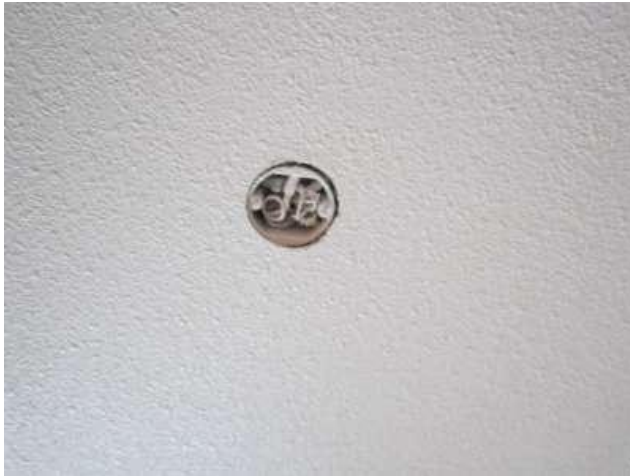
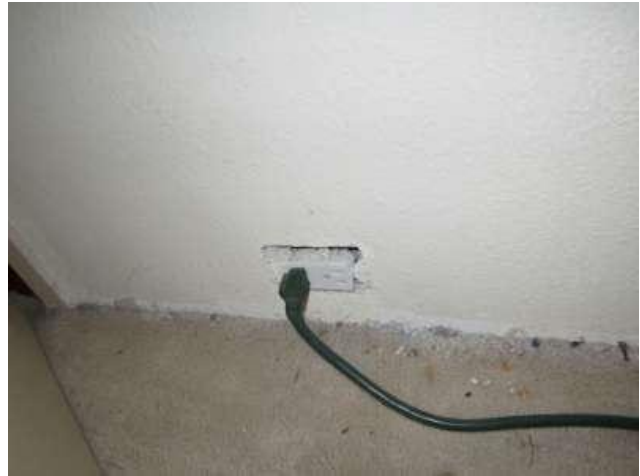
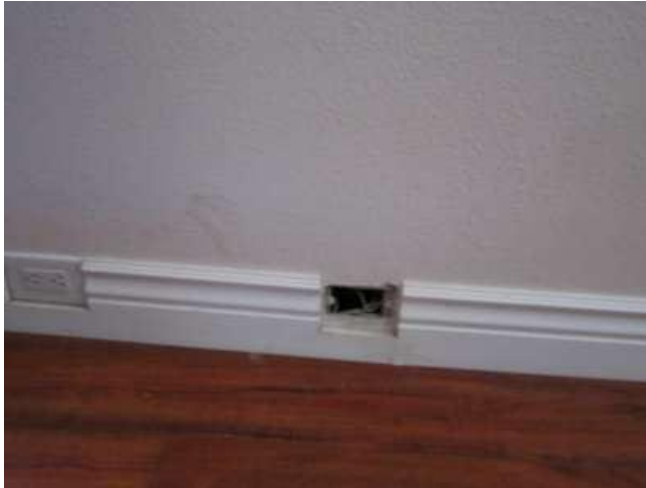
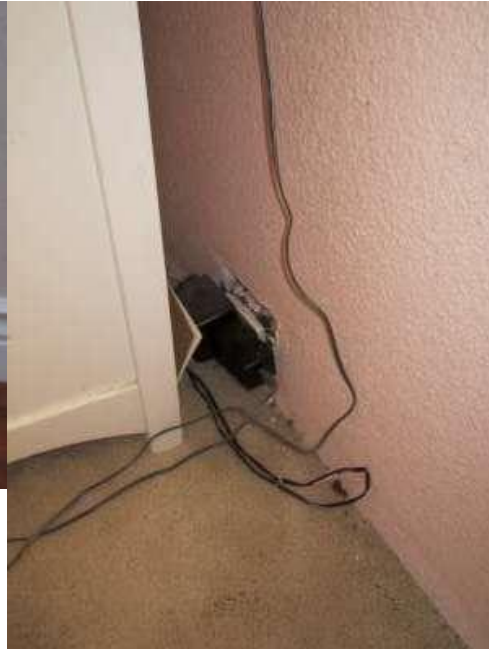
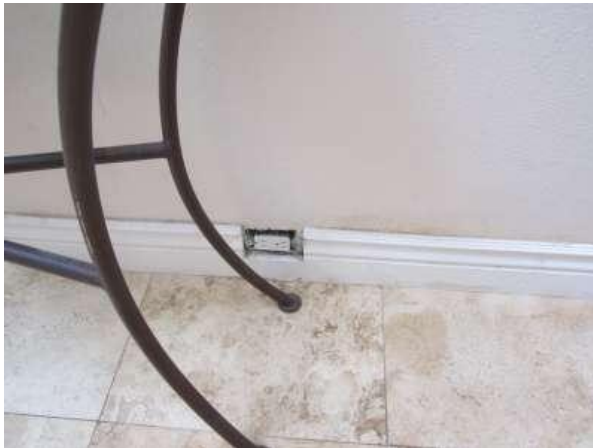
**37)** 🛠️ Cover plate(s) are missing from one or more electric boxes, such as for receptacles, switches and/or junction boxes. They are intended to contain fire and prevent electric shock from exposed wires. This is a safety hazard due to the risk of fire and shock. Cover plates should be installed where missing. Photos are of missing plates but are not exhaustive of all that are missing.

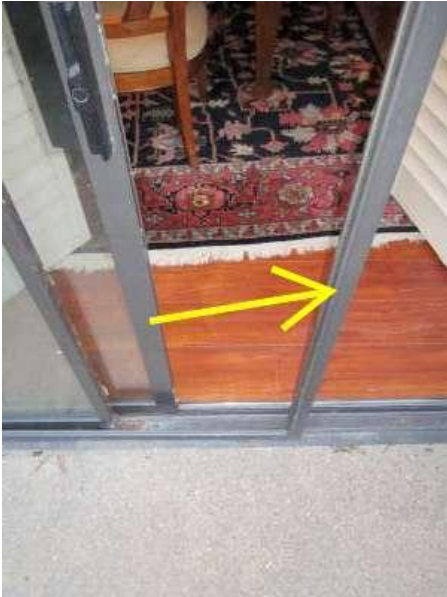
**39)** 🔧🔍 Screen(s) in the dining room, and the lower southwest corner bedroom sliding doors are missing.

The frame is present in the dining room, but no screen. In the bedroom, the entire frame(s) are missing

**Photo 5**  
No screen.

window cleaning and they may be stored somewhere. If not, then recommend installing screens where missing.

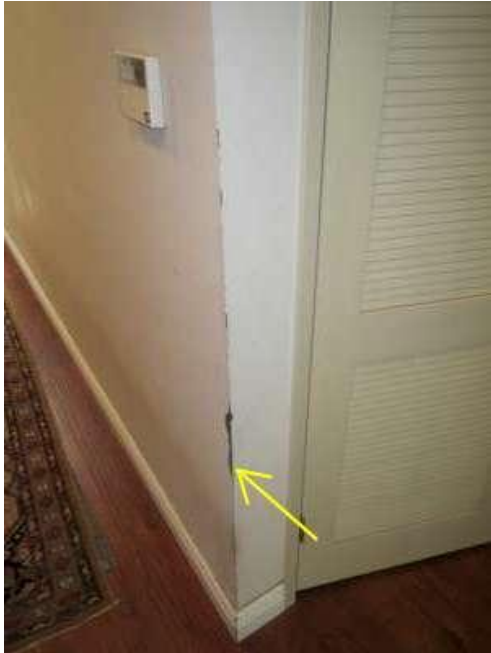
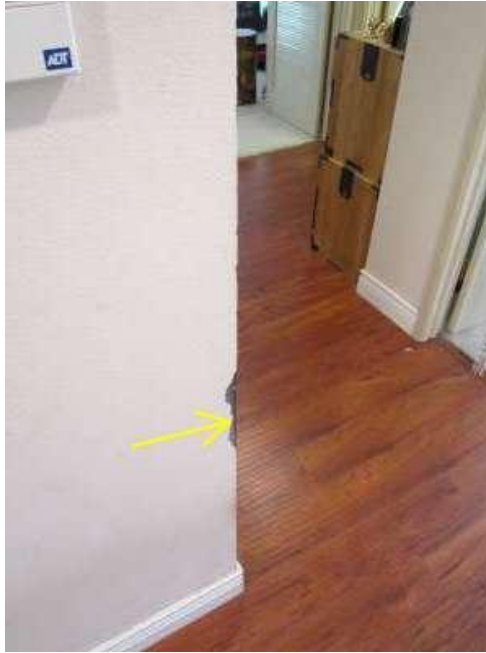
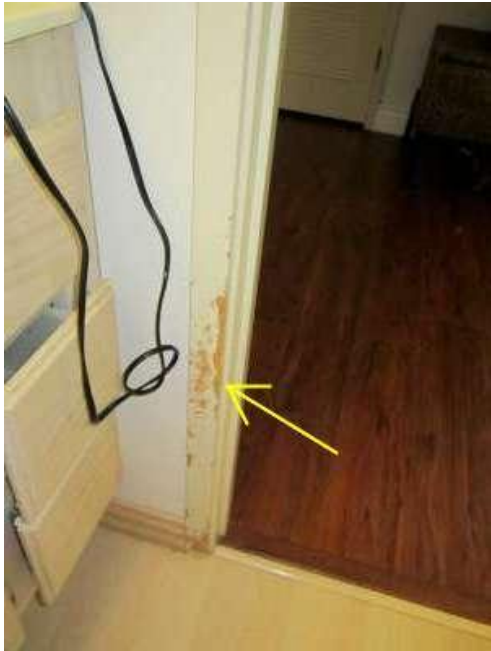
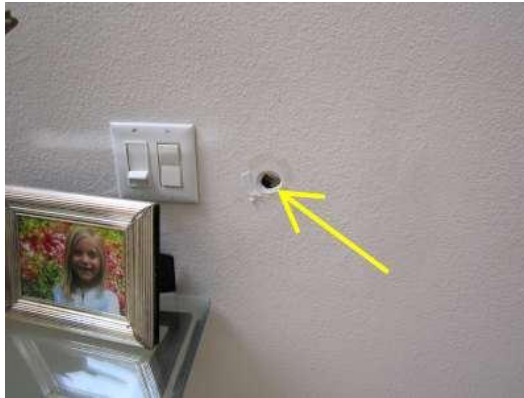
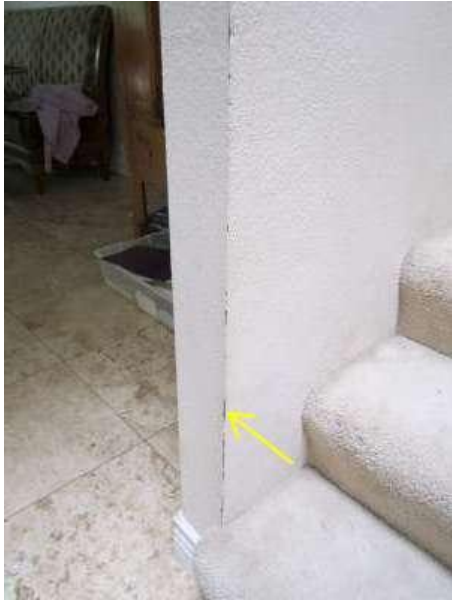
1) The entrance way hall has a 1" whole it.  
2) Some of the wall edges at the base of the stairway are deteriorated down to the steel edging.  
3) An outside corner edge of the downstairs hallway is damaged and the finish has been worn down to the steel edging.  
4) A lower section of the downstairs bathroom molding has been damaged by a dog.

These repairs should be made by a qualified contractor.

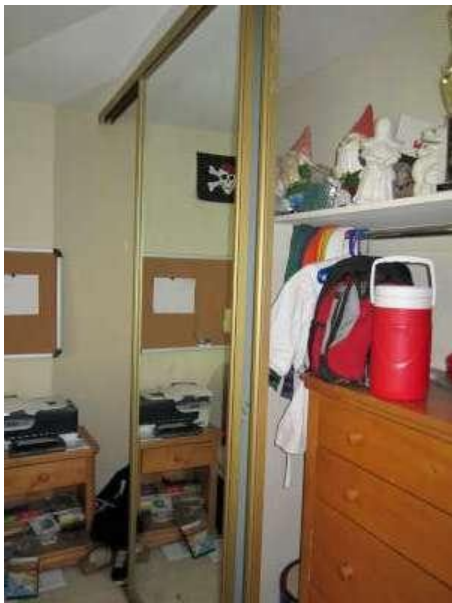
**Photo 42**

**41)** One of the glass sliding doors in the lower southwest bedroom appears to be missing. I suggest consulting with current owner over the whereabouts.

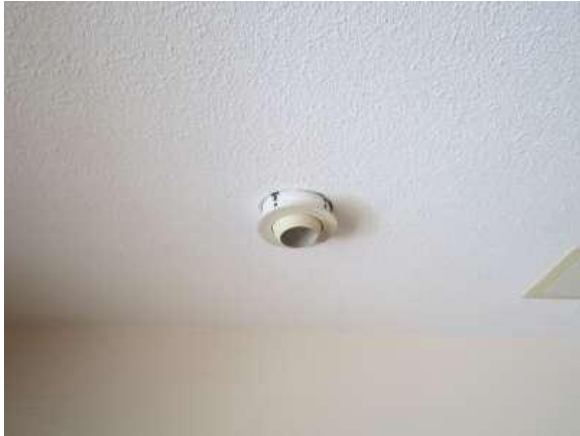
**Photo 28**

**42)** A ceiling lighting canister in the east lower family room is lowered out of its resting position and is inoperable. Recommend speaking to the current owner about the status of this lighting canister. It may require a licensed electrical contractor to repair or replace.
