Mercer Inspection Services

Property Inspection Report

This report published on Wednesday, September 12, 2012 2:45:13 PM PDT

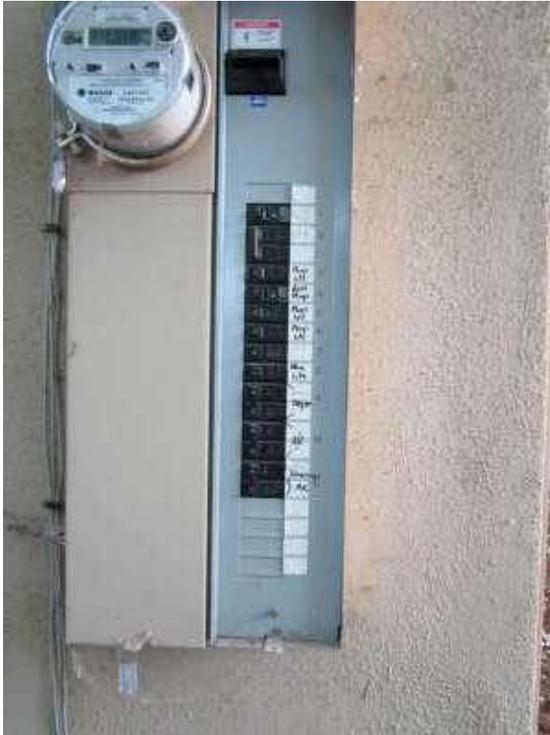
Photo 32

19) Photos of electrical service for reference.

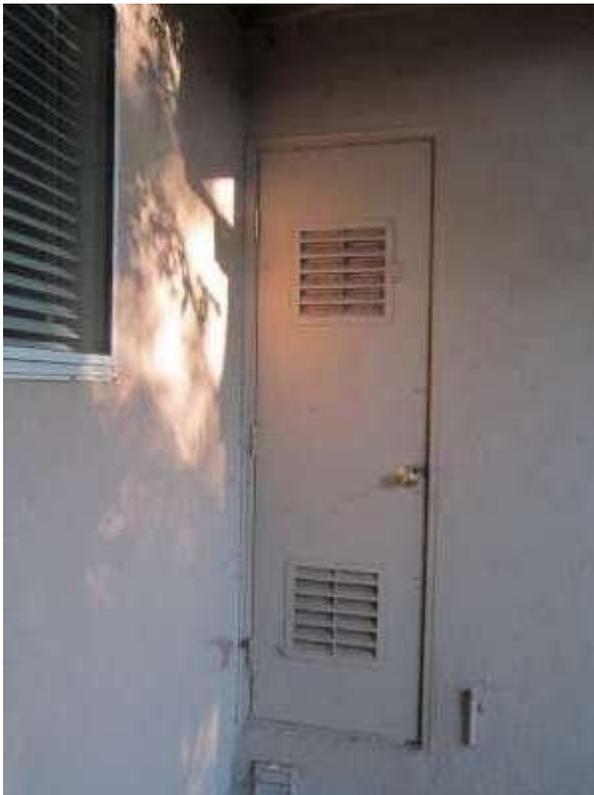
22) Location of water heater is in the water heater closet on the inside corner of rear of house.

Photo 35
Water heater location.
